Preliminary Advice

Insured Vehicle No	: SJP1301Y	Accident Date	: 05/12/2019
TP Vehicle No	: SHA6953K	Assignment Date	: 10/12/2019
Make	: HYUNDAI I40	Est. Duration of Repair	: 3 days
Date of Inspection	: 09/12/2019		
Inspection At	: ComfortDelGro Engineering Pte Ltd (Loyang) 59 Loyang Drive Singapore 508969

VEHICLE DAMAGE INSPECTION REPORT

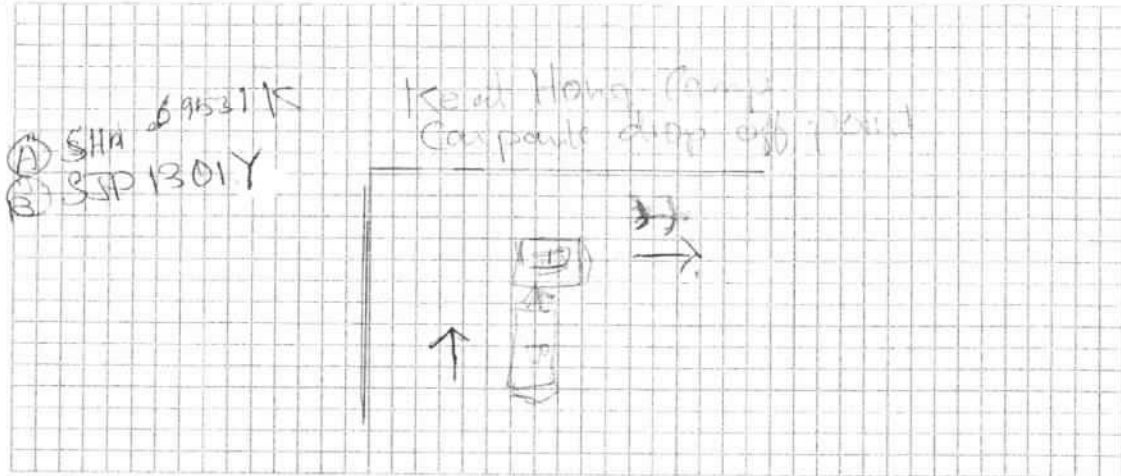
SKETCH PLAN

On 5/12/2014 at about 1900hrs, I vehicle A was driving my taxi along Keat Hong Camp carpark drop-off point when I park my taxi at the pick up point to waiting for my passenger. Vehicle B reverse his vehicle. Collided onto my taxi right near porton. After he hit my taxi I was back out for few second.

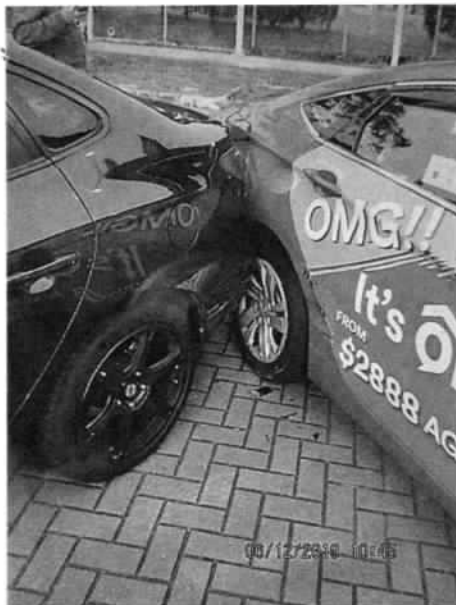
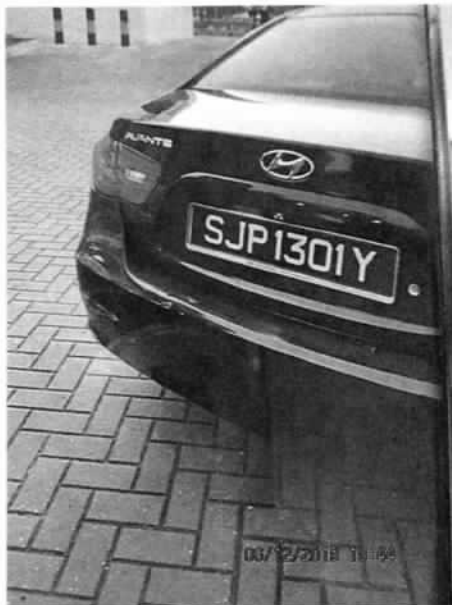
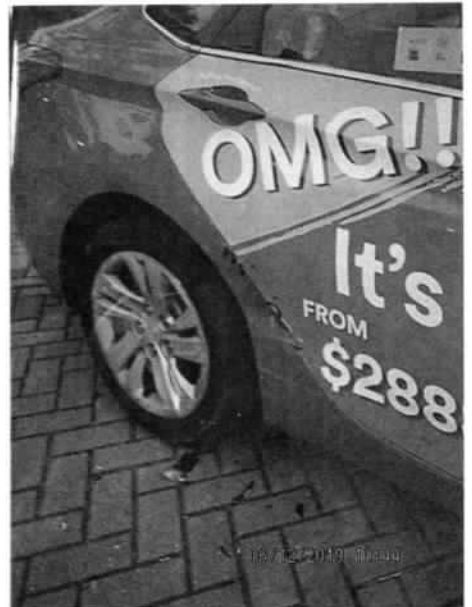
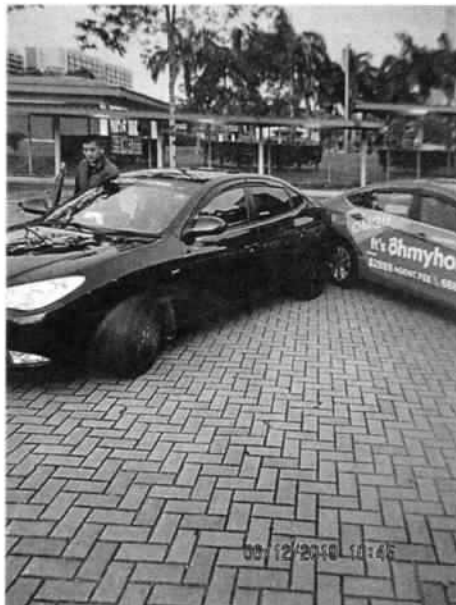
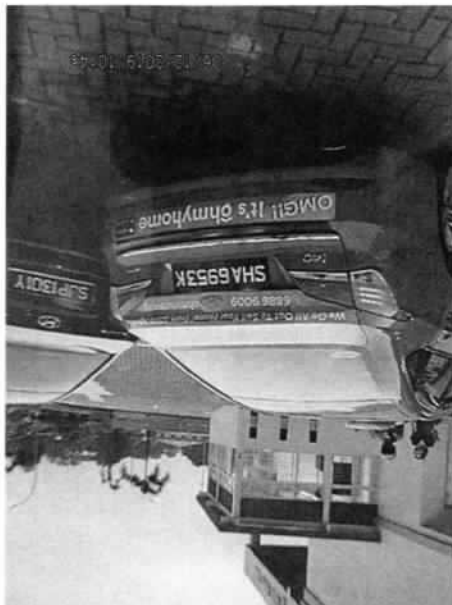
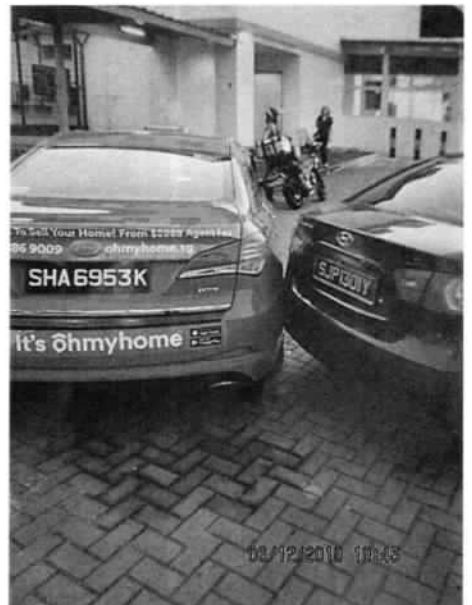
The vehicle sustained impact / damages o/s rear portion and parts claimed are consistent to the accident.
