From: venessa.chan@fwd.com
Sent: Tuesday, 10 December 2019 3:03 PM
To: 'admin-d@lkkauto.com'; 'admin-a@lkkauto.com'
Cc: motorclaims.sg@fwd.com; lionel.tan@fwd.com
Subject: PRE-REPAIR SURVEY --- YOUR REF: SLA 7601 Y --- ACCIDENT INVOLVING SLN 3740 L AND SLA 7601 Y ON 8 DECEMBER 2019 OUR CLAIM REF: 1201900039010

SLN3740L

Renault Megane

VEHICLE DAMAGE INSPECTION REPORT

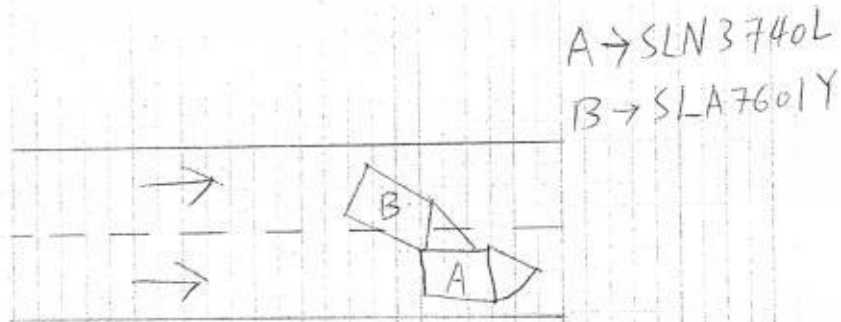
Sketch Plan #2 Pg. 1

On the Sunday 8 of December 2019,
when I was driving straight on Malaysia Second link
Checkpoint, there was a Jam so I come to a stop.
When the car in front of my vehicle move forward,
I move my car straight forward as well, all of a
sudden I heard a sound and feel the impact
coming from the left hand side of my car. (SLN3740L)
I step out of my car and take a look and
realise that Vehicle B (SLA7601Y) collided into
the left hand side of my car.

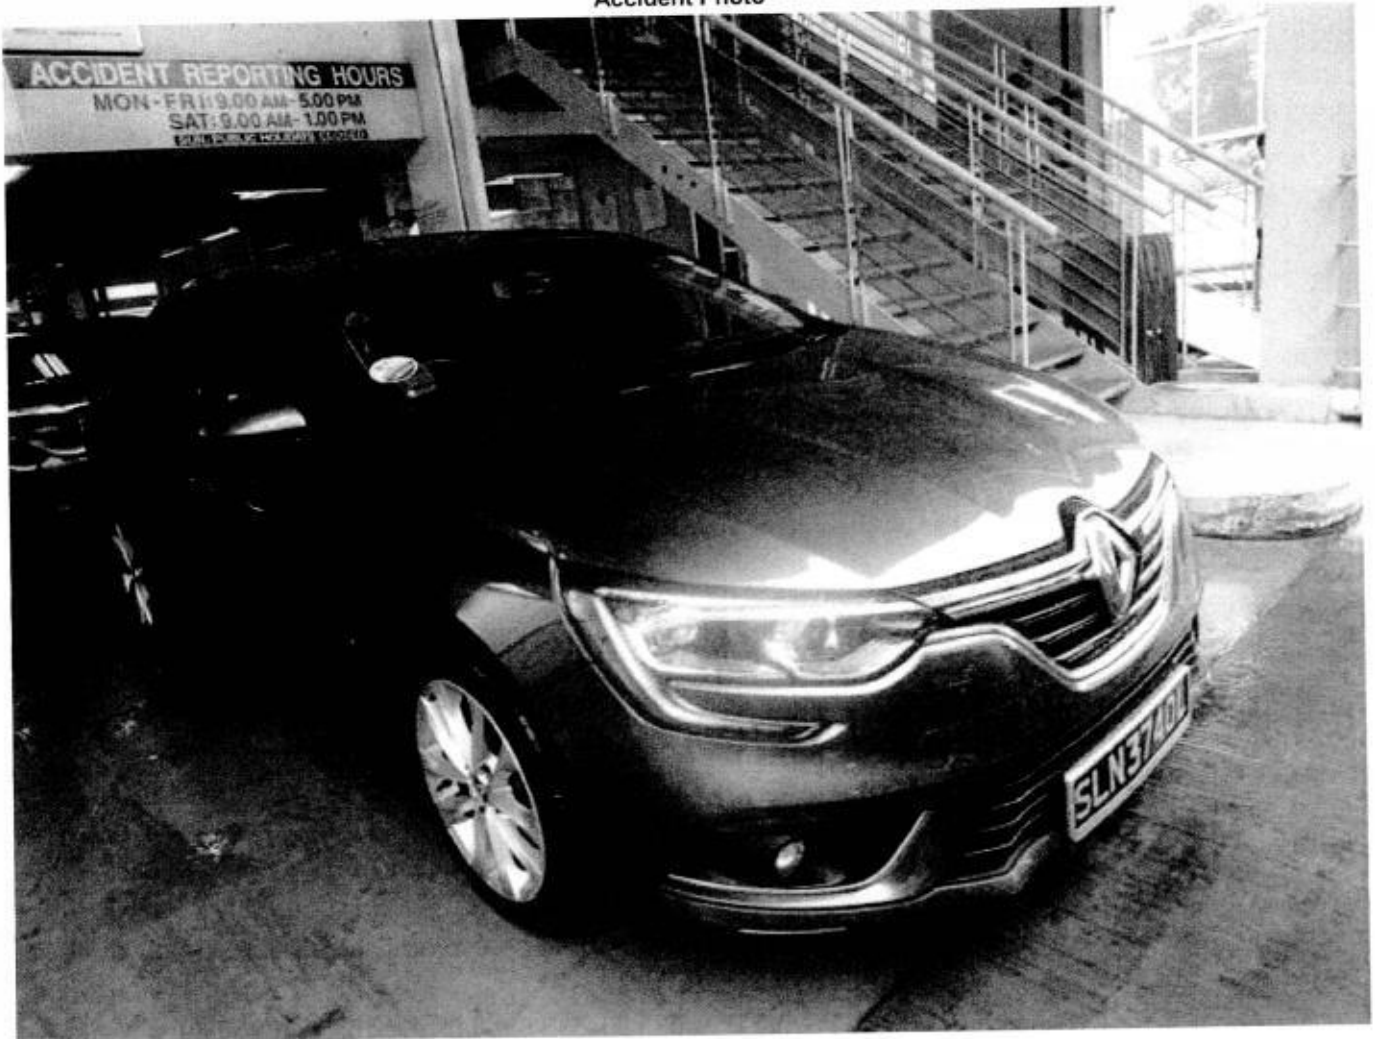
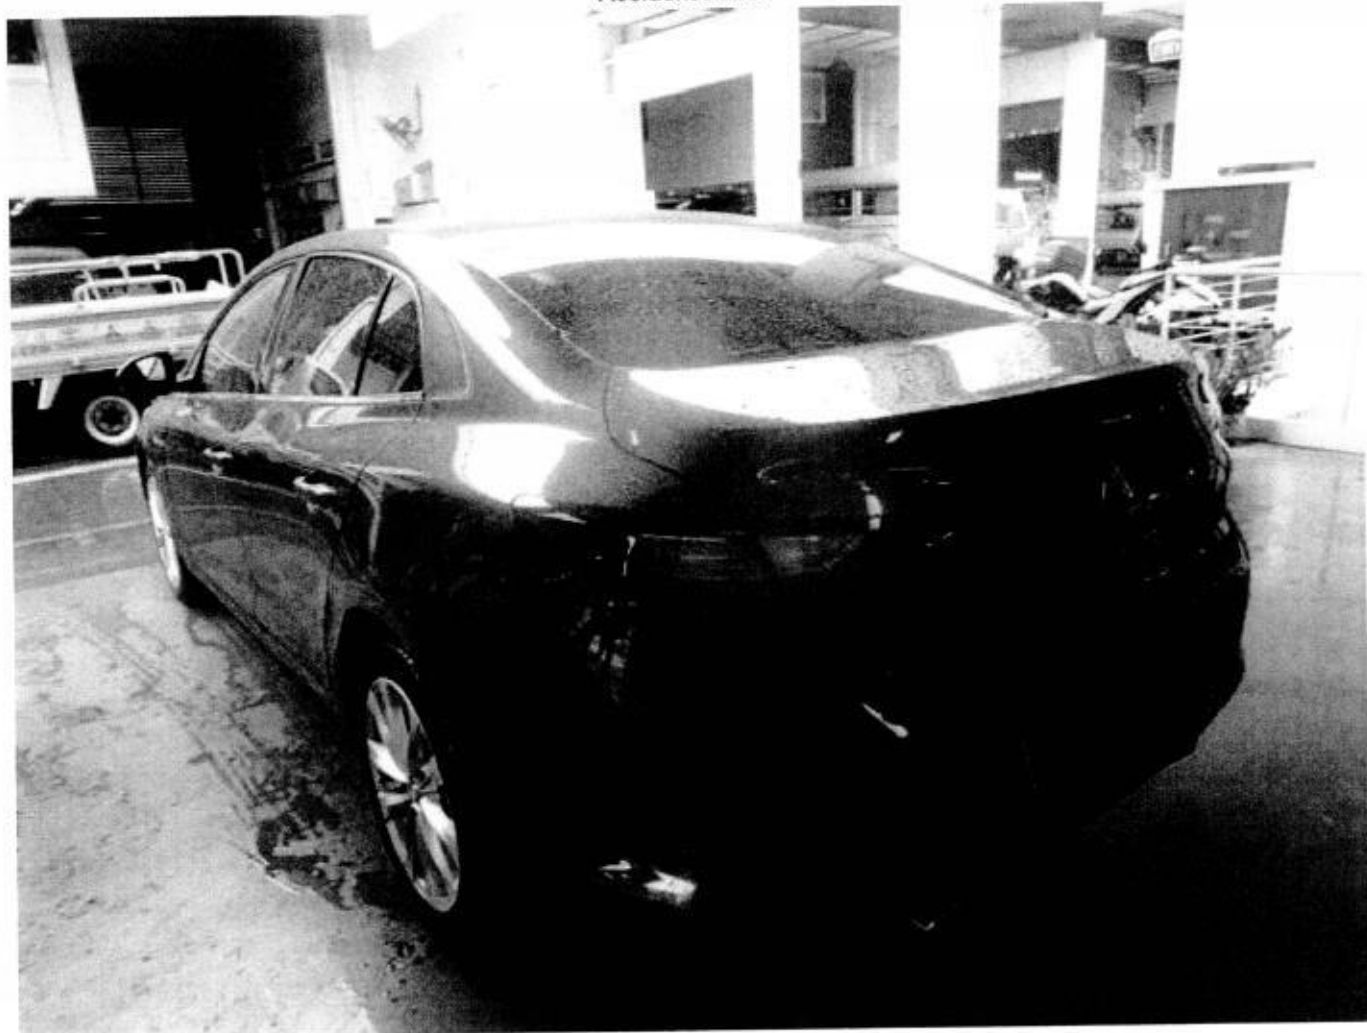
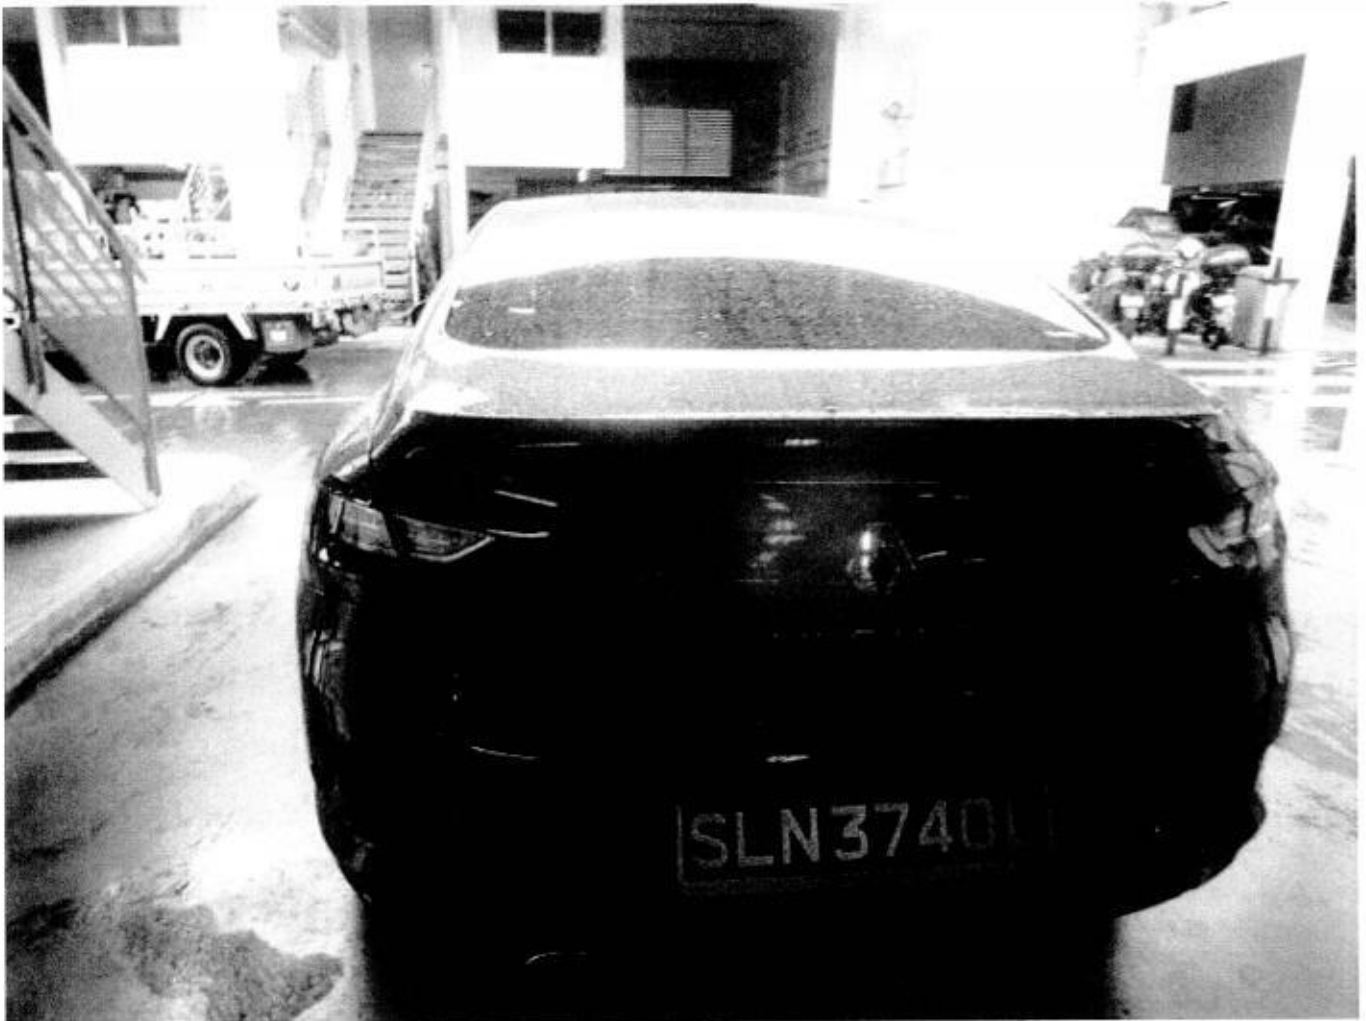
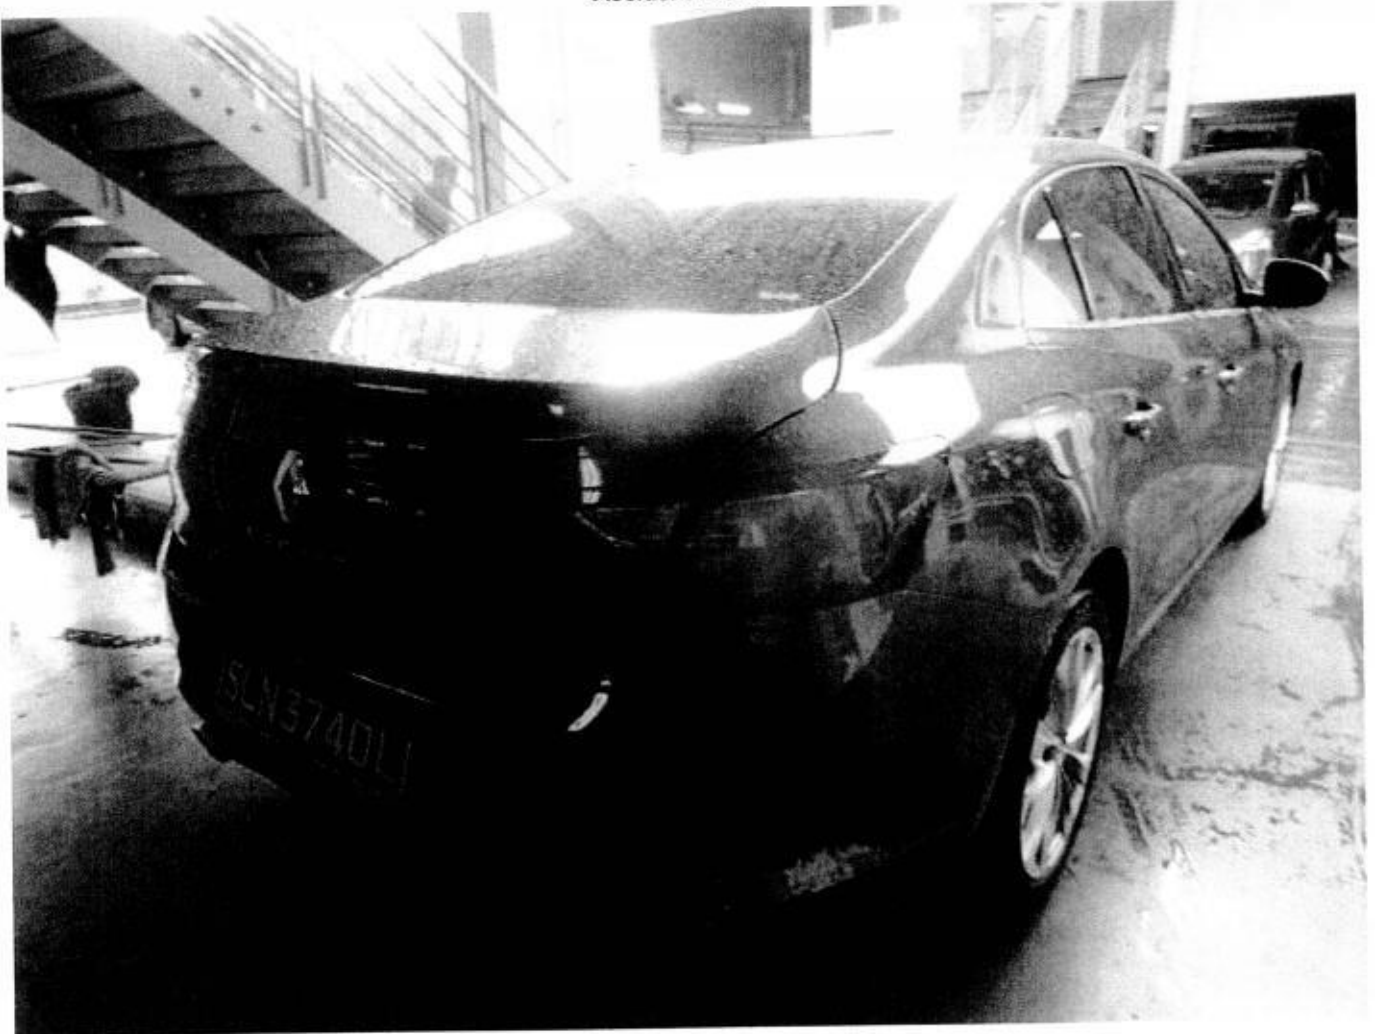
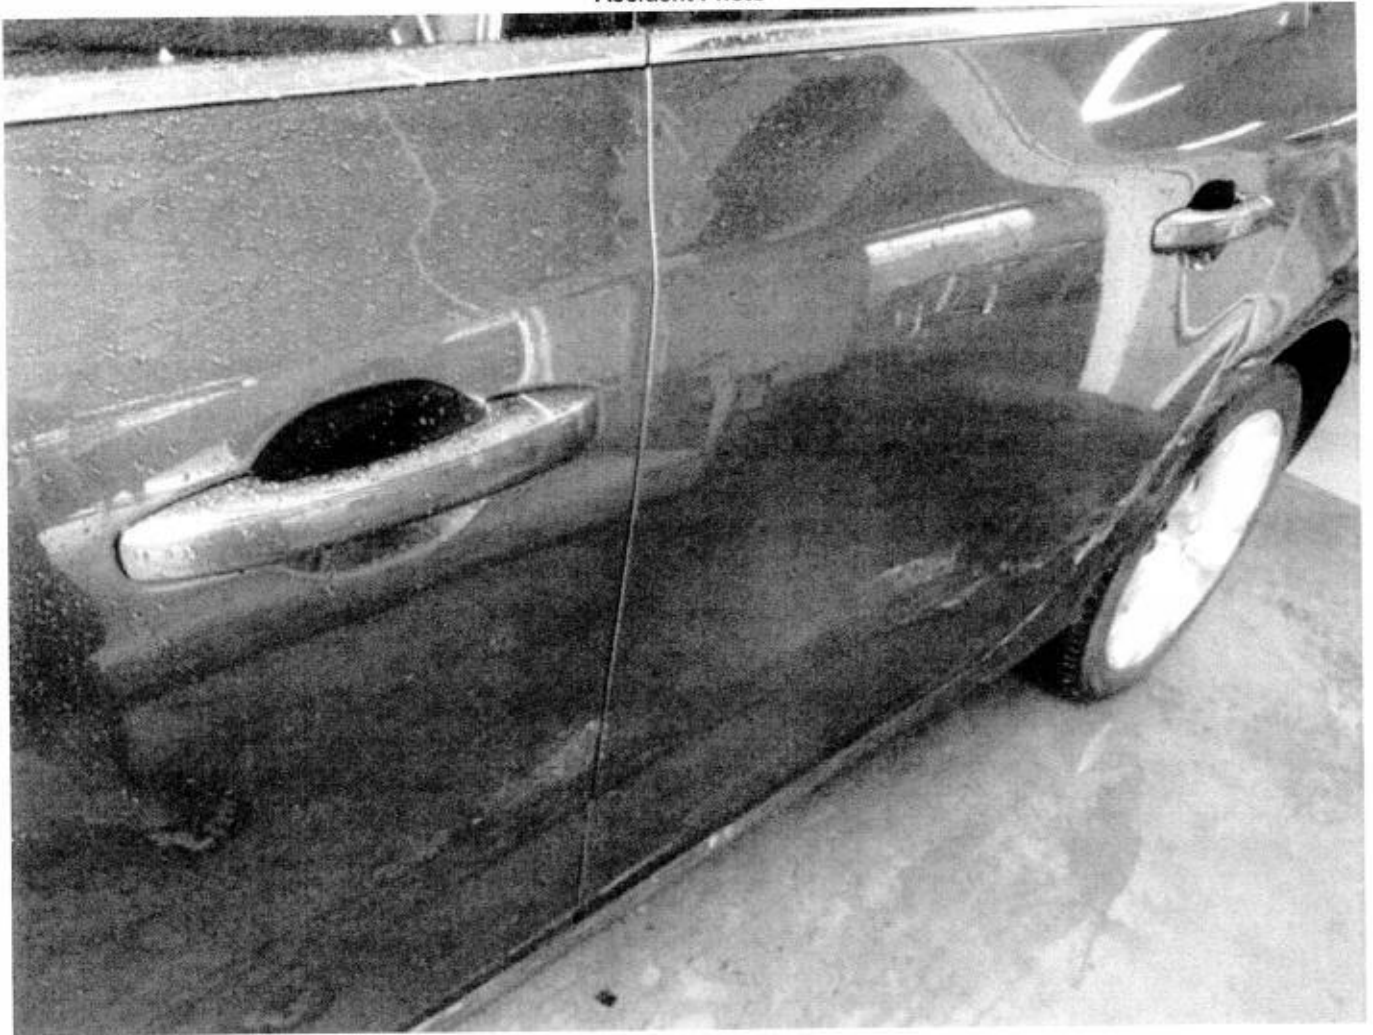
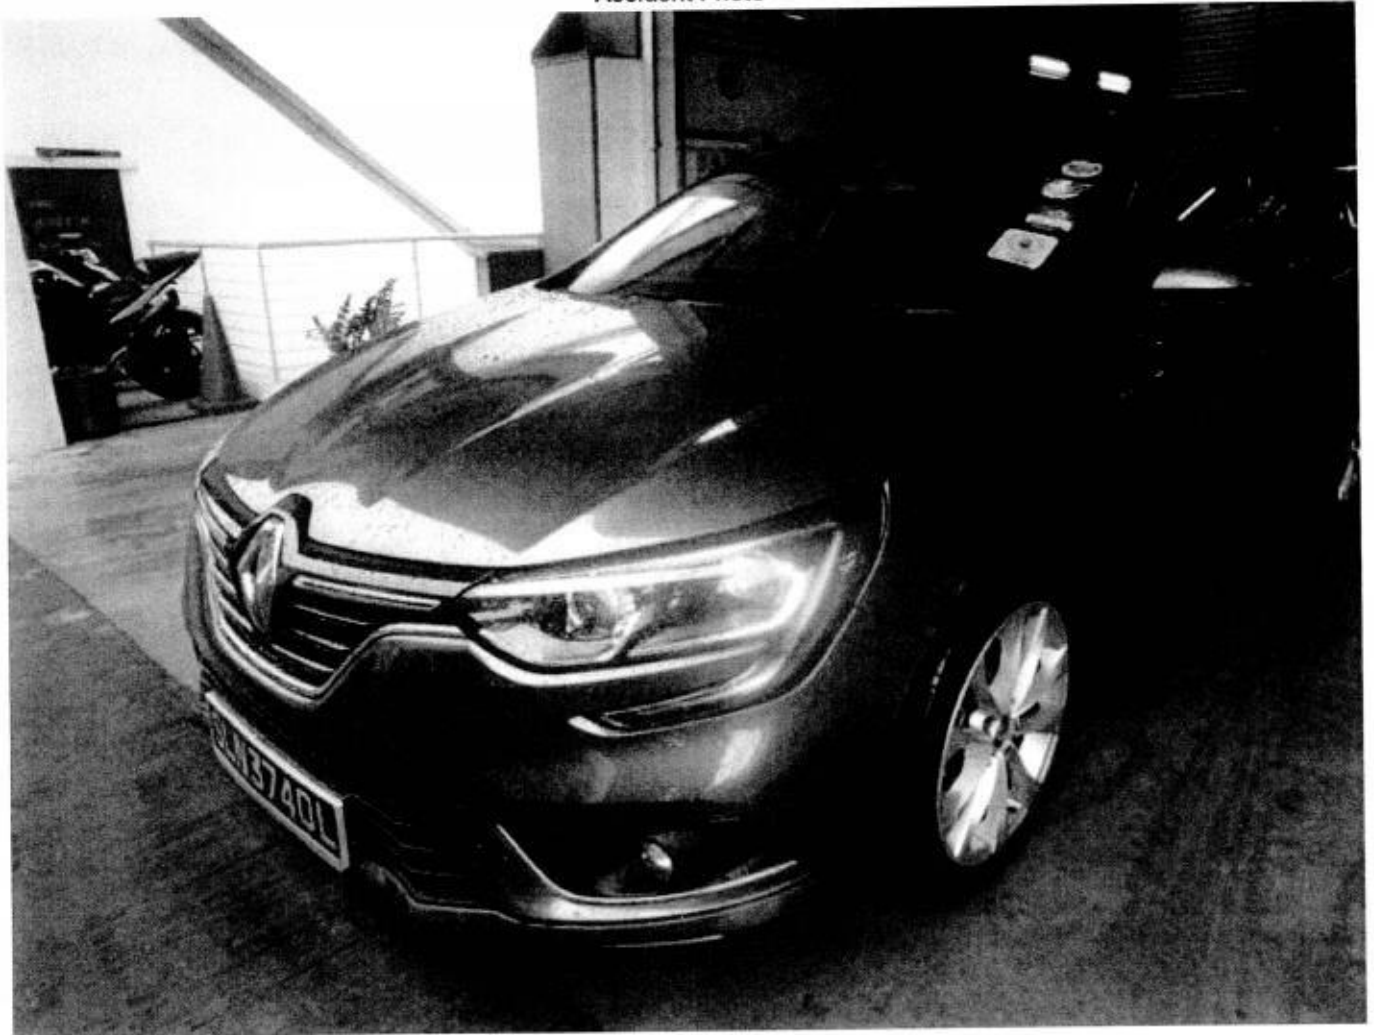
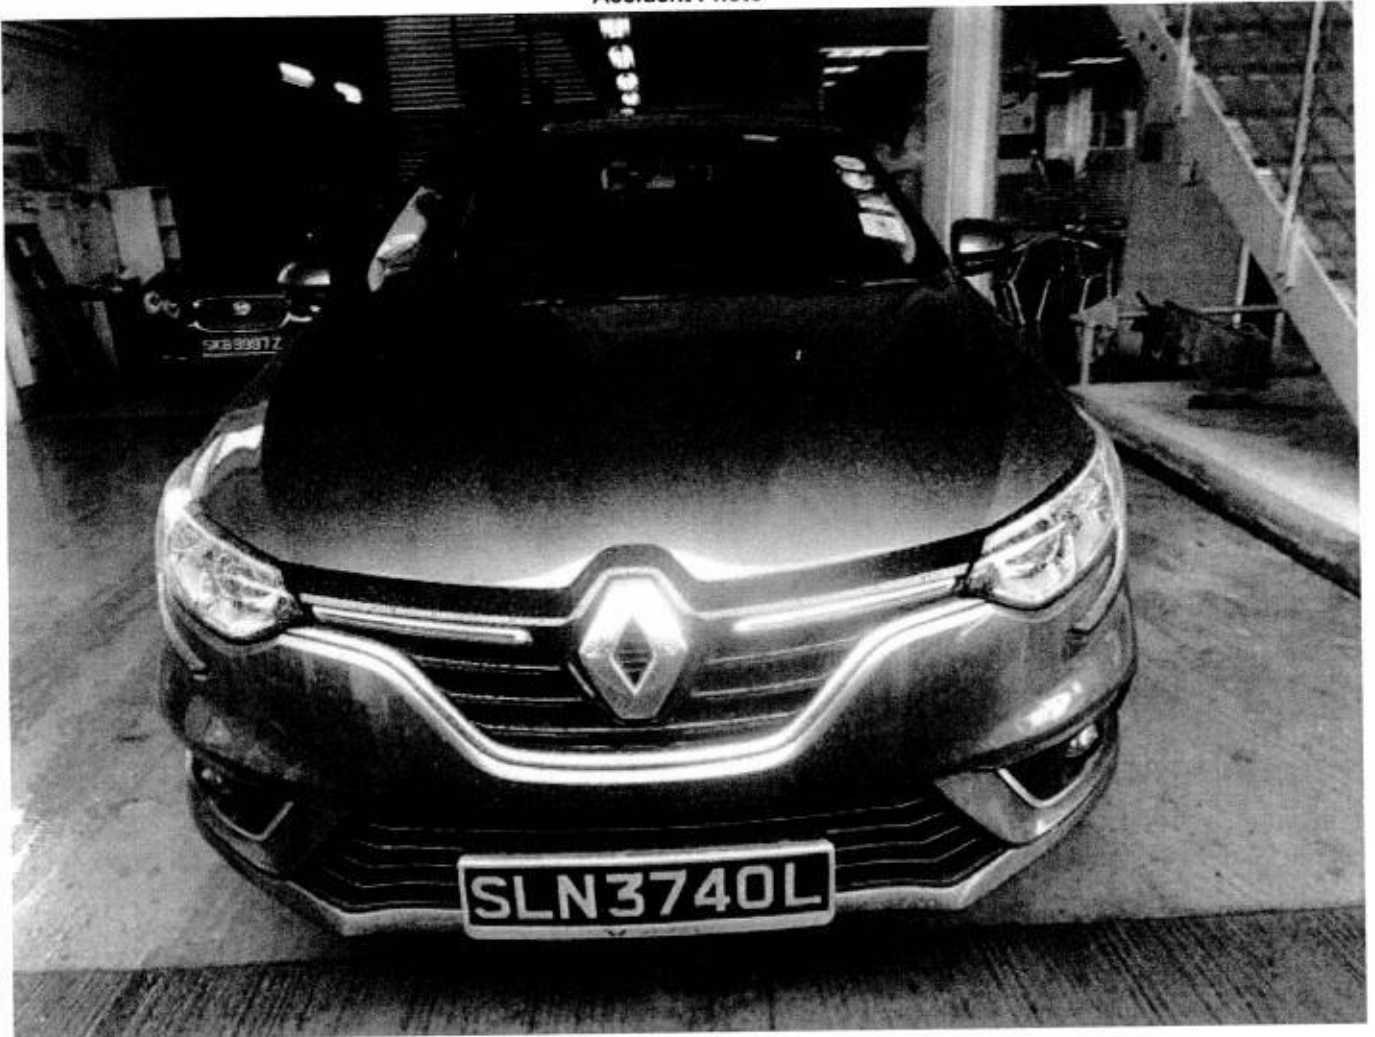
Accident Photo

Des. of Damages: Frt / Rear / O/S ☒ N/S / U/C / Rooftop or

The U/C / Chassis frame / Body Structure affected due to collision

No.	Qty	Part No.	Particulars	Condition	Repairer's	Amount
1	1		*REAR BUMPER	Deformed	1,455.00 F	*1,455.00 FL
2	1		*REAR BUMPER CLIPS	Necessary	30.00 F	*30.00 FL
3	1		*REAR BUMPER SIDE HOLDER LH	Necessary	75.00 F	*75.00 FL
4	1		*REAR LH FENDER	Repair	1,625.00 F	*- FL
5	1		*REAR WINDSCREEN MOULDING	Not Necessary	185.00 F	*- FL
6	1		*REAR LH DOOR	Dented	1,390.00 F	*1,390.00 FL
7	1		*REAR LH DOOR WEATHERSTRIP	Necessary	165.00 F	*165.00 FL
8	1		*FRONT LH DOOR	Repair	1,297.00 F	*- FL
9	1		*FRONT LH DOOR WEATHERSTRIP	Not Necessary	156.00 F	*- FL
10	1		*REAR WINDSCREEN SEALANT	Not Necessary	60.00 FS	*- FS
11	1		*REAR WHEEL RIM LH	Cut	950.00 FS	*750.00 FS

No	Particulars	Lab.Type	Repairer's	Amount
Labour Items				
1	PANEL BEATING.	New	1,500.00	600.00
2	SPRAY PAINTING.	New	1,200.00	800.00
3	WIRING.	New	100.00	30.00
4	TO UNDERSEAL.	New	150.00	60.00
5	TO REMOVE REAR WINDSCREEN.	New	180.00	0.00
6	TO TRANSFER DOOR FITTINGS.	New	300.00	80.00
7	TO REMOVE UPHOLSTERY.	New	150.00	80.00
8	TO REMOVE REVERSE SENSOR.	New	100.00	60.00
9	TO REMOVE FUEL TANK.	New	150.00	0.00
Gross Labour Cost (\$\$)			3,830.00	1,710.00
