CS3/LPC 1901679 Gvt 3-1

SJL 9389U

PAPER SURVEY OF SJL8389U

ADJUSTMENT ON REPAIR COST FOR VEHICLE NO. SJL 8389U

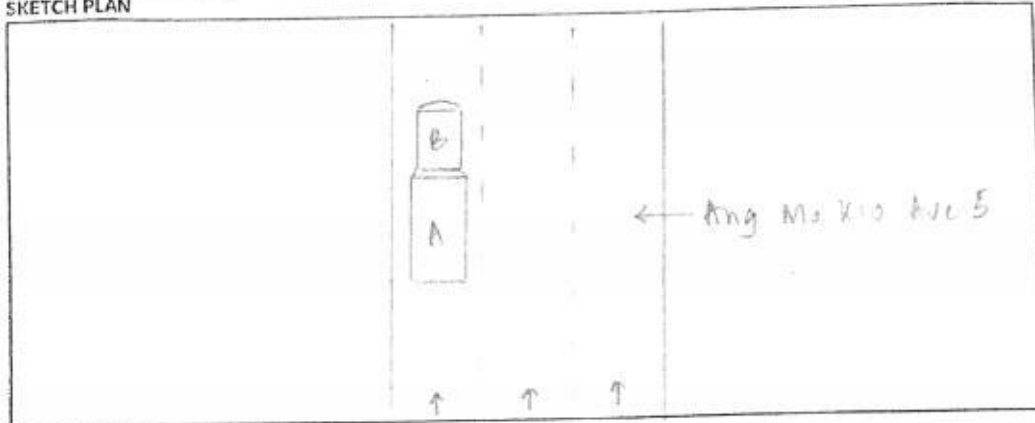
Date of accident: 21/09/2019 Time: 14:15 Location: Ang Mo Kio Ave 5
 Veh A: YN3160 G Veh B: SJL 8389 U No of pax: 1 Weather: Clear/dry Rain/Wet

I was driving along Ang Mo Kio Ave 5 towards Honggang on the inner left most lane. Traffic was smooth. Vehicle B was in front of me. While driving, all of a sudden veh B e-brake and I could not stop in time, hit into its rear. veh B driver did not 'on' signal to indicate that he is stopping, nor were there any obstruction in front of veh B (refer to video). Nobody was injured.

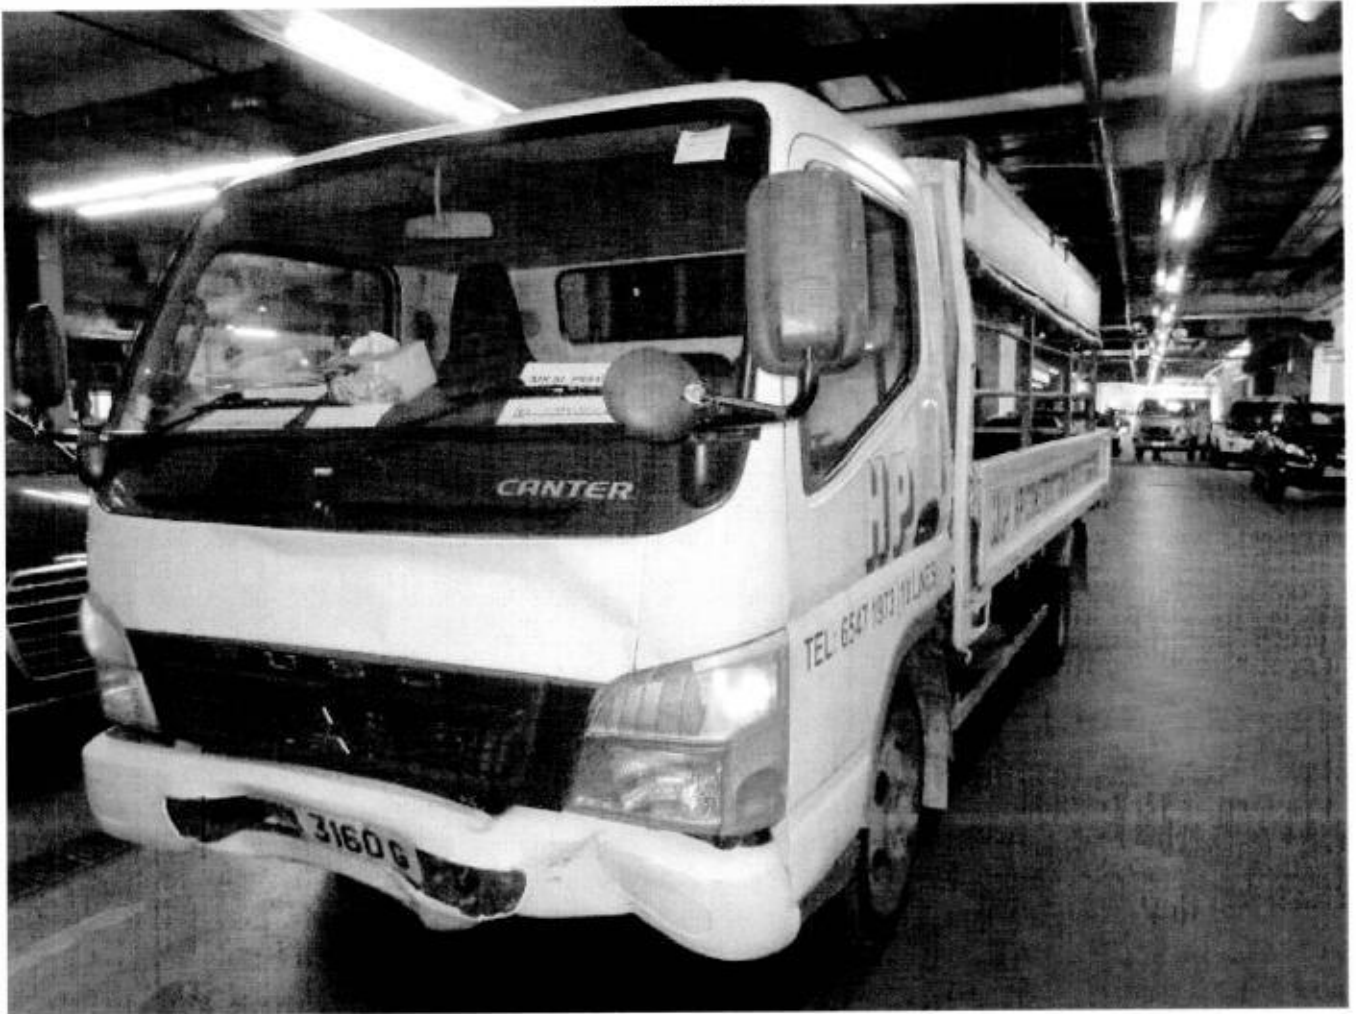
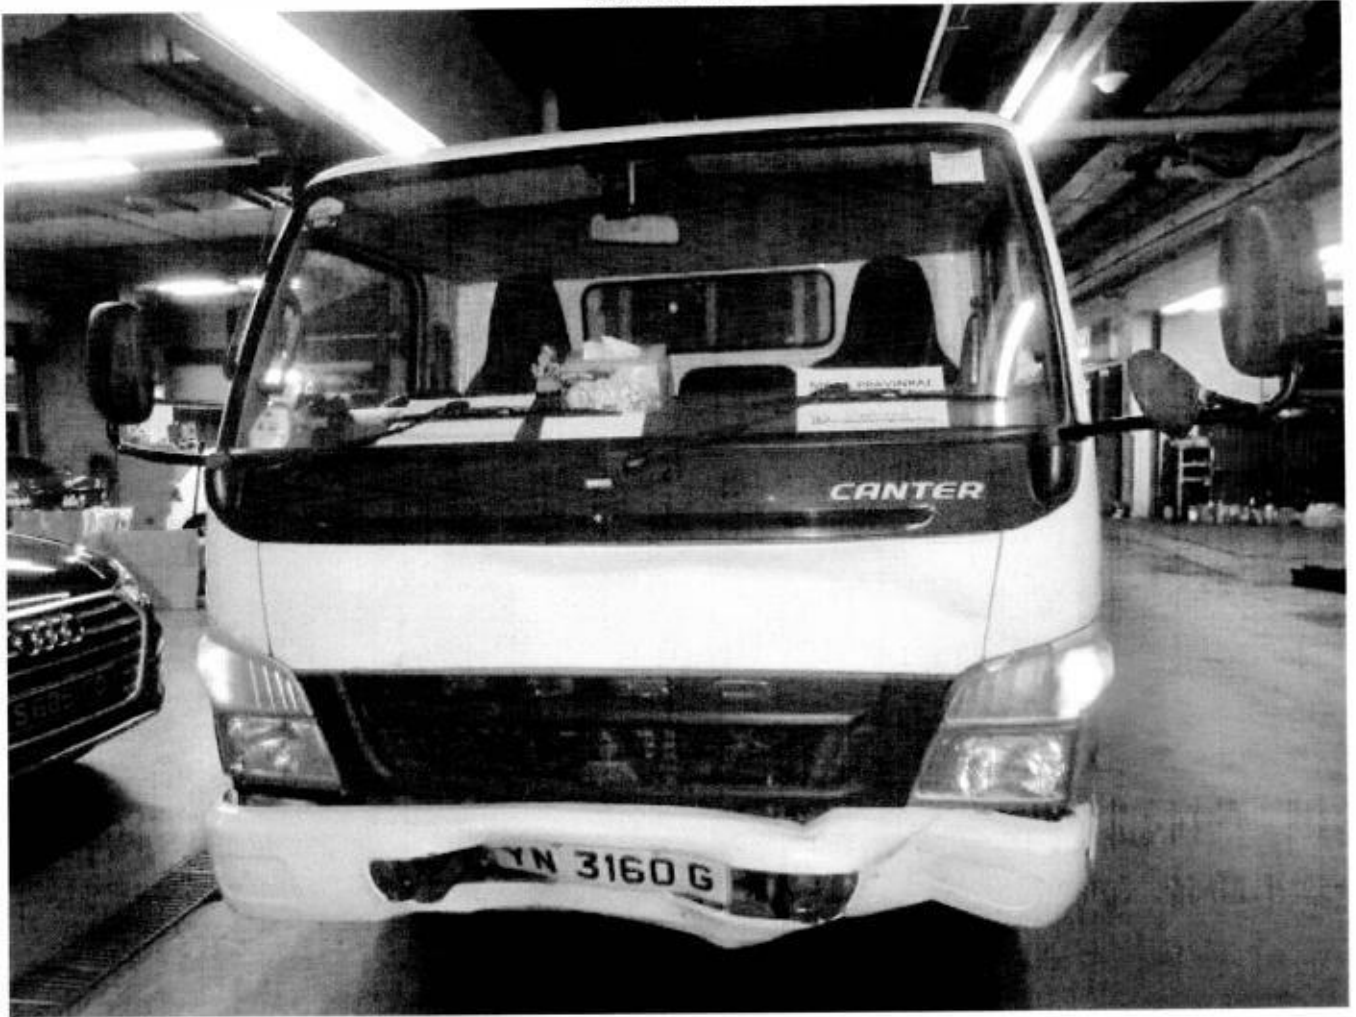
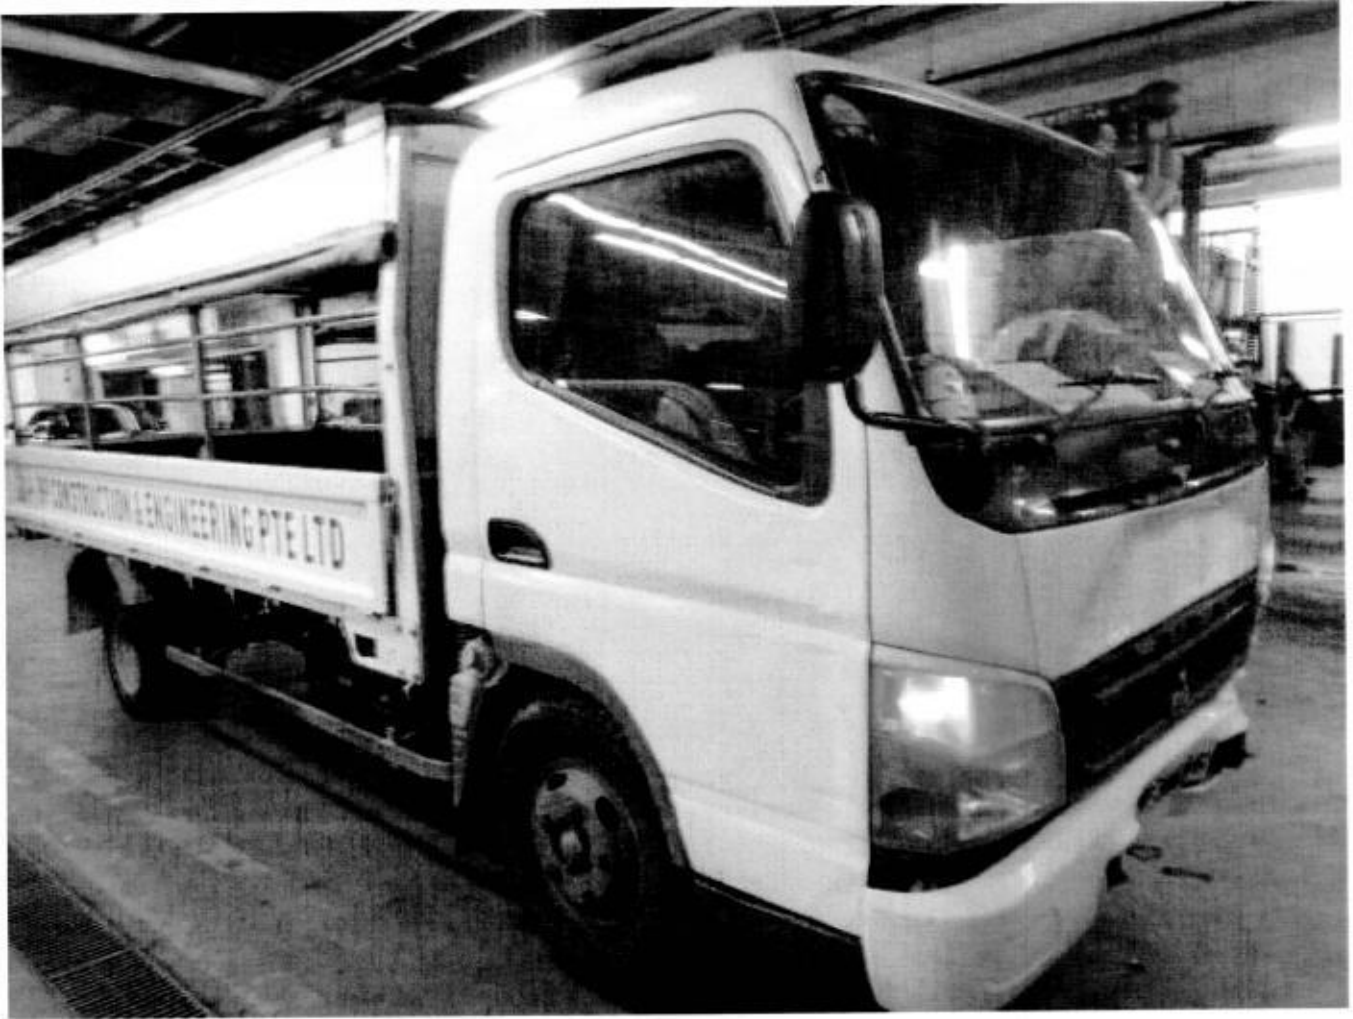
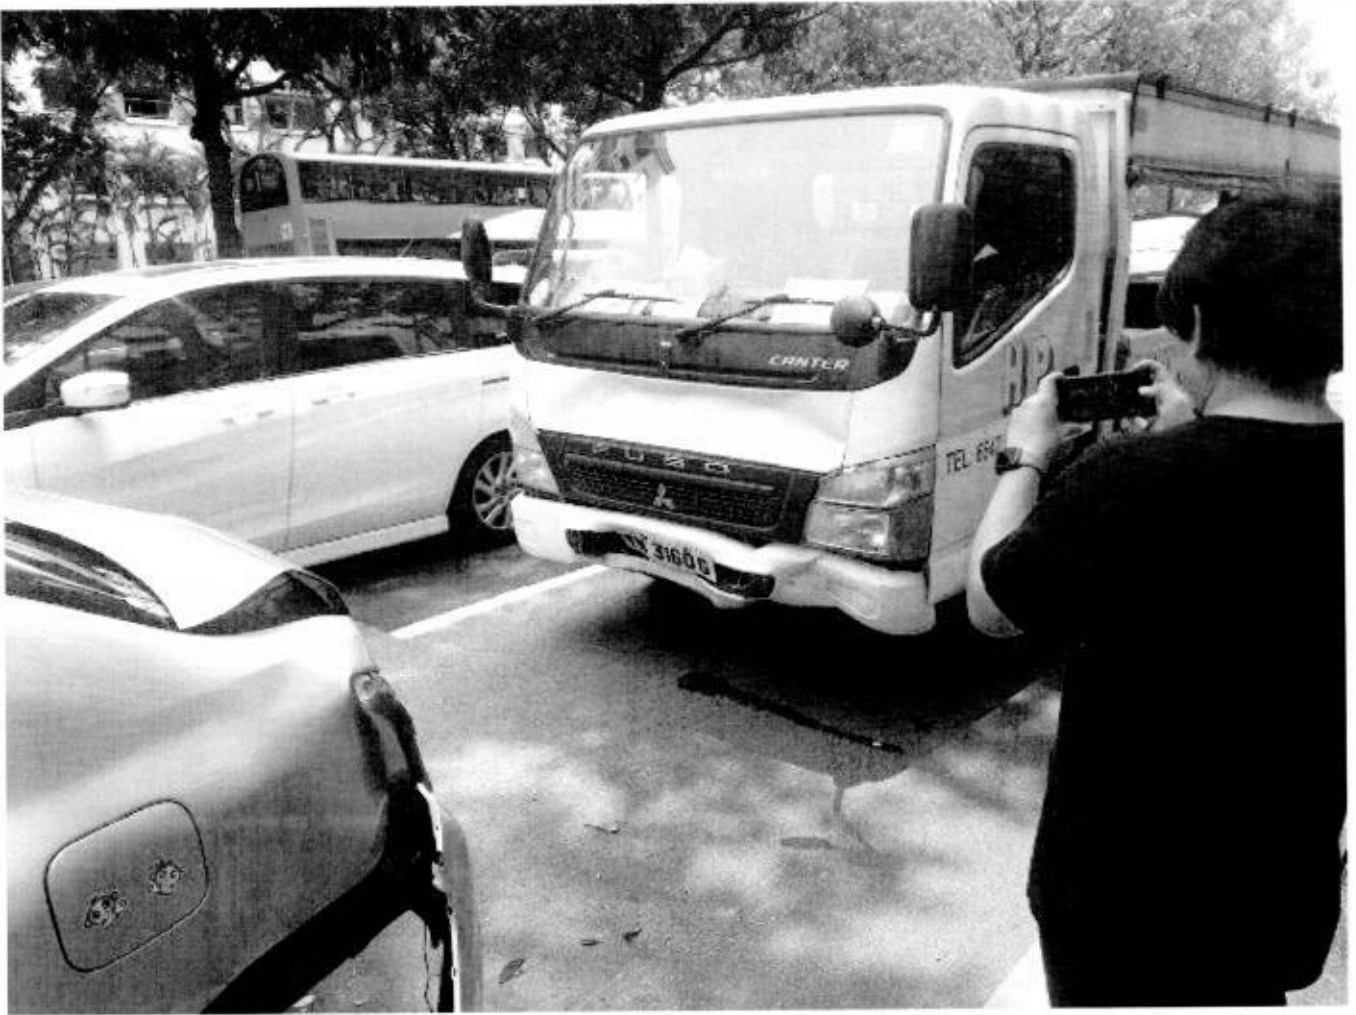
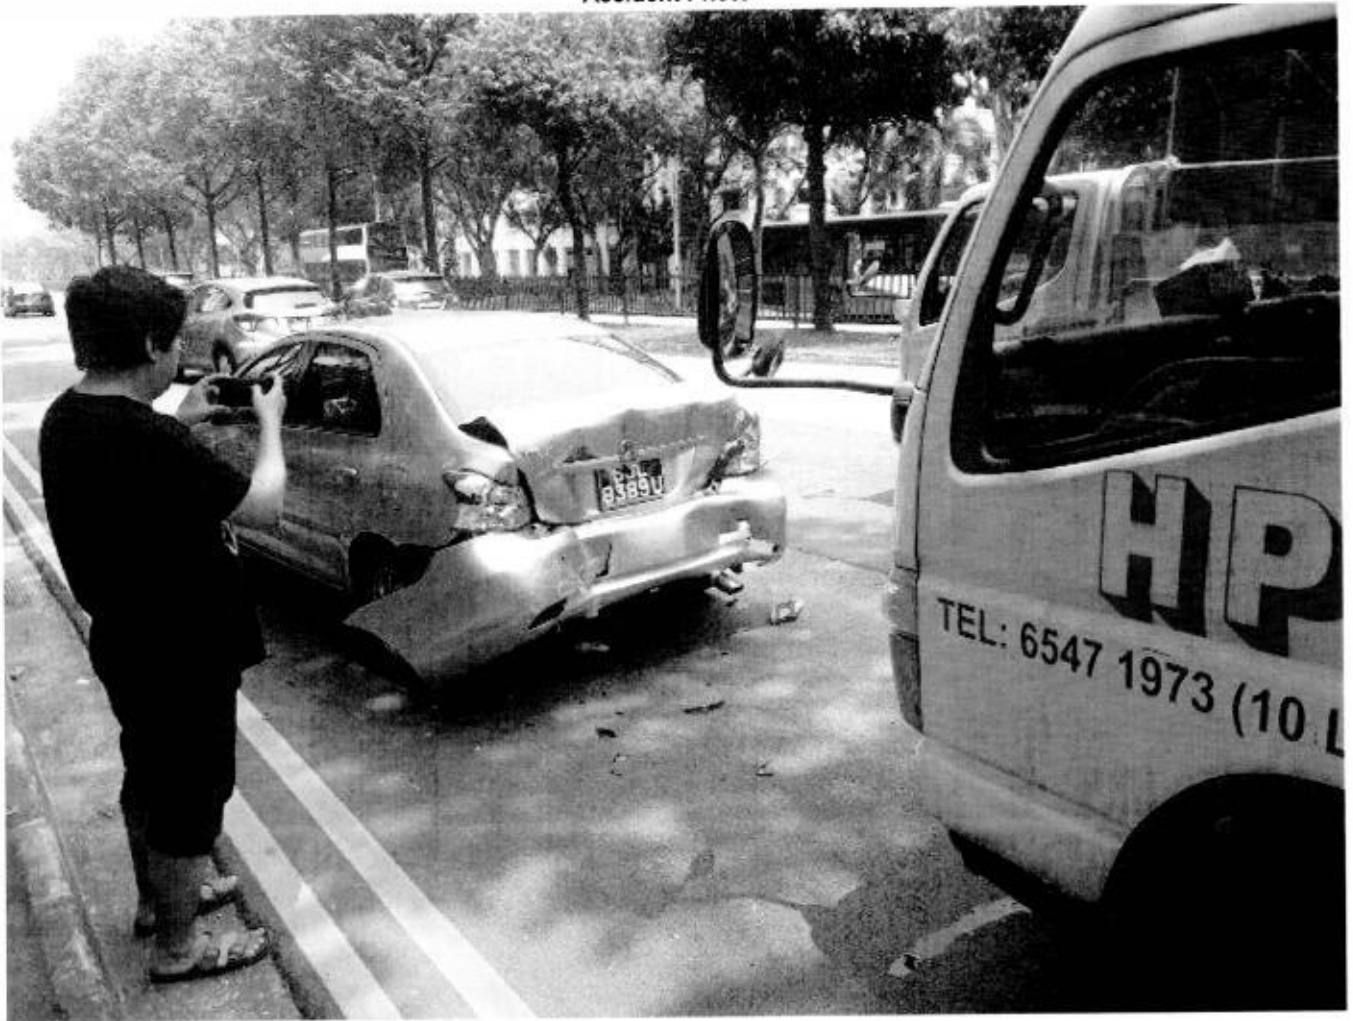
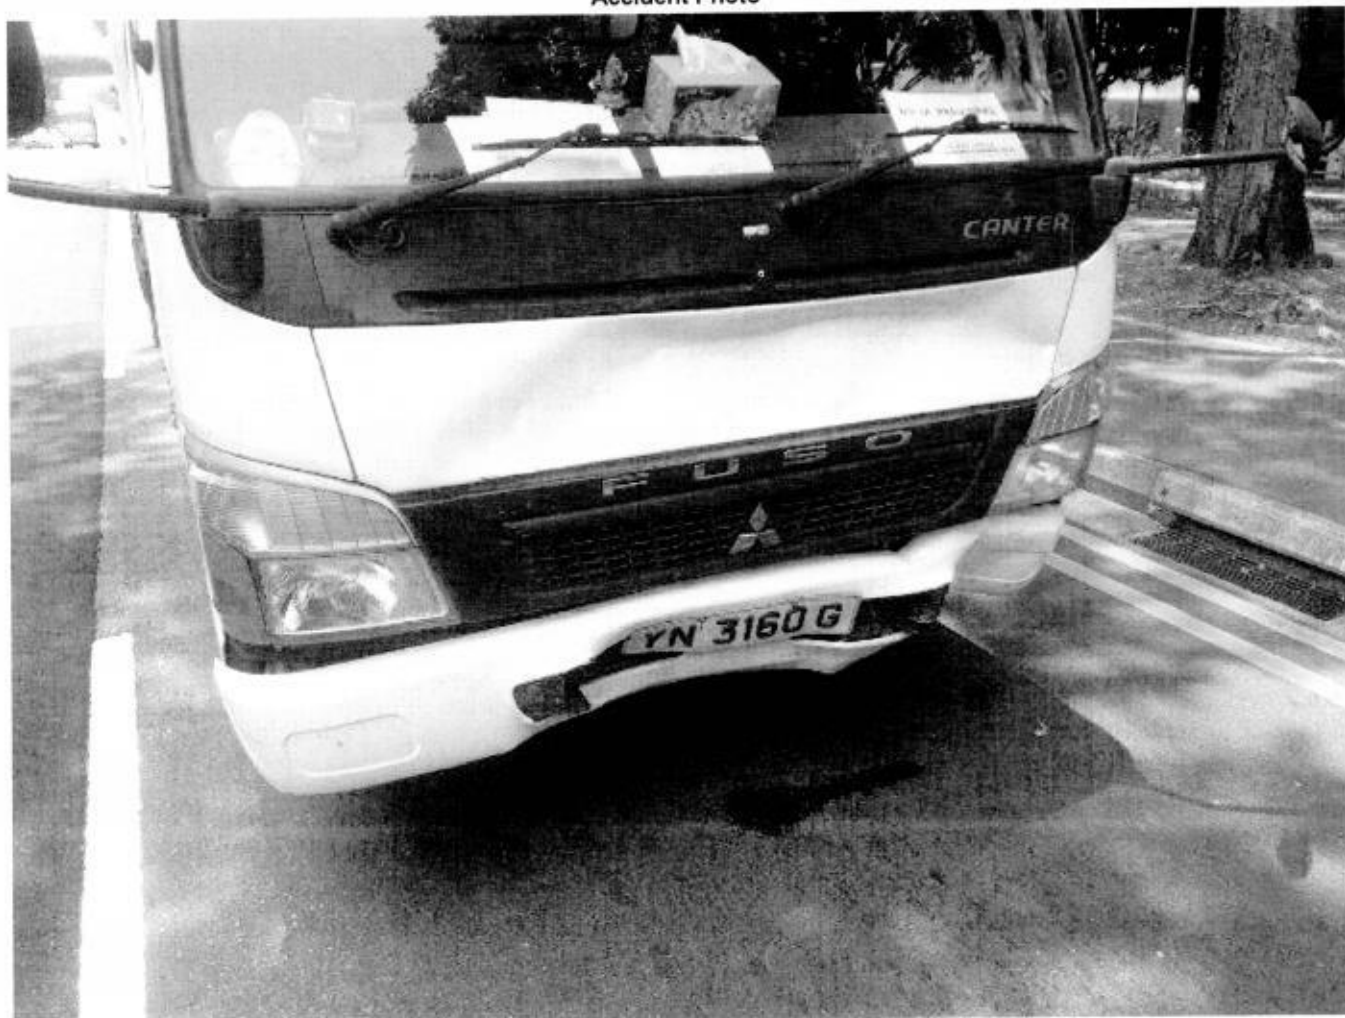
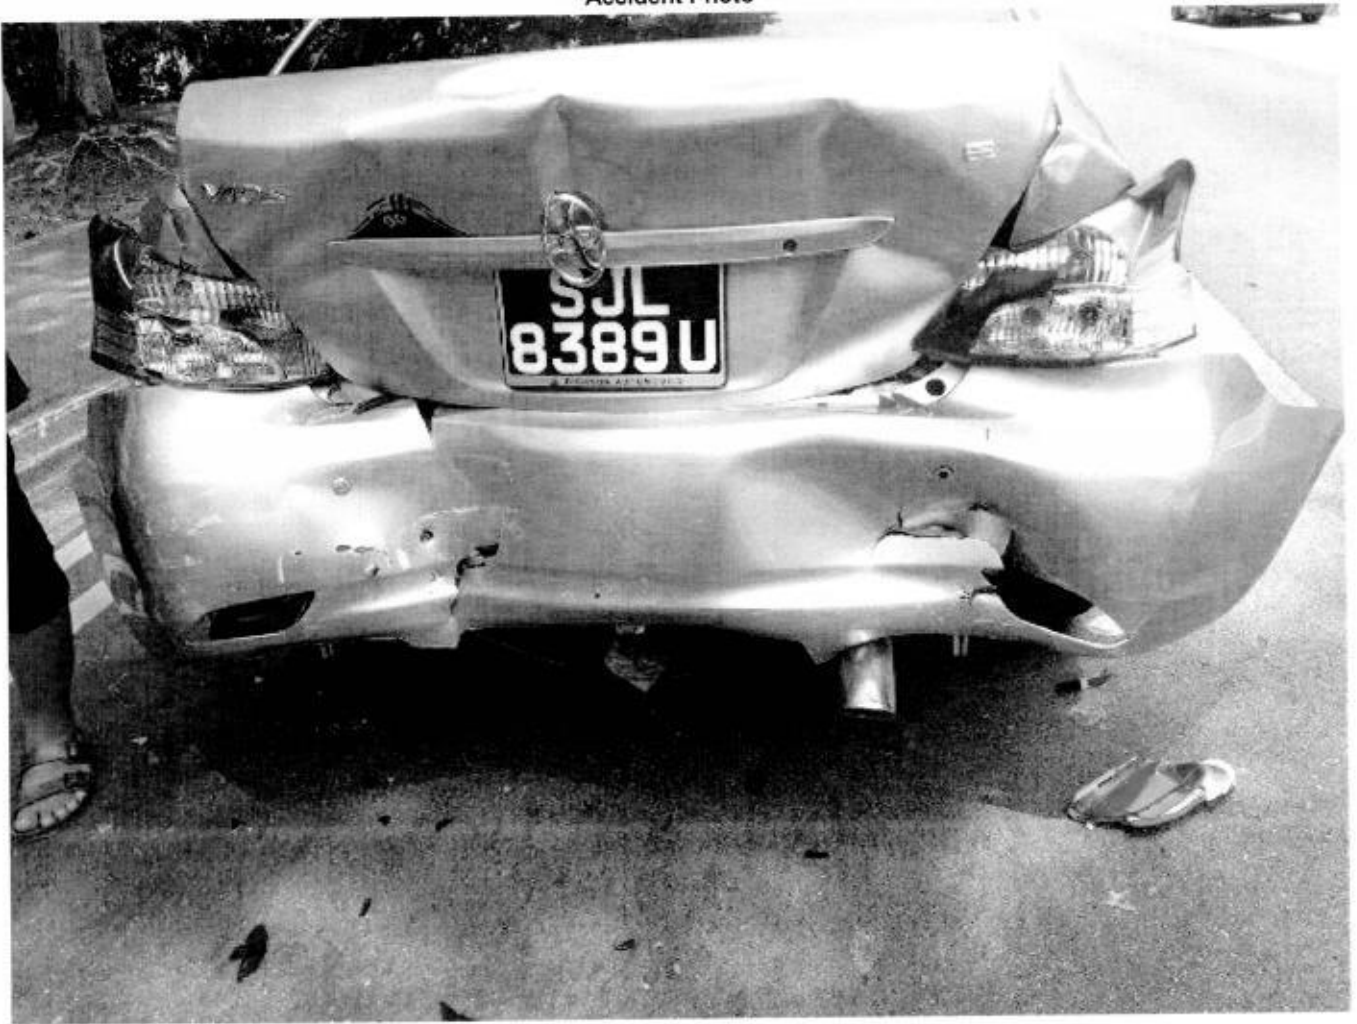
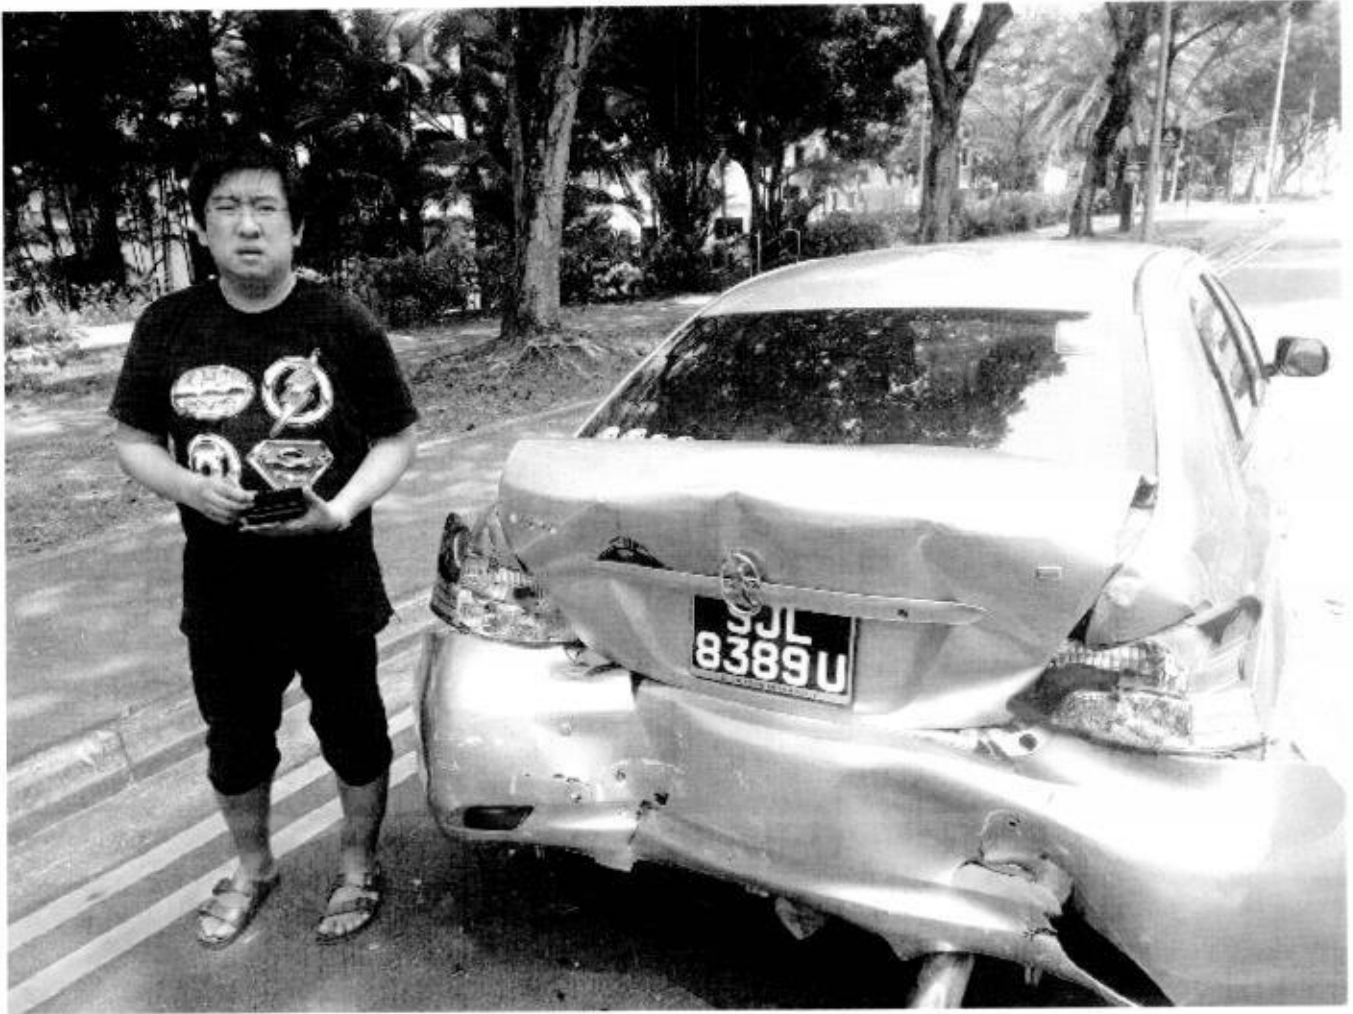
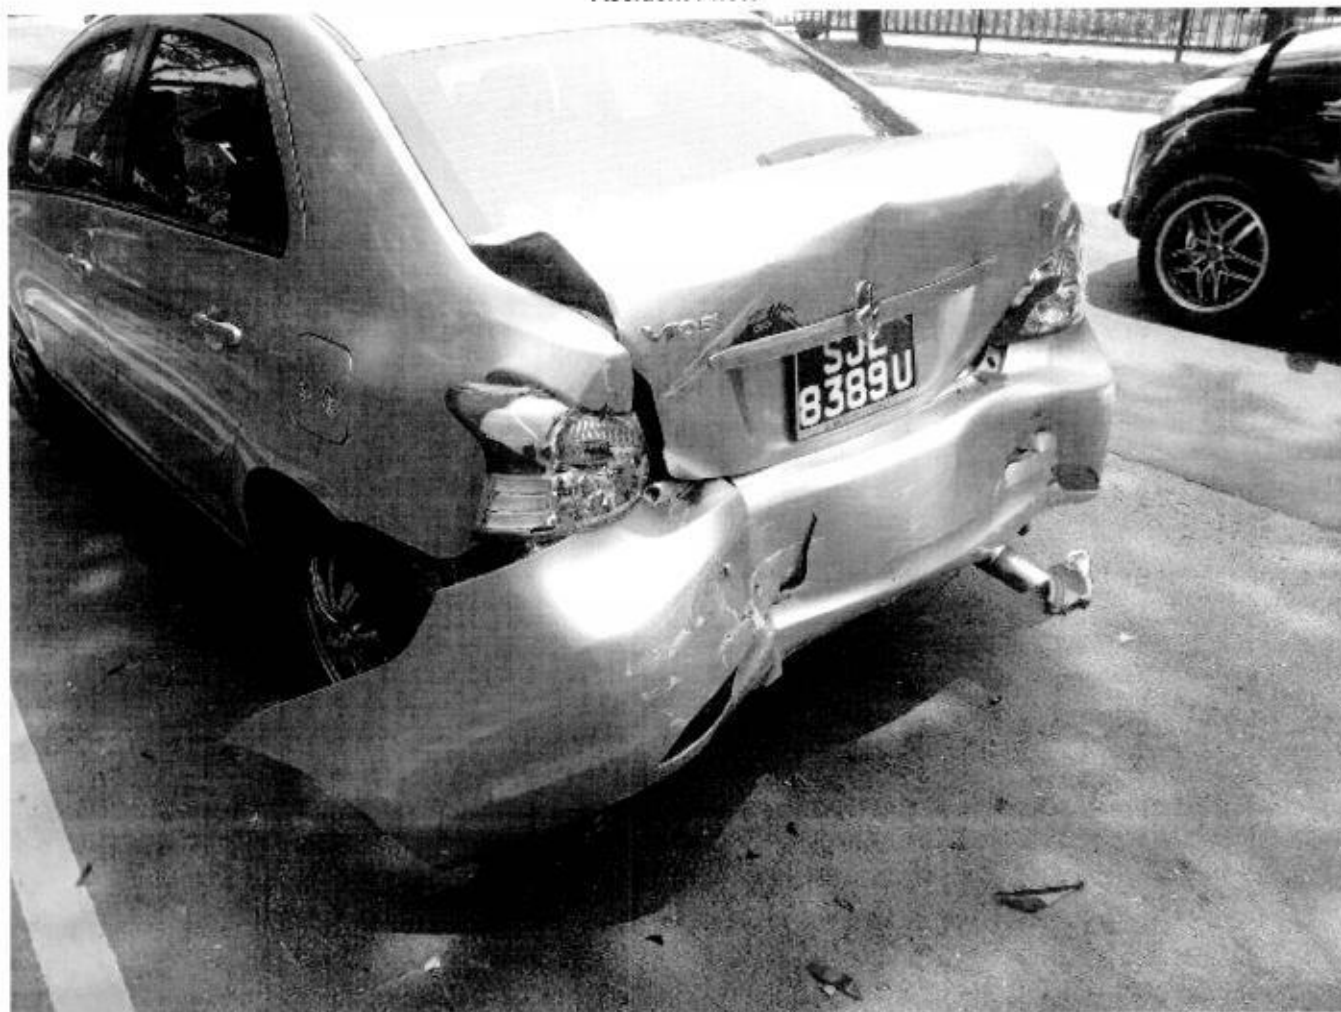
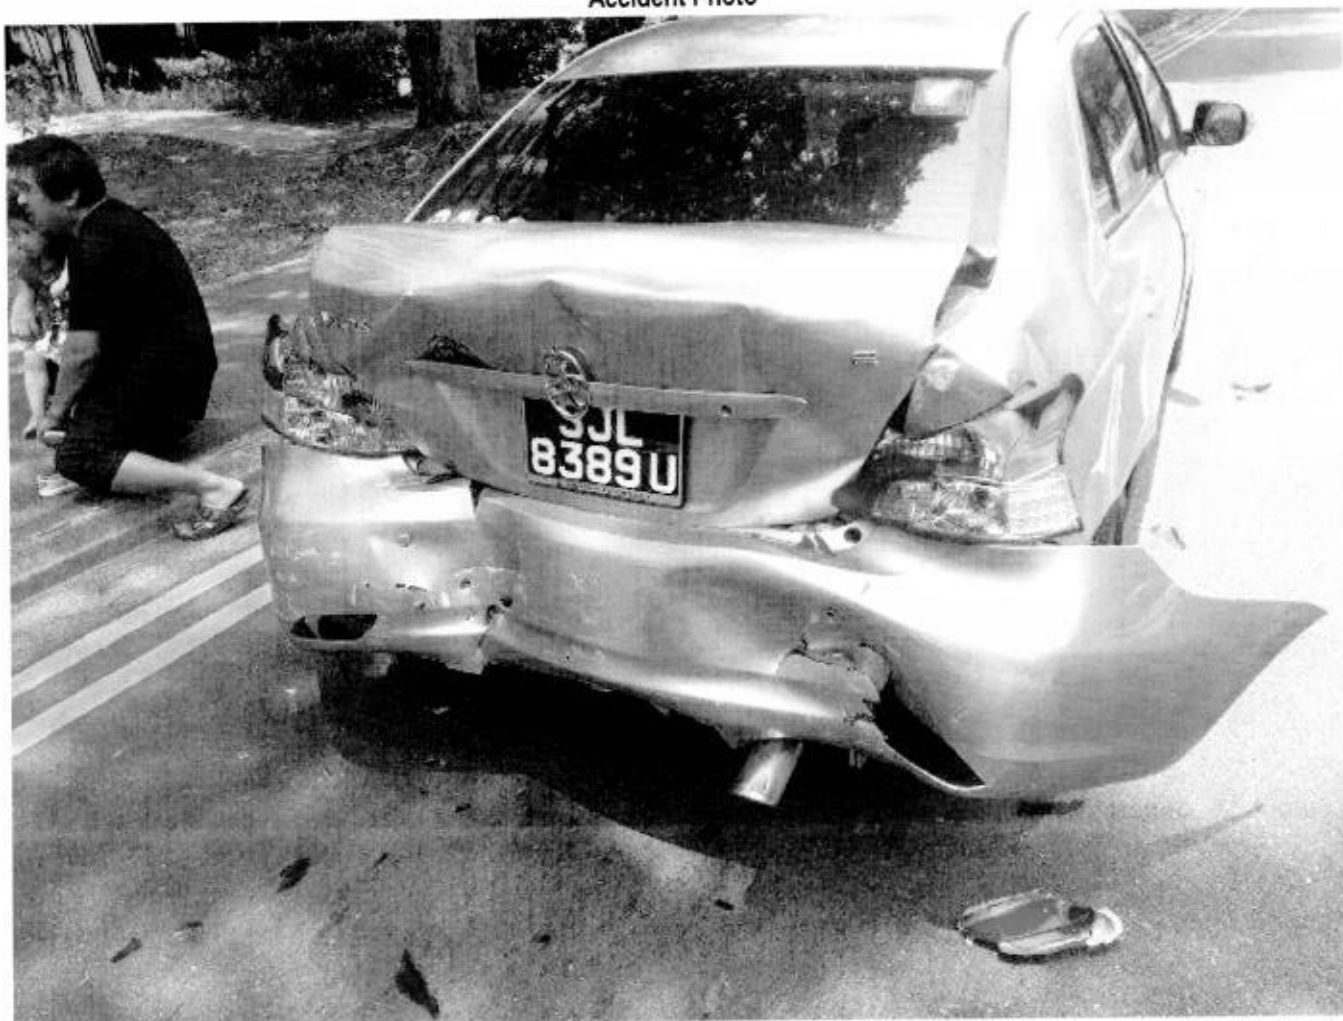
Accident Photo

Other parts were also found damaged. (See schedule for details)

The estimate cost of repair submitted by M/s Eng Shing Mechanical Works as per schedule attached have been revise and scrutinize. We list the breakdown of our findings and recommendation as per attached.

The repairer has agreed to undertake the repair at a lumpsum of SGD \$11,200.00
