From: Bryan Ang (LKKAUTO)
Sent: Thursday, 30 January 2020 2:30 PM
To: Chan, Peggy
Cc: Veron Chen (LKKAUTO); Motorsurvey; SUR; Hew, Lee Fong; KKLau
Subject: RE: OD survey assignment for SCL 89X - DOA : 09-12-2019 Our Ref: NSV1900610 / HLF
Attachments: Porsche Manual.png

Attached is the owner's manual for Porsche Panamera 2017 to 2019 model pertaining to the allowable range for tyre size and wheel rim size for all variants under the 2017 to 2019 model range. From the attached, 315/30 R21 for the rear tyres is within the allowable size range.

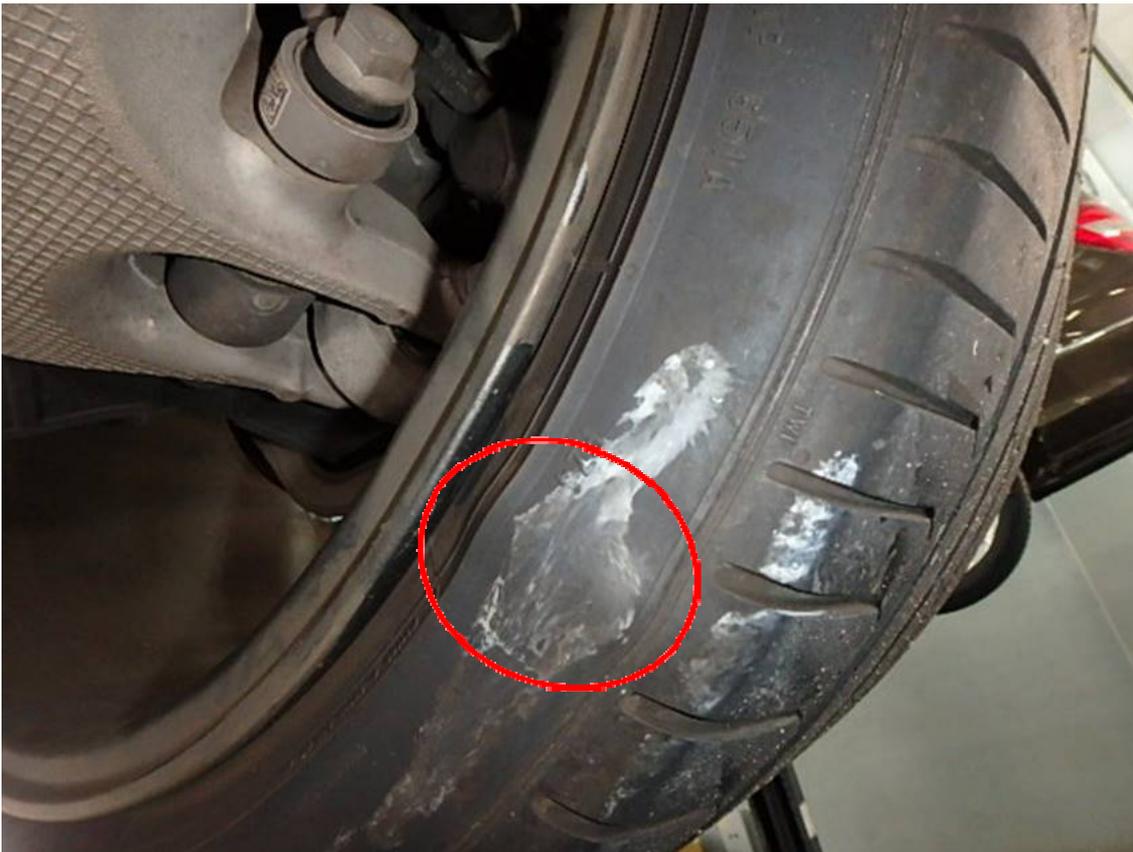
With regard to the condition of the 2 rear tyres, I have re-verified with my surveyor and at the time of his inspection, the 2 rear tyres were deformed or normally referred to as "bulged". This was at the sidewalls at the inner side of the tyres. There were whitish marks found at the bulged area which corresponds to the reported accident scenario where the insured vehicle had travelled up and down an island kerb. Photos of the 2 rear tyres are shown below.

Rear right tyre with the bulged area circled.

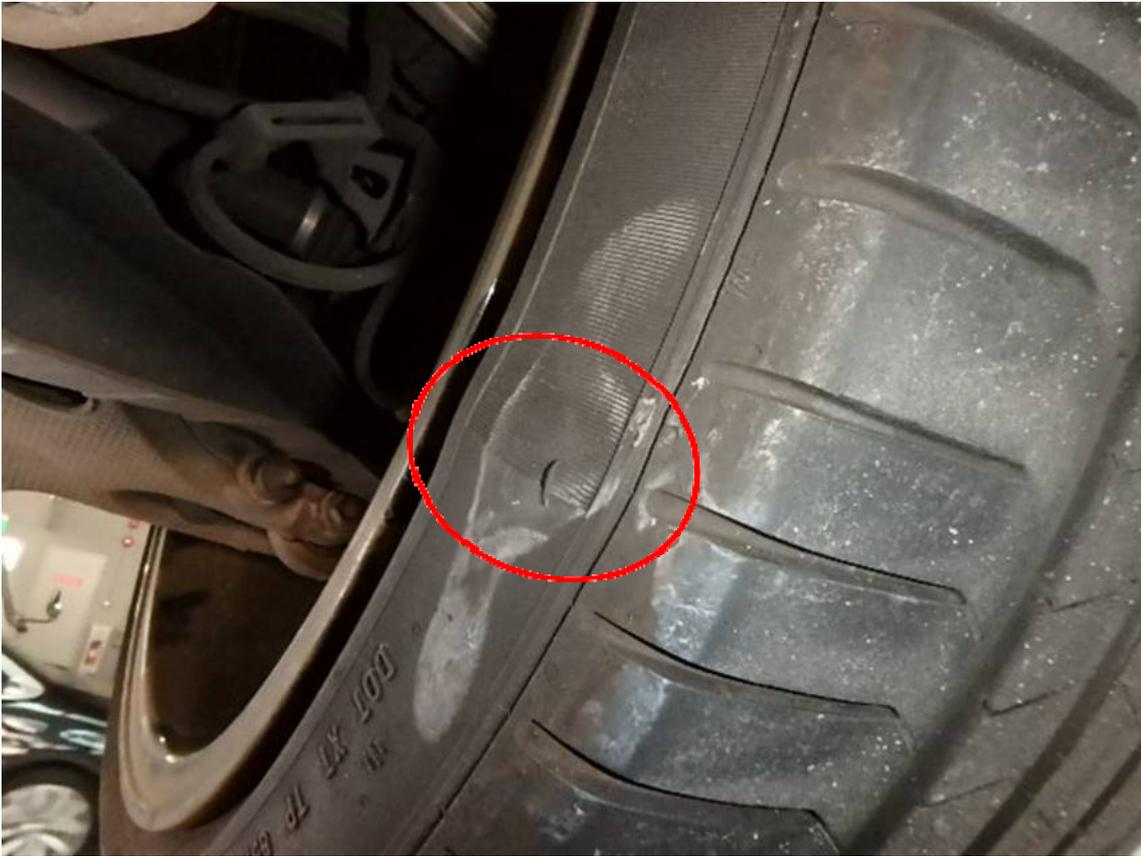
Rear left tyre with the bulged area circled.
