**From:** Chan, Peggy <Peggy.Chan@awac.com>  
**Sent:** Thursday, 30 January 2020 4:24 PM  
**To:** Bryan Ang (LKKAUTO)  
**Cc:** Veron Chen (LKKAUTO); Motorsurvey; SUR; Hew, Lee Fong; KKLau  
**Subject:** RE: OD survey assignment for SCL 89X - DOA : 09-12-2019 Our Ref: NSV1900610 / HLF  
**Attachments:** Porsche Manual.png; PC120059.JPG

| Make / Model | : | Porsche Panamera 4S / 2017 | | |

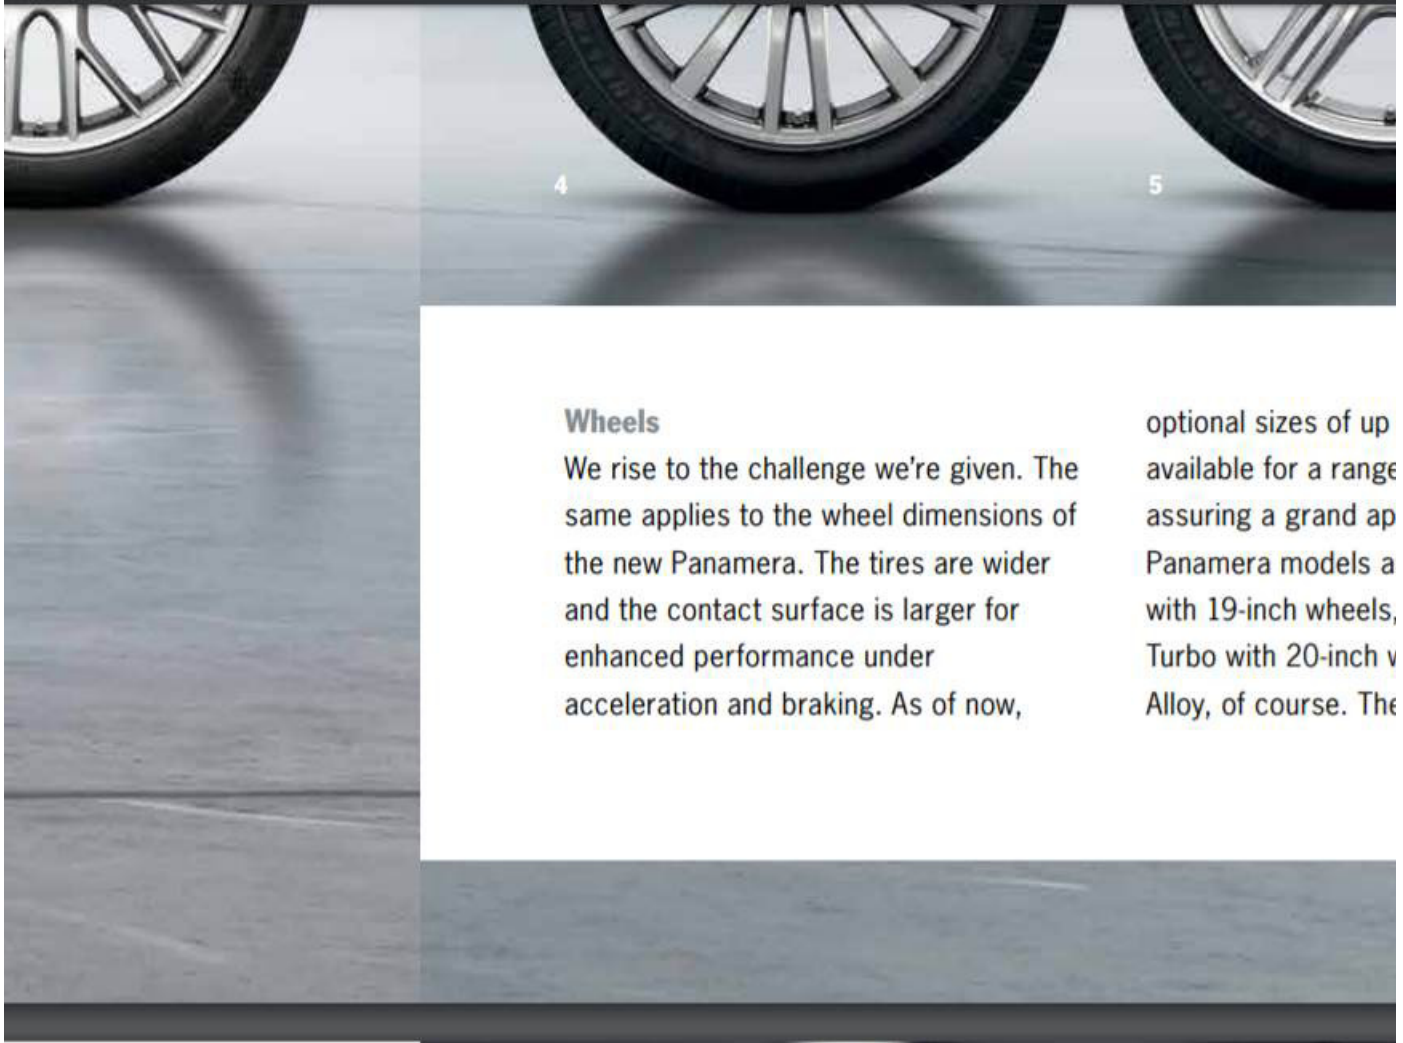
We noted your findings that the tyre size for Porsche Panamera 2017-2019 model range and 315/30 R21 for the rear tyres is within the allowable size range. As much as we are aware, all new Panamera model are standard equipped with 19-inch wheels (see screenshot below).

### Wheels

We rise to the challenge we're given. The same applies to the wheel dimensions of the new Panamera. The tires are wider and the contact surface is larger for enhanced performance under acceleration and braking. As of now,

optional sizes of up to 20 inches are available for a range of models, assuring a grand appearance. Panamera models available with 19-inch wheels, Turbo with 20-inch wheels, Alloy, of course. The

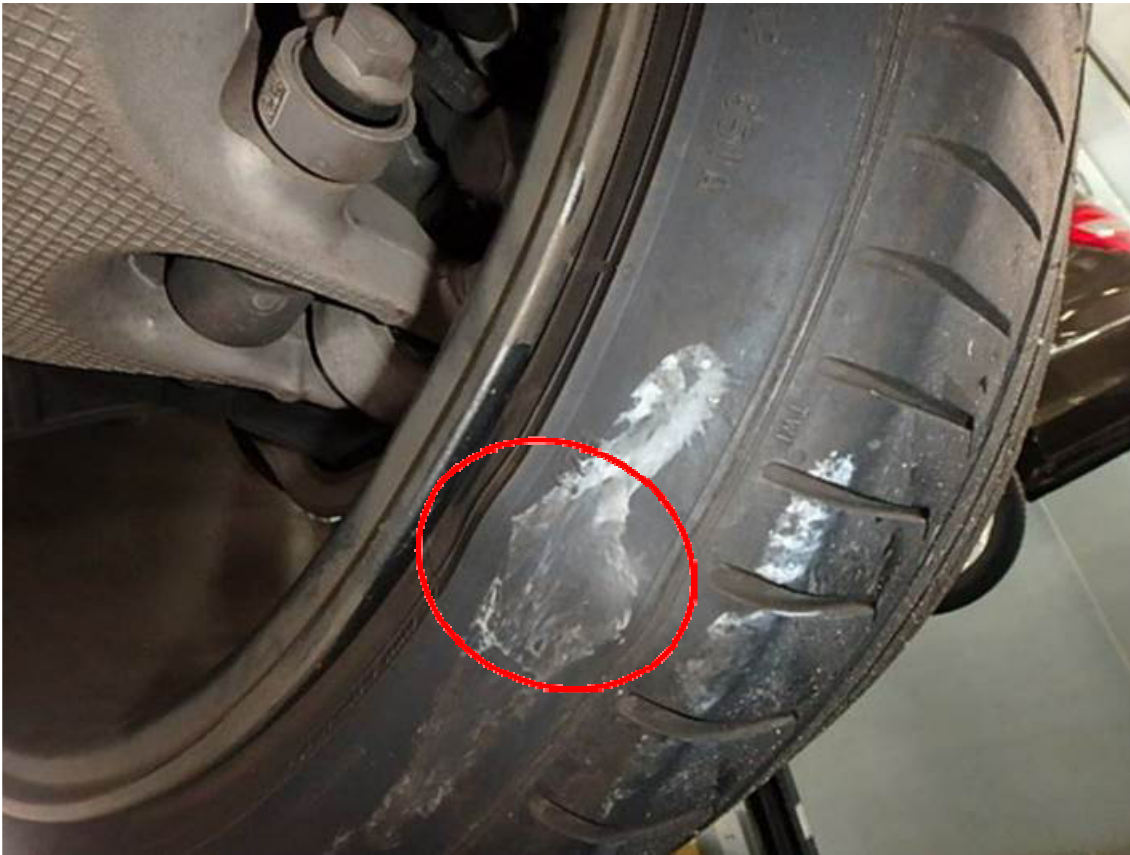
With regard to the condition of the 2 rear tyres, I have re-verified with my surveyor and at the time of his inspection, the 2 rear tyres were deformed or normally referred to as "bulged". This was at the sidewalls at the inner side of the tyres. There were whitish marks found at the bulged area which corresponds to the reported accident scenario where the insured vehicle had travelled up and down an island kerb. Photos of the 2 rear tyres are shown below.

Rear right tyre with the bulged area circled.

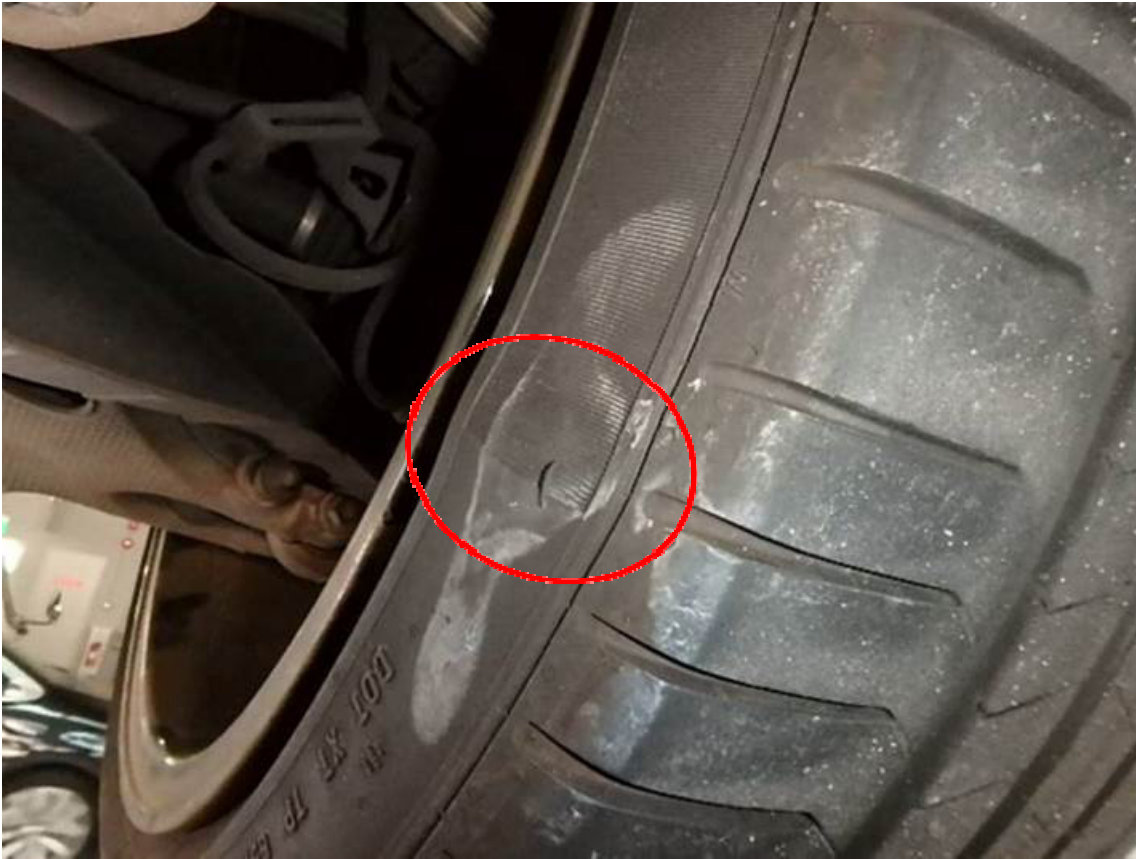
Rear left tyre with the bulged area circled.
