ACCIDENT DAMAGED VEHICLE INSPECTION REPORT

Reg. No. : FBK 2466 U
Make : Kawasaki
Model : ER300B
Year : 2015

The motorcycle sustained damage at the left and right side portion.

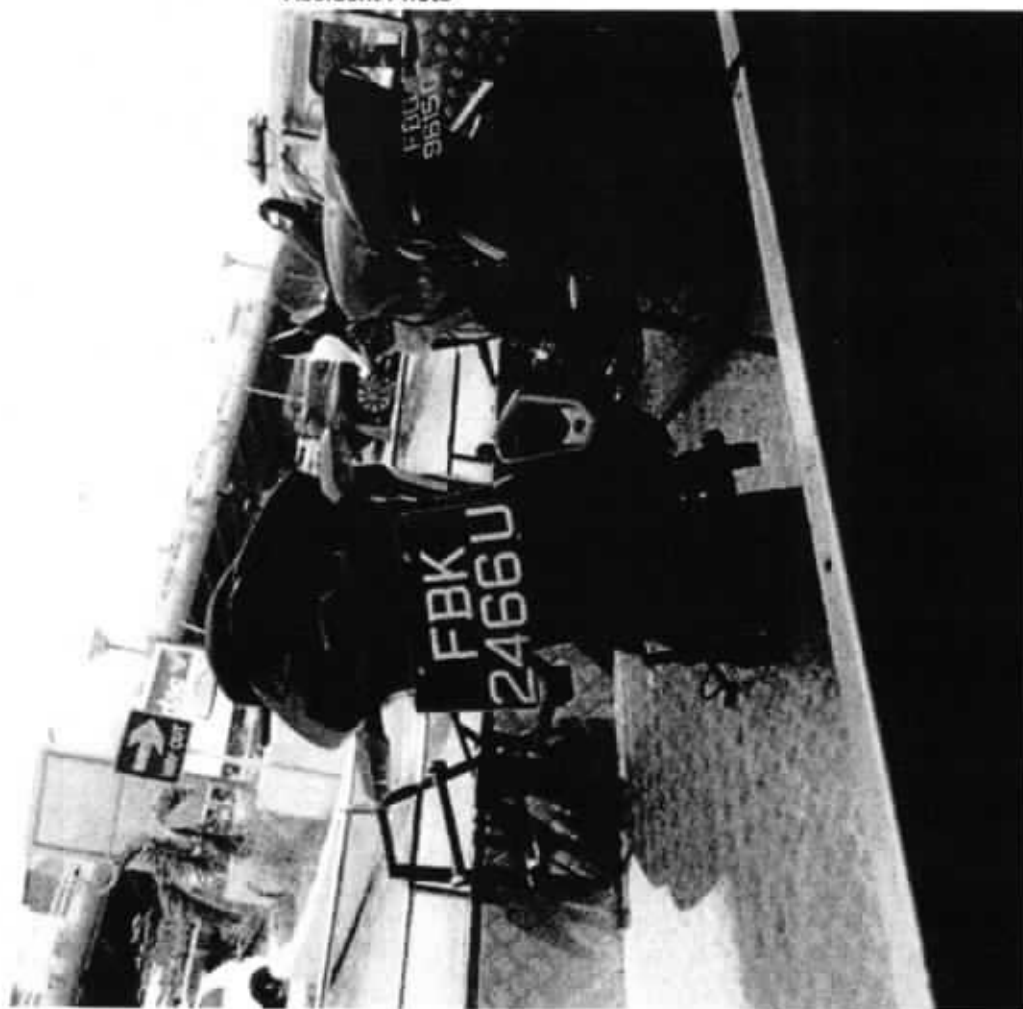
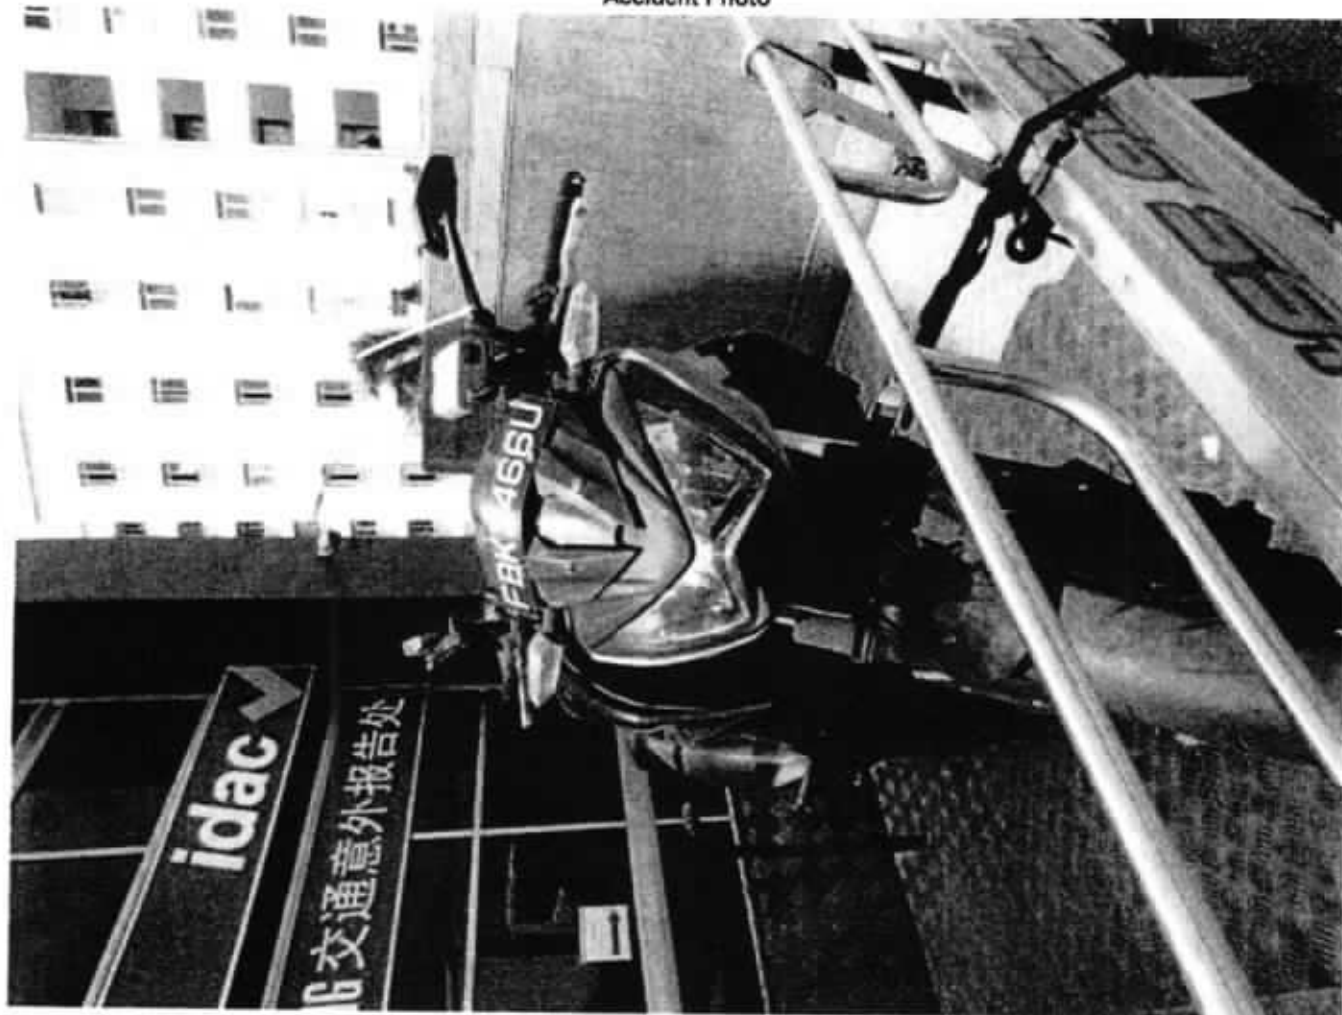
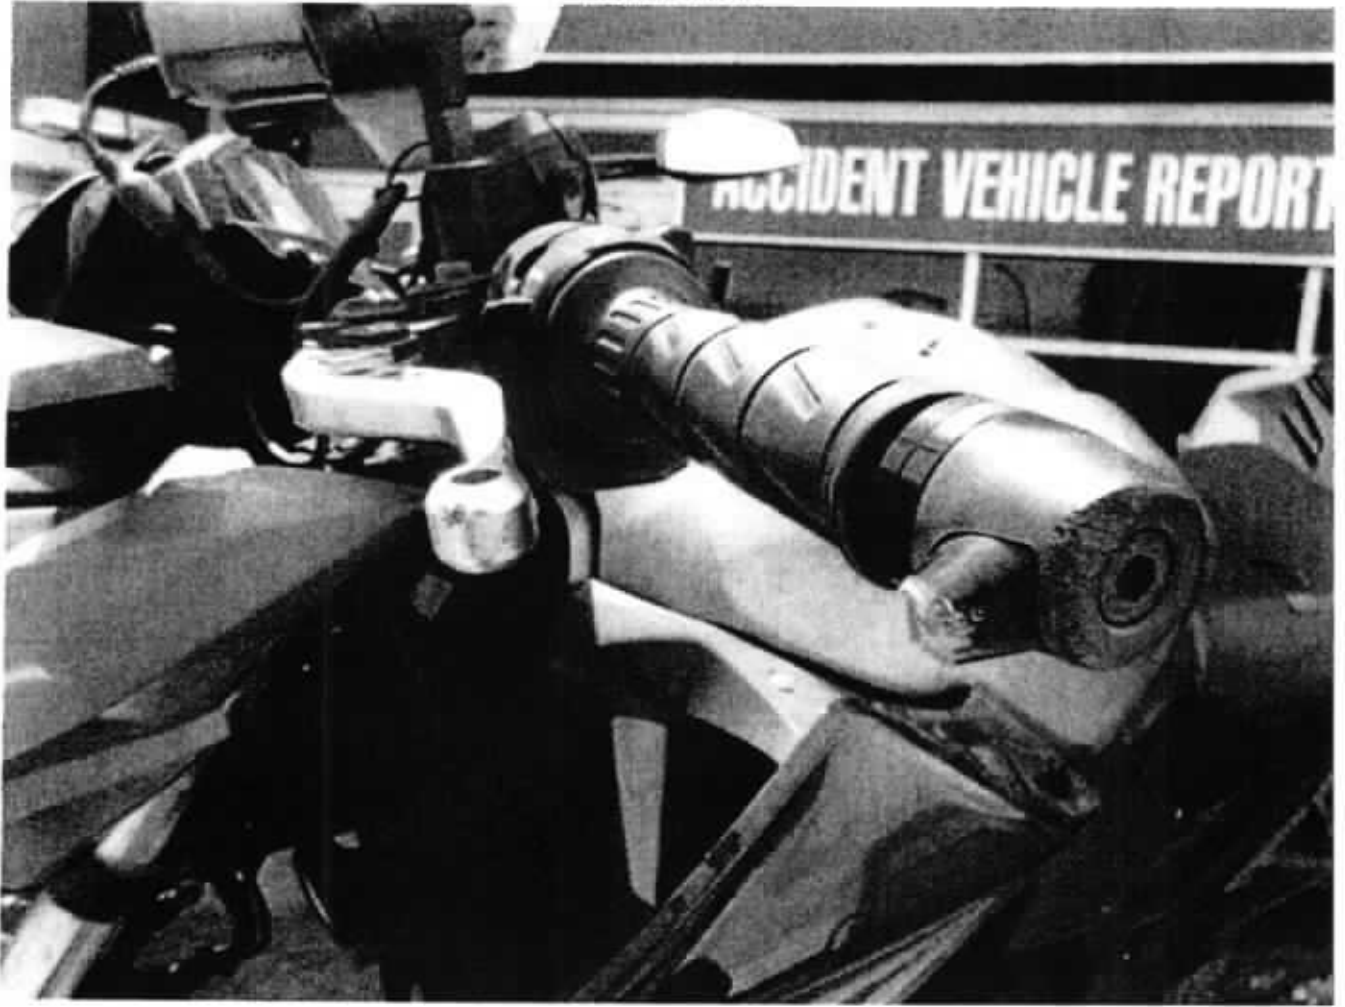
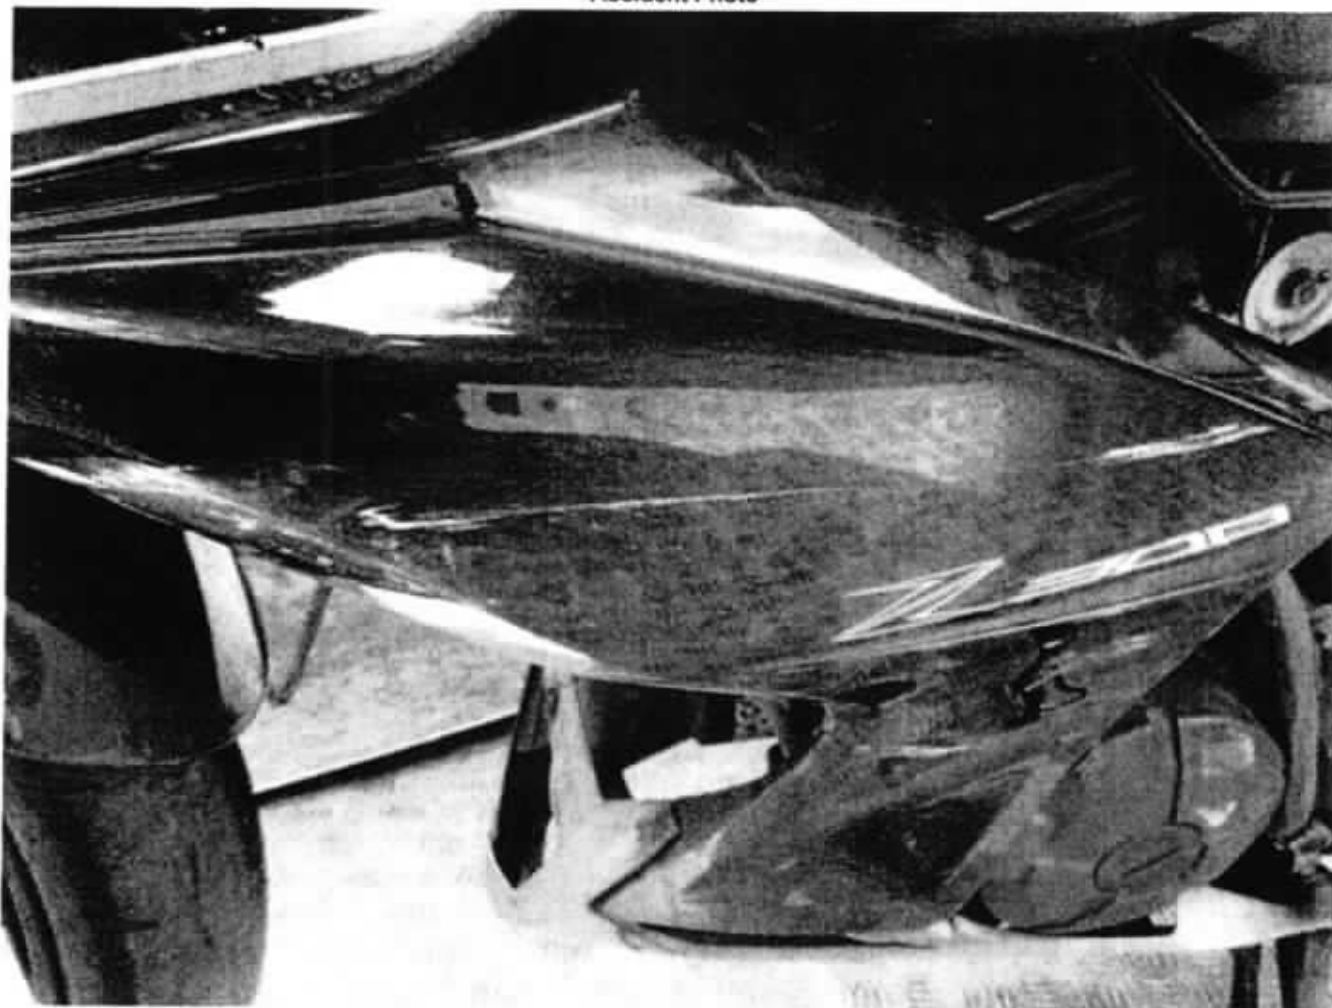
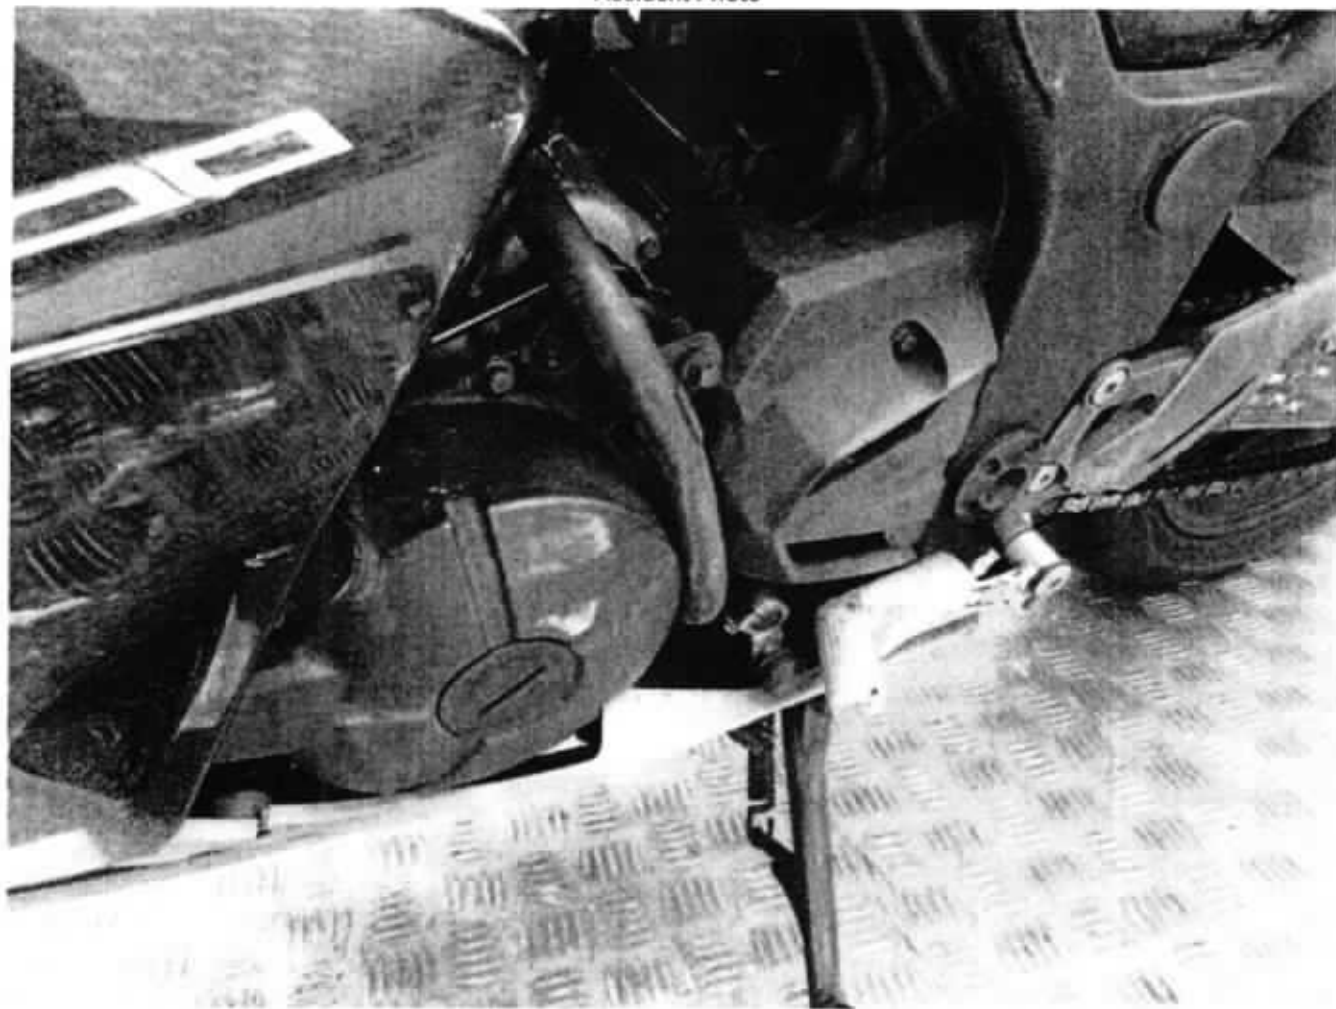
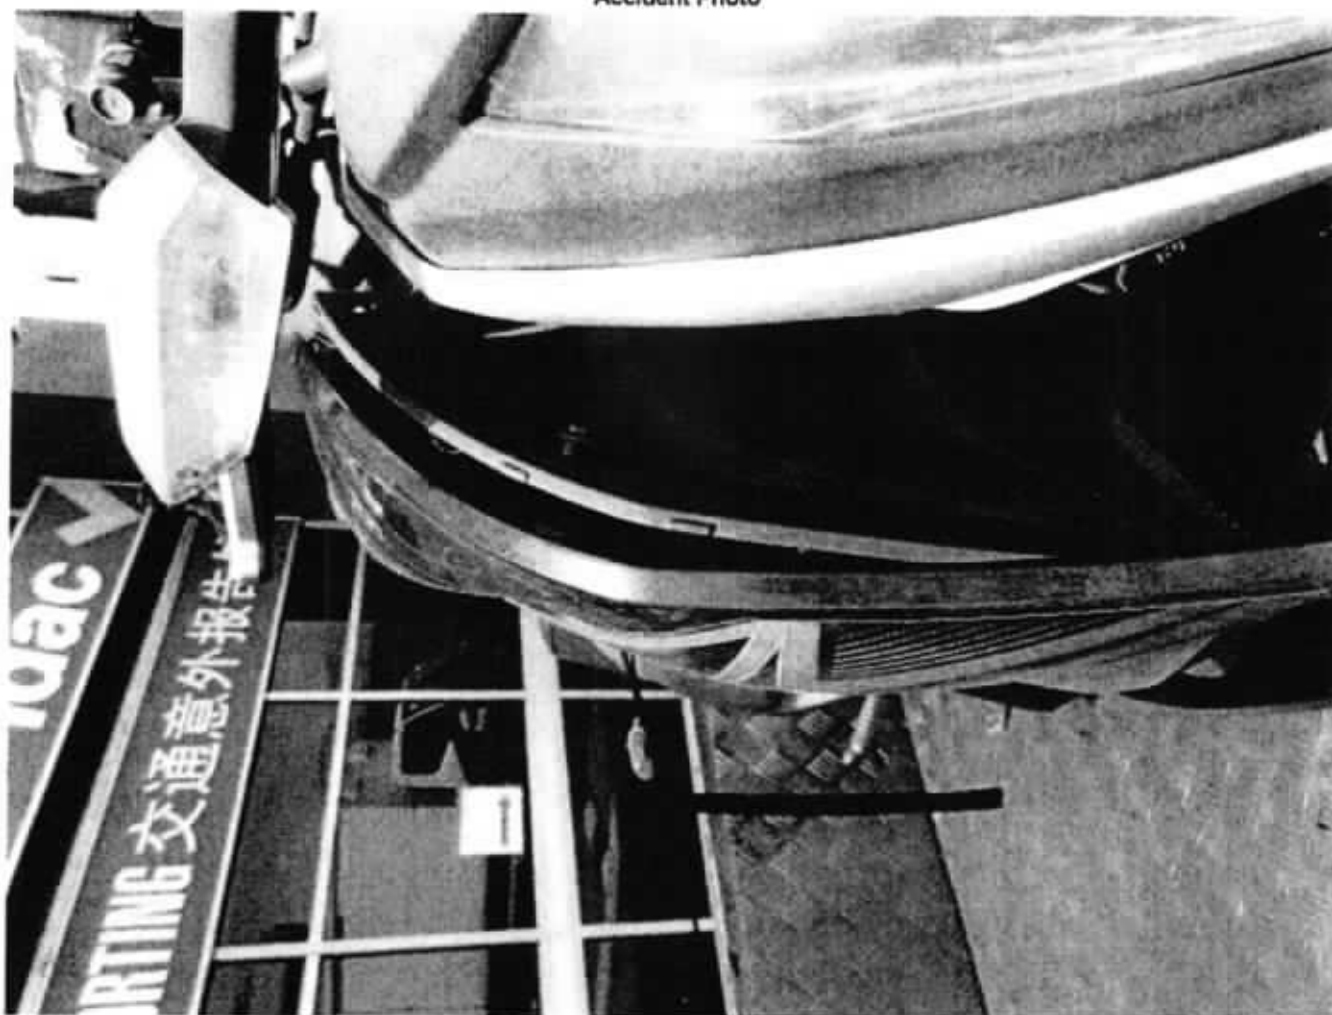
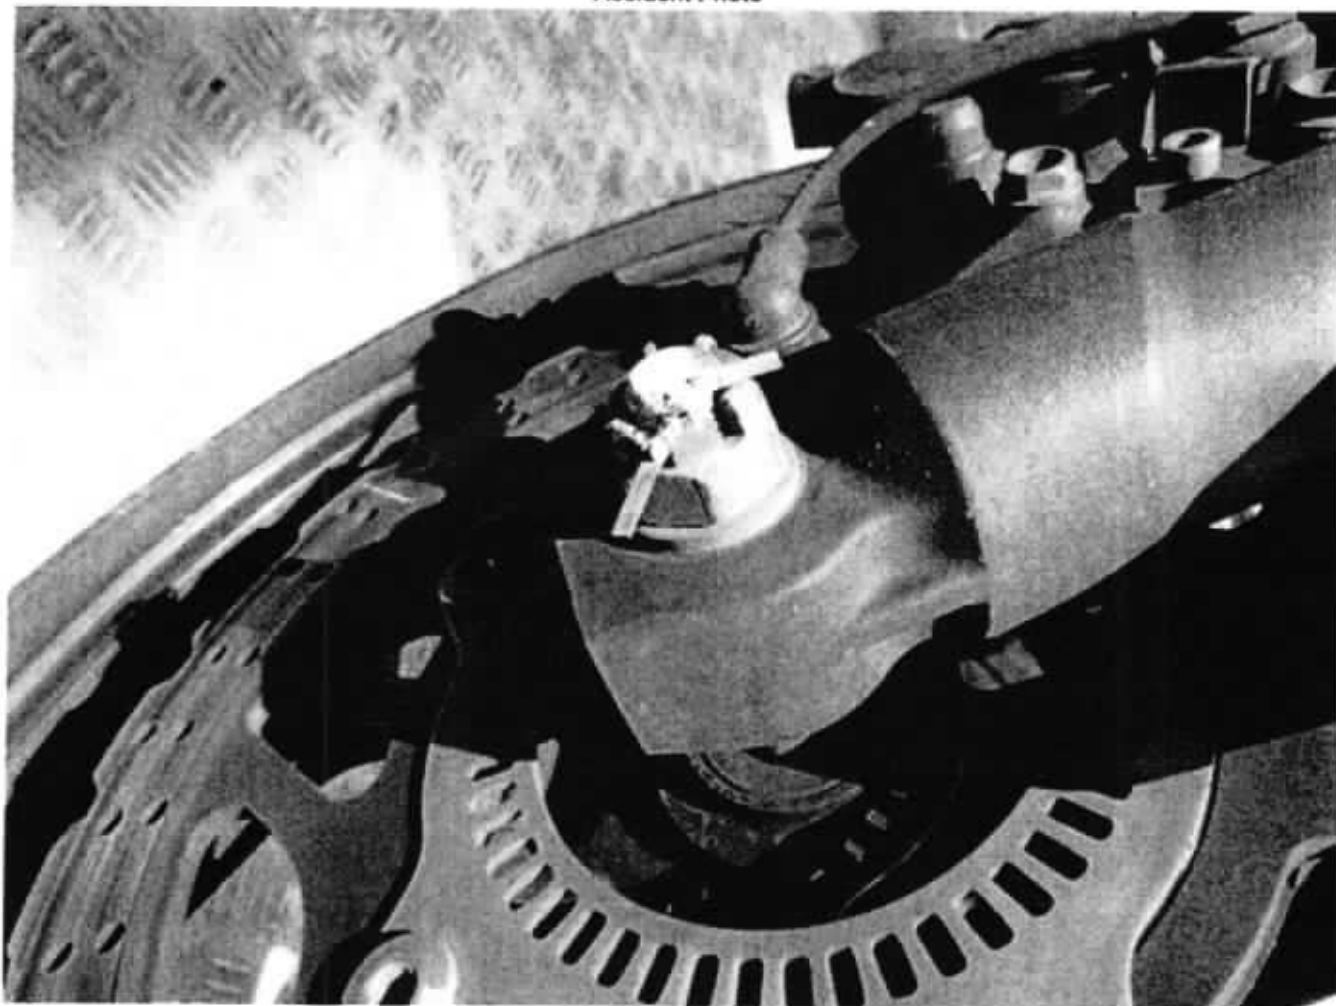
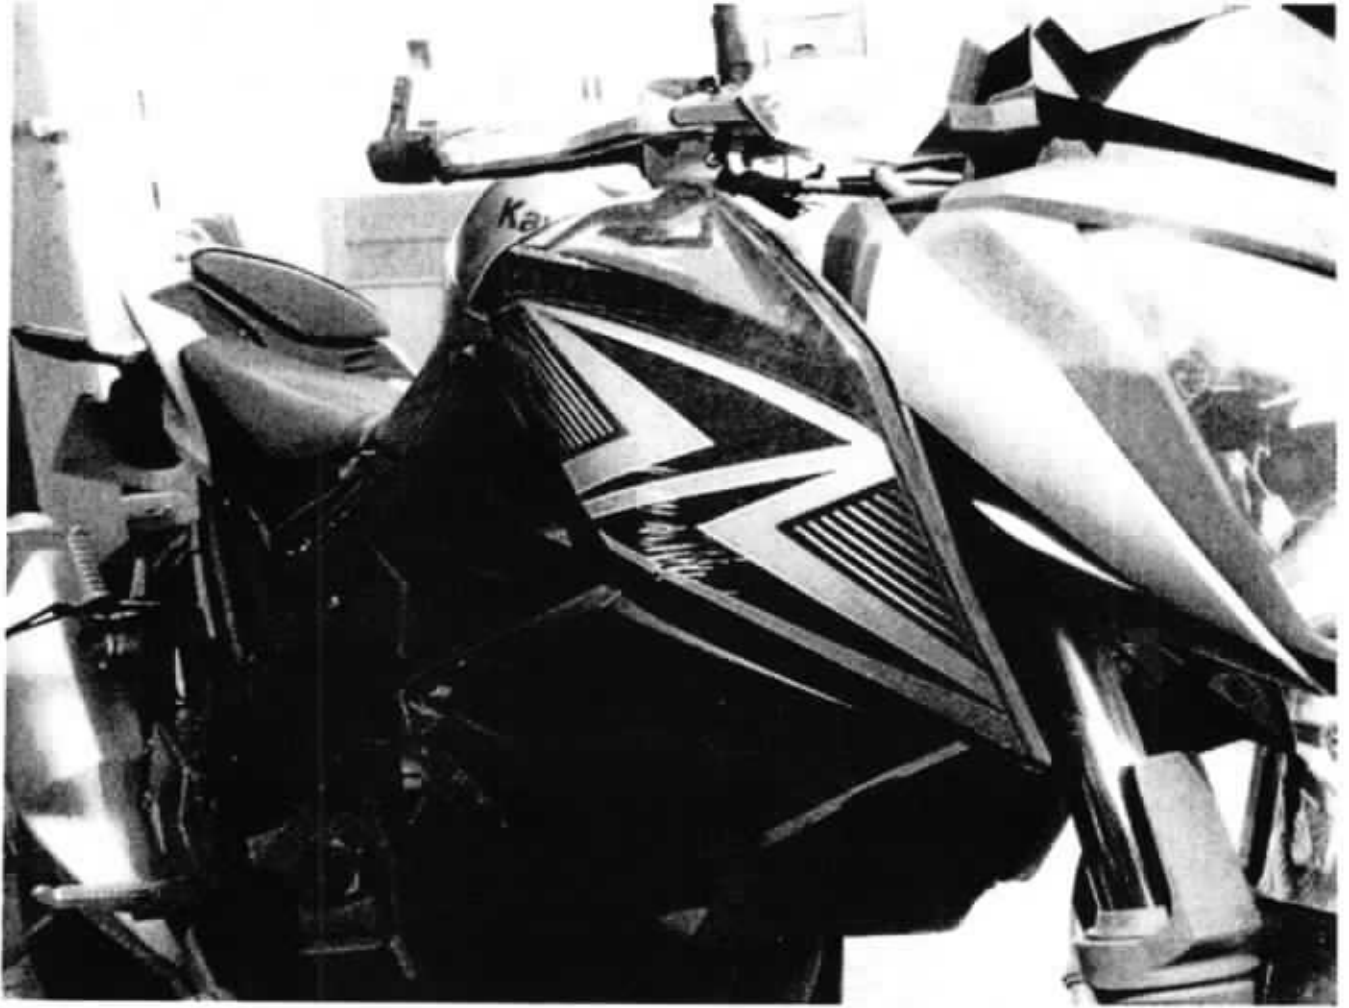
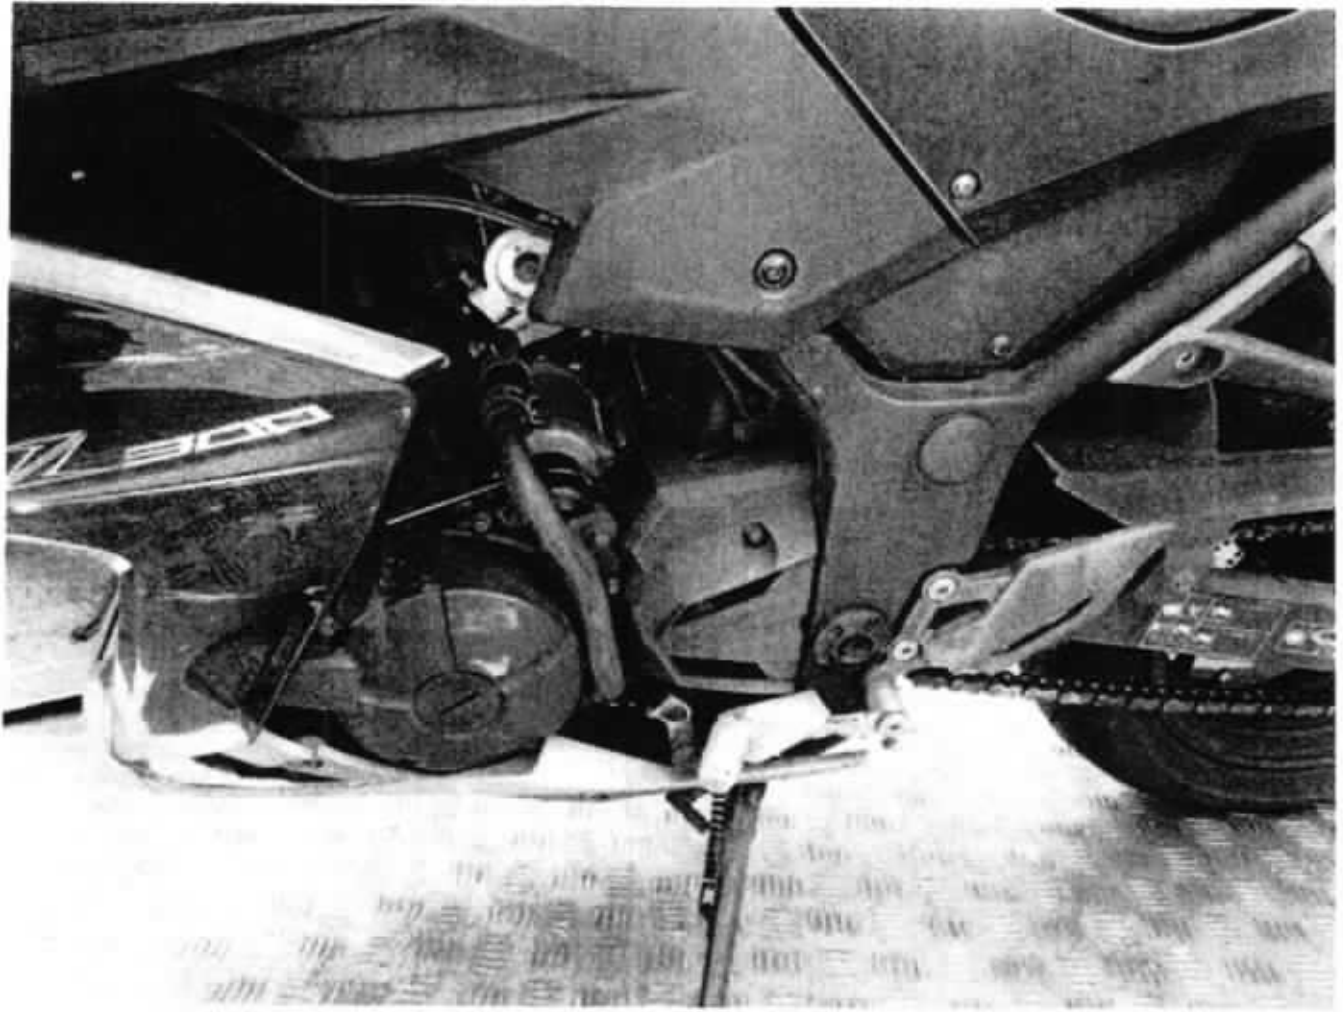
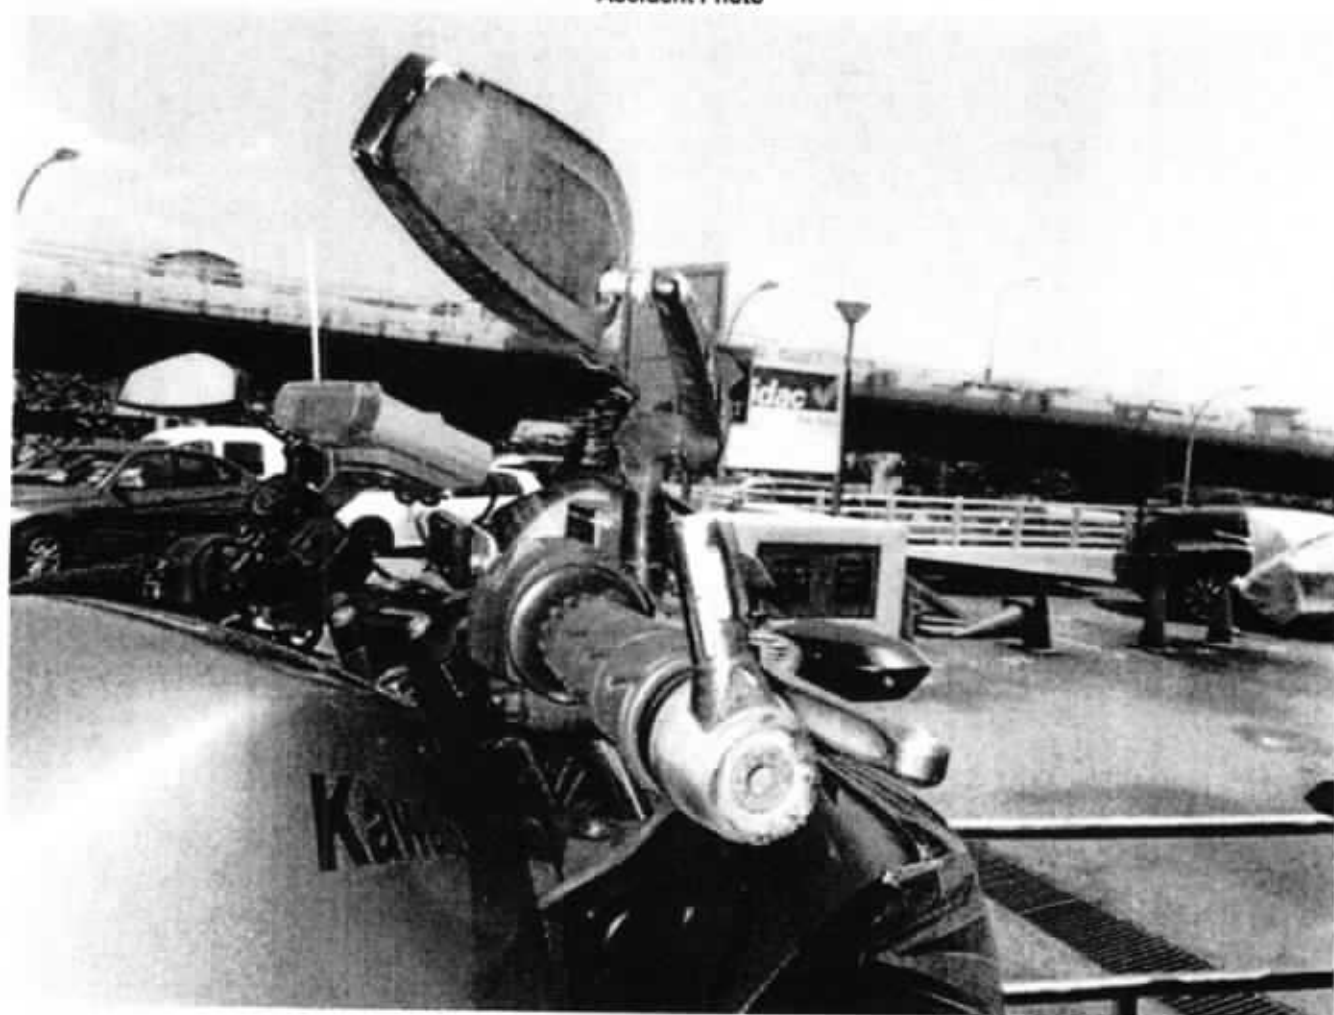
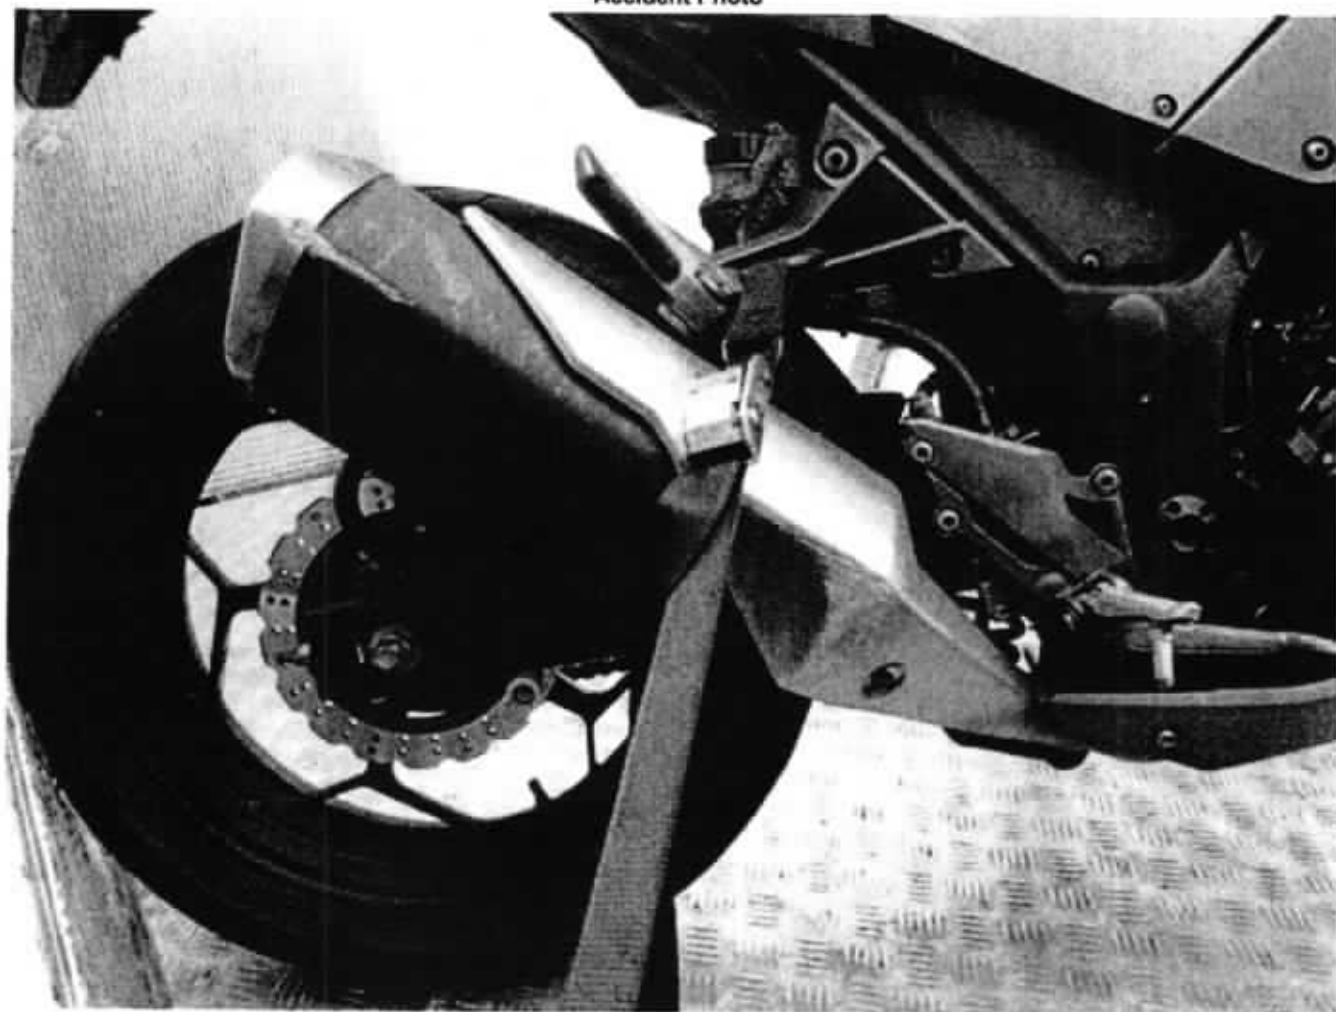
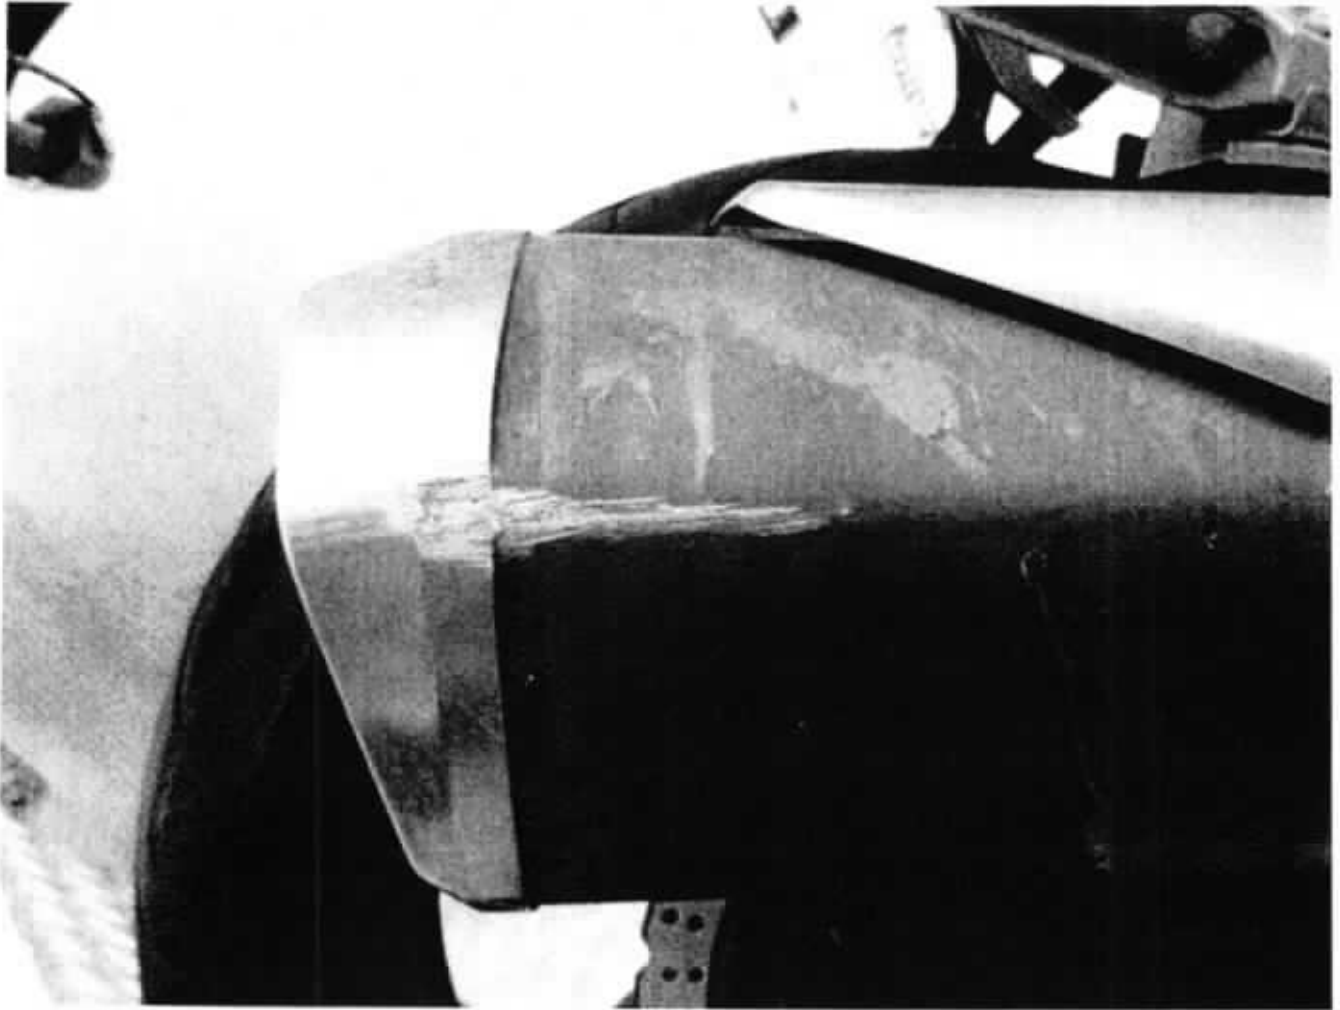
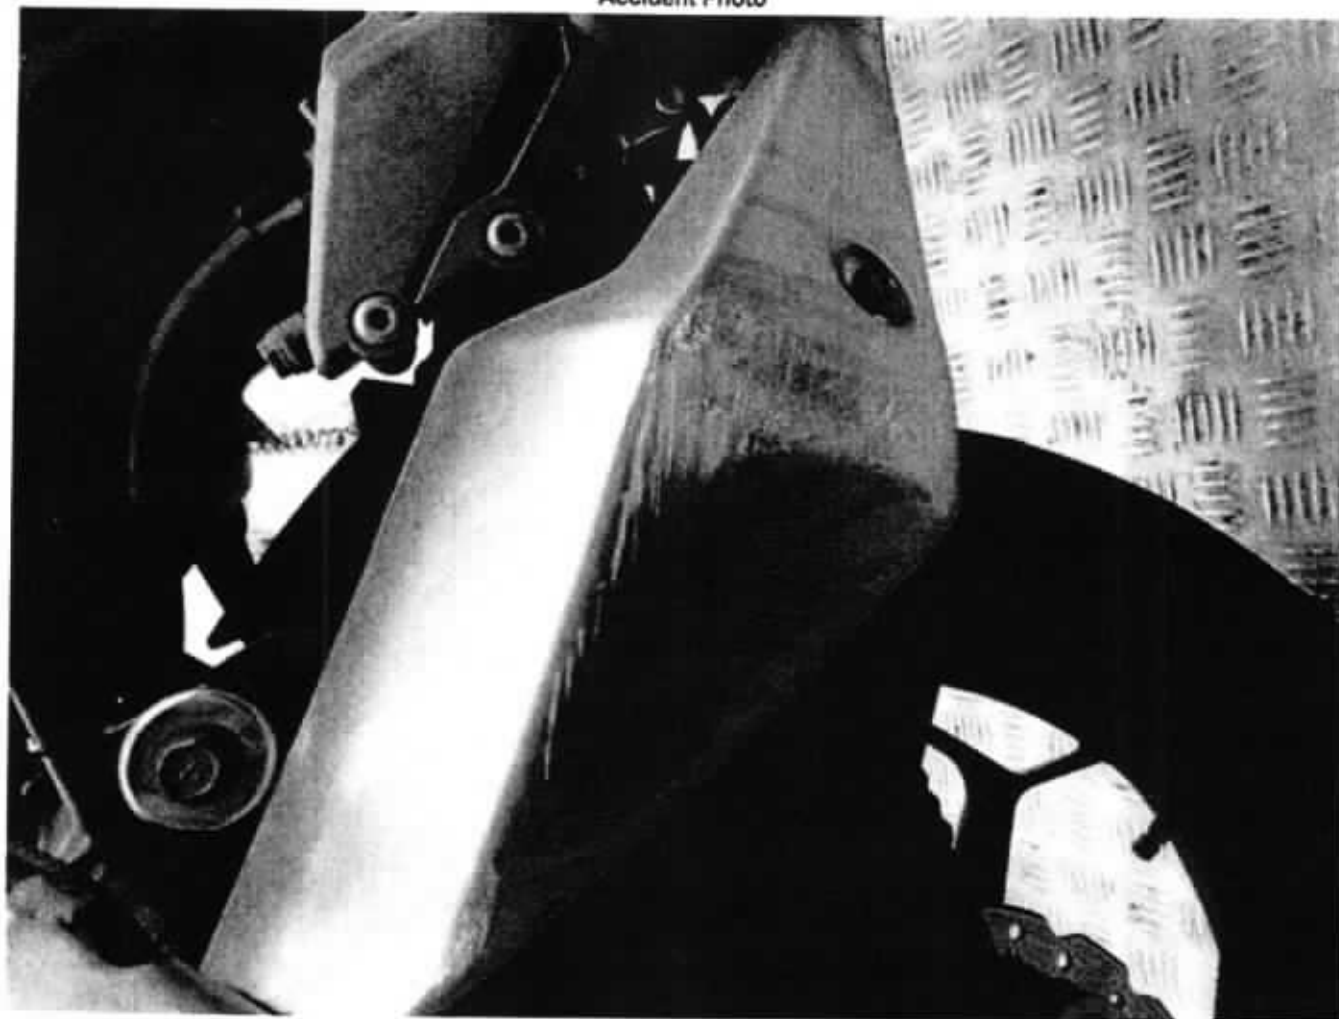
Front cowl, brake lever, clutch lever, handle bar, fork inner tubes, front fender, front rim, radiator assy, fuel tank, brake pedal, gear pedal, front footrest, front footrest bracket, exhaust protector, exhaust muffler, etc damaged.

Repair cost to the vehicle is assessed as \$ 5,900.00 (Lump Sum)
