To Inspect Vehicle No: SLR 2356Z

Hyundai Elantra

SINGAPORE ACCIDENT STATEMENT

VEHICLE DAMAGE INSPECTION REPORT

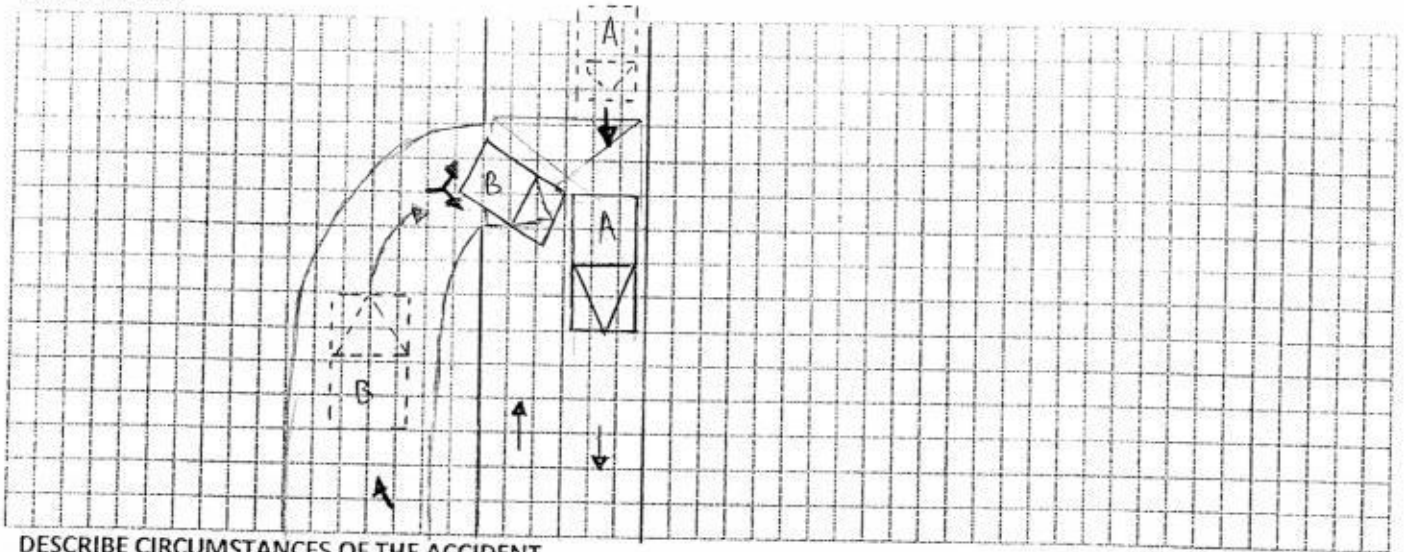
SKETCH PLAN

I was driving out of Carpark towards main road, a taxi went to exit and accidentally hit my rear door (right side)
