REF: CS310 19017631 Q+ 134-1 Special Instruction

To Inspect Vehicle No:

SLW 4031X

Toyota C-HR HYBRID

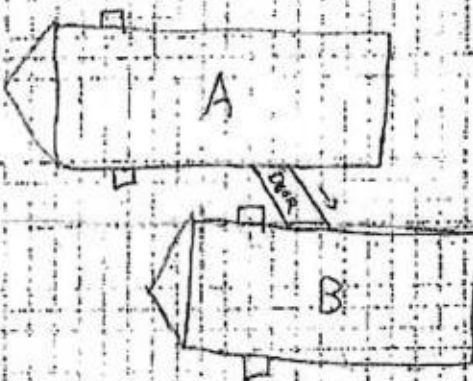
Sketch Plan #2

A) CHE 1114m

B) SLW 4031X

On 5th of Oct 195.19pm after dropping passenger at Amk HUB drop off point, while exiting the drop off point pass by a taxi Car A taxi passenger open the taxi door fully and Hit my side of the door Car B Scratch all the way to the back passenger seat door.

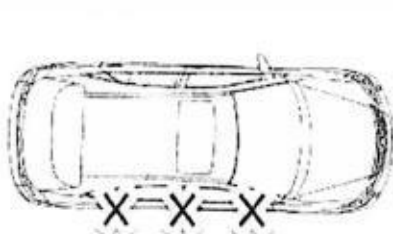
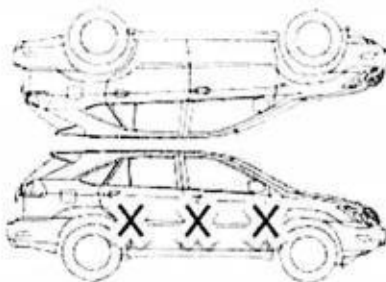
Damages sustained were consistent with the accident reported.

The general area of damages is at the **RH Side portion**
(Please refer to the parts list and photographs as attached for more information)

THE VEHICLE SUSTAINED DAMAGES AT THE O/S BODY.
DAMAGES SEE DETAILS.

The estimated repair costs submitted by Messrs **Apex Motoring** is \$ 7,058.45 .
We have adjusted the cost to \$ 4,614.26 and the repairer has agreed to undertake the repairs at a
Contract Lump Sum of \$ 3,700.00 to a acceptable quality and standards.
However, we have not given authorization and instruction to the repairer to proceed with the repairs.

The repairs should be completed within a reasonable period of **4** working days.
