SMN 48176

**ACCIDENT BETWEEN VEHICLE NO. SMN 4817 G AND VEHICLE NO. SDV 3533 X ON 15/12/2019 @ 1705 Hrs**

## VEHICLE DAMAGE INSPECTION REPORT

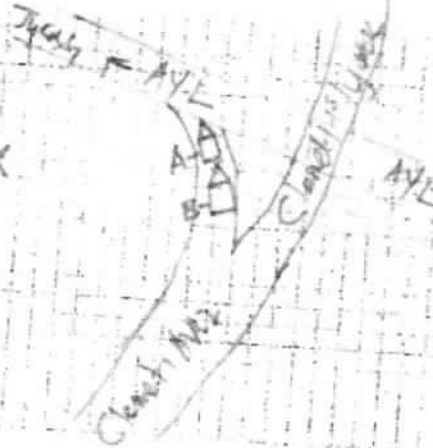
# Accident Sketch Plan

STOPPED AT THE STOP LINE AND VEHICLE SDV3553X COLLIDED ONTO MY VEHICLE REAR PORTION

A-SMN 48176  
B-CDV 3333X
