NTUC INCOME INSURANCE CO-OPERATIVE LTD Ref: NS/INC19022445/Fvf3n2			
73 BRAS BASAH ROAD #05-01 NTUC TRADE UNION HOUSESINGAPORE 189556		Date: 07-01-2020	 
		Code: INC4

1. Policy Particulars :- THIRD PARTY CLAIM			
Insured Veh.	SHD 1402B	Veh. Inspected	SHC 3149A
Policy No.		Coverage (\$)	0.00
Claim No.	MT/1076543-002	Excess (\$)	0.00
Assign From		Assign Date	20/12/2019

4. Description of Damages			
THE VEHICLE SUSTAINED DAMAGES AT THE O/S FRONT PORTION. DAMAGES SEE DETAILS.			
5. General Information			
Accident Date	20/12/2019	Inspection Date	20/12/2019
Survey held at	COMFORTDELGRO ENGINEERING PTE LTD 59 LOYANG DRIVE SINGAPORE 508969		
5a. Remarks			
A)THE INSPECTION WAS CONDUCTED ON A"WITHOUT PREJUDICE" BASIS. B)IN ACCORDANCE TO YOUR INSTRUCTIONS, WE HAVE NOT AUTHORISED REPAIRS.			
5b. Estimate Days of Repair			
ESTIMATED NORMAL PERIOD FOR REPAIR:		4 Working Days

ADJUSTMENT ON REPAIR COST FOR VEHICLE NO. SHC 3149A

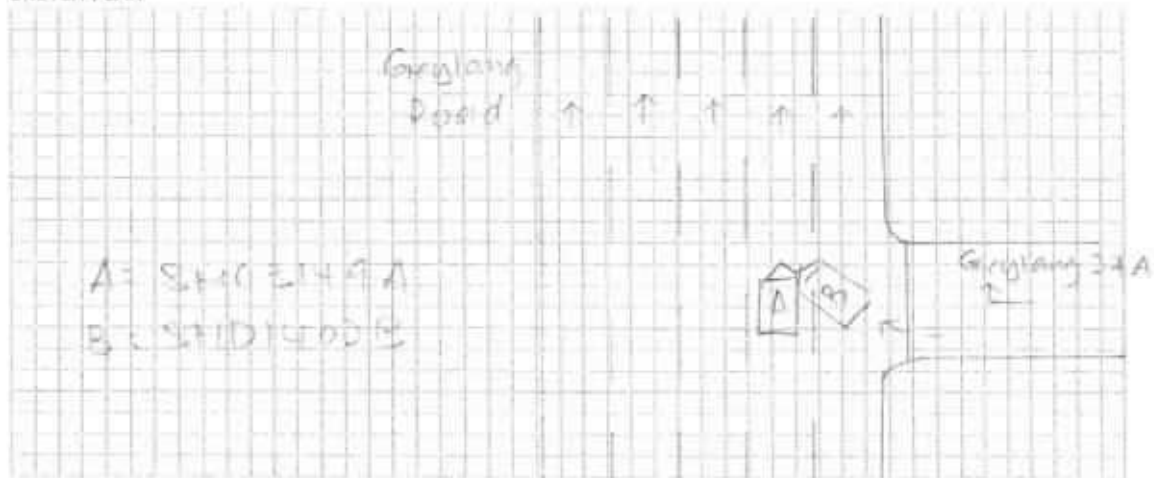
SKETCH PLAN

On 20/12/19 at about 01:40 hrs, I

veh A was driving at above said location,

without passenger onboard. Out of sudden,

veh B dashed out from minor road and it

front left portion collided onto the right front

portion of my taxi. Scene photo taken to

support my claims. No injury at the point of

accident.

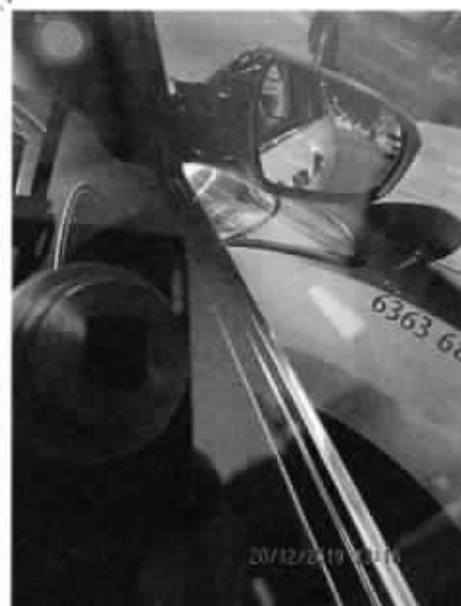
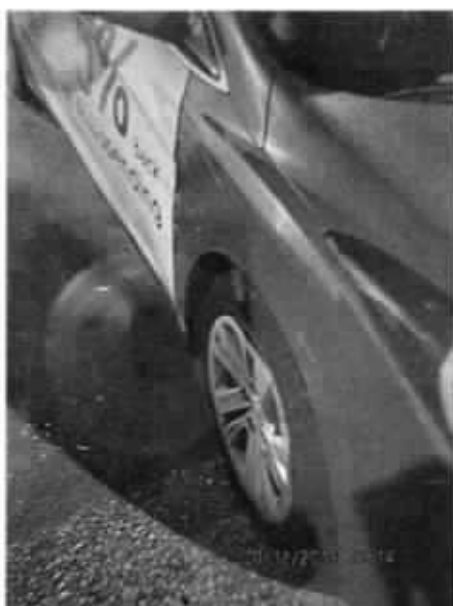
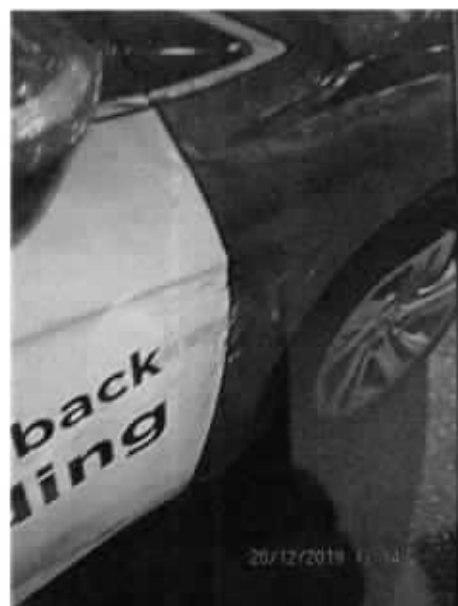
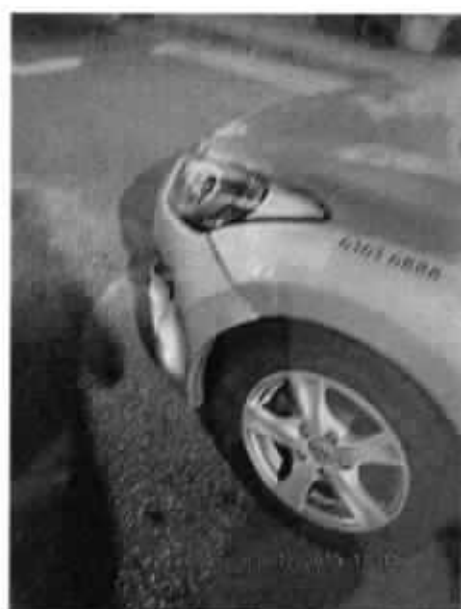
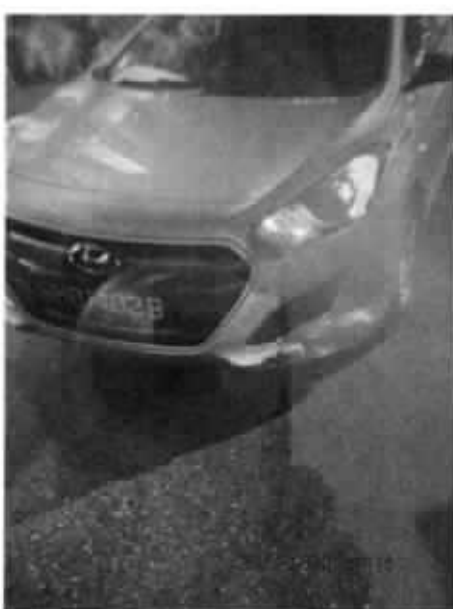
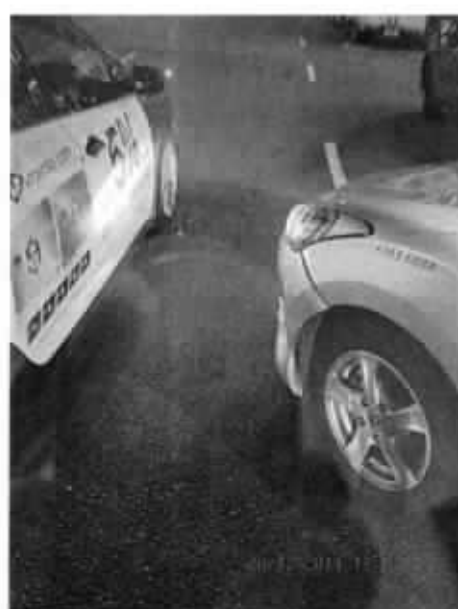
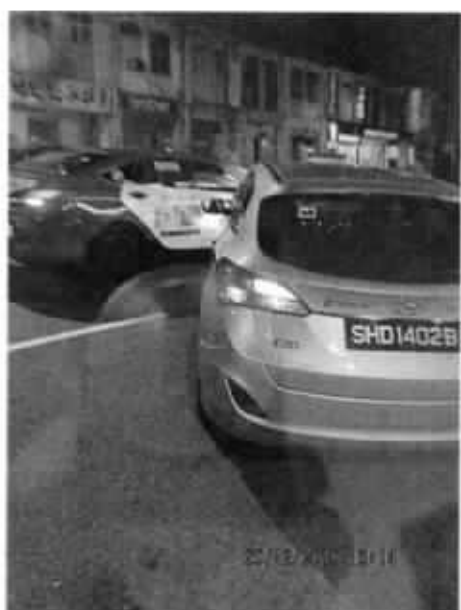
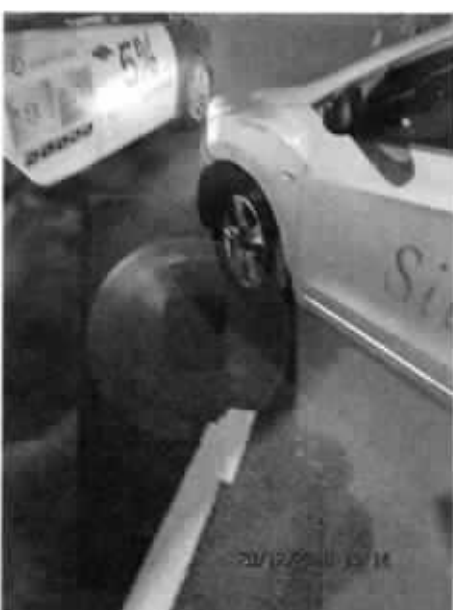
O/S frt

The U/C / Chassis frame / Body Structure affected due to collision.

Qty	Description of Parts	Condition	Estimate By Workshop (\$)	Our Adjusted (\$)
<u>REPLACEMENT OF PARTS</u>				
1	FRONT BUMPER COVER	TO REPAIR SEE LABOUR	544.50	-
1	FRONT BUMPER BRACKET TOP (RH)	NOT NECESSARY	22.40	-
1	FRONT BUMPER BRACKET (RH)	NOT NECESSARY	24.60	-
1	FRONT FENDER (RH)	DENTED	663.00	663.00
1	FRONT FENDER SHIELD (RH)	NOT NECESSARY	174.90	-
1	FRONT FENDER RETAINER	NECESSARY	24.60	24.60
1	FRONT DOOR (RH)	TO REPAIR SEE LABOUR	2,256.40	-
1	FRONT WHEEL HUB CAP (RH)	CUT	107.10	107.10
1	ROCKER PANEL (NPA)	TO REPAIR SEE LABOUR	-	-
1	WING MIRROR COVER (NPA)	TO REPAIR SEE LABOUR	-	-
	LESS 20% DISCOUNT		-763.50	-158.94
			3,054.00	635.76
<u>SPECIAL NETT ITEMS</u>				
1	FRONT FENDER ADVERTISEMENT LOGO (RH)(SN)	NOT NECESSARY	100.00	-
1	FRONT DOOR COMFORT LOGO (RH)(SN)	NECESSARY	75.00	75.00
1	FRONT DOOR ADVERTISEMENT LOGO (RH)(SN)	NECESSARY	100.00	100.00

275.00	175.00
<u>LABOUR</u>				
	PANEL BEATING.INCLUSIVE OF THE REPAIR OF FRONT BUMPER COVER,FRONT DOOR (RH),ROCKER PANEL AND WING MIRROR COVER.		850.00	720.00
	SPRAY PAINTING CHARGE.		750.00	680.00
	WIRING CHARGE.		50.00	30.00
	TUFF KOTE.	NOT NECESSARY	50.00	-
	TRANSFER OF DOOR.		80.00	80.00
	FRT WHEEL ALIGNMENT.		80.00	80.00
			1,860.00	1,590.00

GRAND TOTAL		5,189.00	2,400.76
RECOMMENDED COST OF LUMP SUM REPAIRS (TO ITS PRE-ACCIDENT CONDITION) (CONFIRMED)			1,900.00
