PAPER SURVEY OF GY4460P

Registration Number	:	GY 4460 P	Odometer Reading	:	483 451 Km
Make/Model	:	Toyota Hiace 2.0	Radio/Cassette/CD	:	Fitted
Year of Manuf/Reg	:	2005	Air Conditioner	:	Fitted
Engine Number	:	2KD1242632	View Mirrors	:	Fitted -O/s & n/s
Chassis Frame Number	:	JTFHS0ZP300012688	Seat Belts	:	Fitted -Front only
Class/Type	:	Panel Van (Goods)	Other Assessories	:	
Colour	:	White	(Specify)	:

ADJUSTMENT ON REPAIR COST FOR VEHICLE NO. GY 4460P

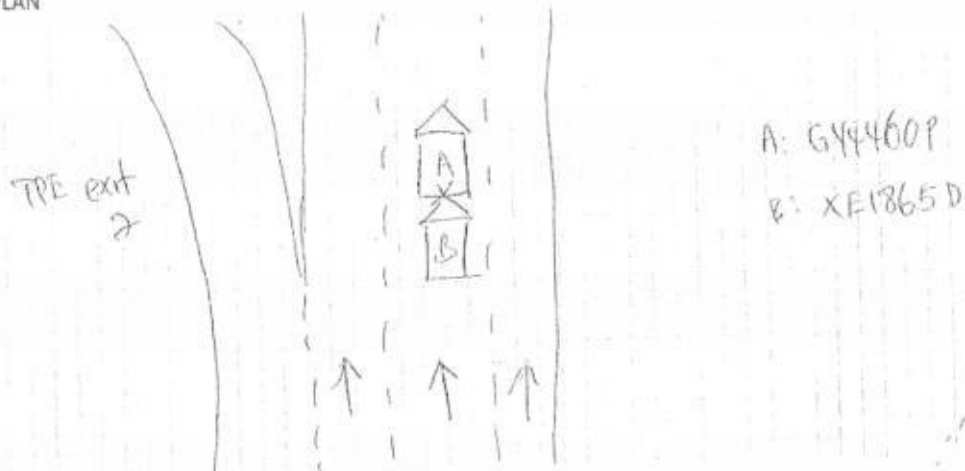
SKETCH PLAN

I was driving along TPE before exit 2 around 1pm on 29/10/19. I ~~also~~ changed lane from the third lane to the second lane. After changing lane, the driver of XE1865D did not notice and hit onto the back of my vehicle.

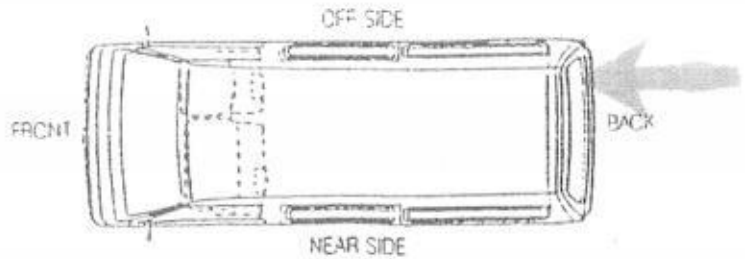
Direction of Impact (→)

Damages sustained were consistent with the subject vehicle being involved in a collision with another vehicle and the impact was delivered onto the rear o/s portion of the vehicle.
