Preliminary Advice

Insured Vehicle No	: SLQ7687R	Accident Date	: 23/12/2019
TP Vehicle No	: SLW6102L	Assignment Date	: 30/12/2019
Make	: BMW 318I	Est. Duration of Repair	: 4.00
Date of Inspection	: 26/12/2019		
Inspection At	: FASTECH AUTO PTE LTD (HQ) 1 KAKI BUKIT AVE 6, #01-46/48/50 AUTOBAY SINGAPORE 417883

Point of Impact / General Description of Damages

VEHICLE DAMAGE INSPECTION REPORT

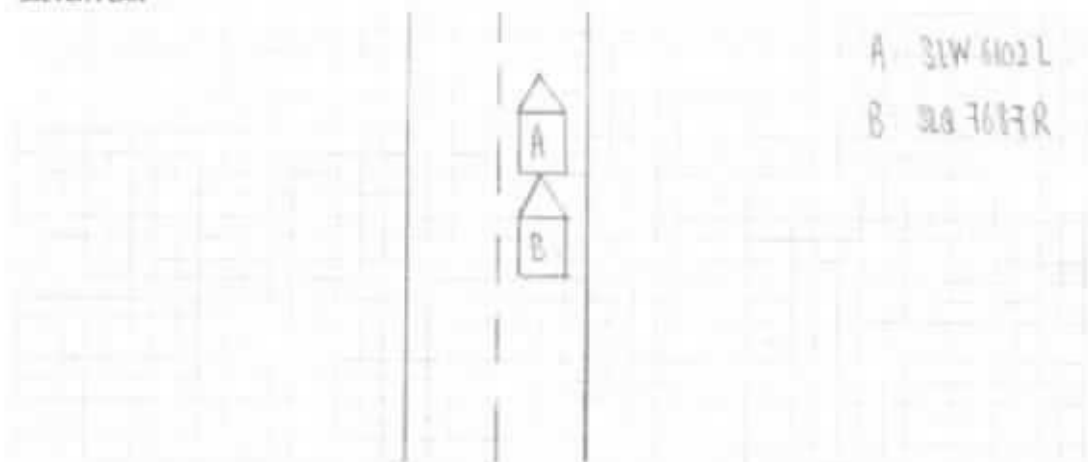
SKETCH PLAN

On 23.12.2019 at about 21:10, I was travelling along Kitchener Road Towards Serangoon Road. I was stationary due to front traffic. Suddenly Vehicle B hit my rear.
