To Inspect Vehicle No: GBA 9931A

GBA 9931A - X

**Subject:** re-Repair Inspection for GBA 9931 A // Accident on 24/12/2019 @ 17:55HR at along Ubi Avenue 1, after Ubi Road 1 involving Vehicle Number GBA 9931 A & SKV 556 S

## VEHICLE DAMAGE INSPECTION REPORT

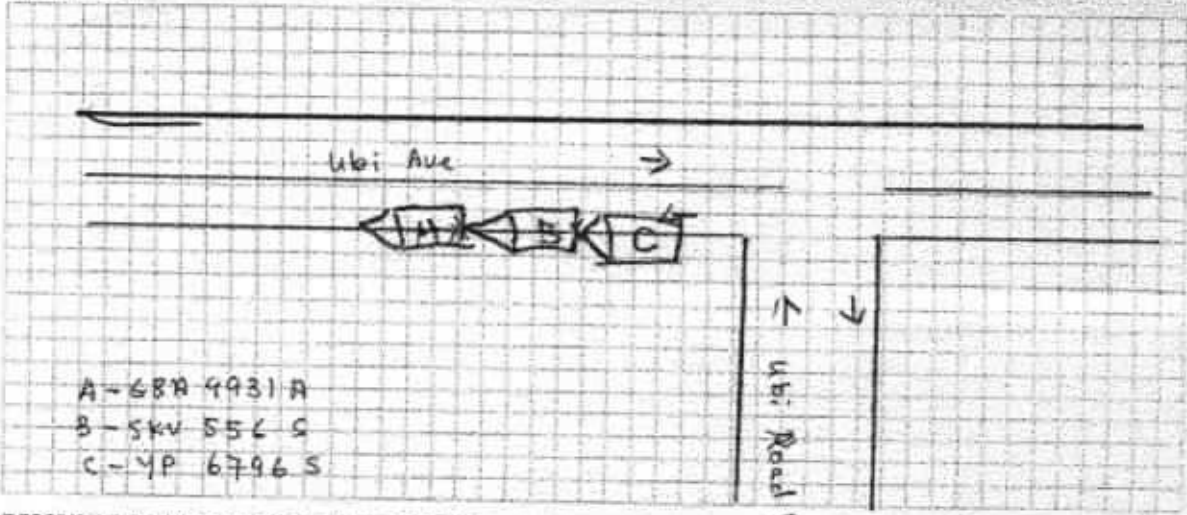
SKETCH PLAN

Traveling from Ubi Road 1, turn to Ubi Ave 1, after go straight, suddenly behind car (B) Honda Odyssey hit my rear door, bumper, side pillar. Beside car (B) the lorry hit (B) force hit my van.
