To Inspect Vehicle No: SJW 4464D Insured: GBF 2329J

Date Of Report	08/11/2018 17:00
Date Of Accident	07/11/2018 16:30
Exact Location Of Accident	BLK 546A MSCP SERANGOON NORTH AVE 3
Country/State of Loss	SINGAPORE

PROMINENT APPRAISER SERVICES PTE LTD

ADJUSTMENT ON REPAIR COST FOR VEHICLE NO. SJW 4464D

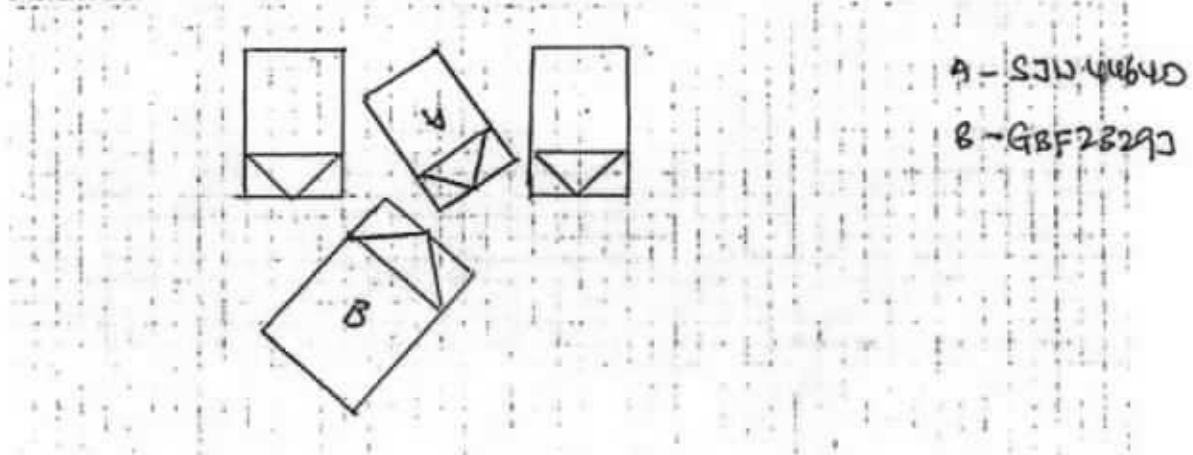
SKETCH PLAN

A
MY VEHICLE WAS STATIONARY IN THE MULTISTORY CARPARK.
VEHICLE B, WHO WAS MAKING A RIGHT TURN COLLIDED INTO MY
FRONT RIGHT OF MY VEHICLE A. THE IMPACT WAS SO HARD THAT IT
CAUSED THE VEHICLE TO MOVED. THE REAR LEFT OF MY VEHICLE
GRAZED ONTO THE WALL DUE TO THE FORCEFUL IMPACT FROM
VEHICLE B.
TRAFFIC POLICE REPORT NO: A120181107 0095
