REPAIR BILL FOR VEHICLE NO. YL 8312 M

AUTOMOBILE INSPECTION REPORT

Registration No. : YL 8312 M
Make/Model : ISUZU NQR70P
Yr of Manuf/Regn : 2004
Carrying Capacity : -
Chassis No. : JAAN1R70P47101153
Engine No. : 4HE1106494
Colour : White
Class : Goods (Lorry)

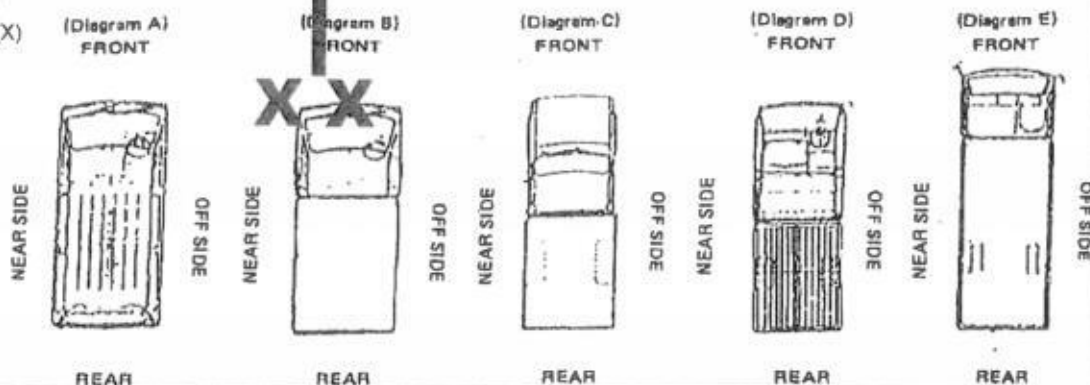
POINT OF IMPACT

Direction of impact/damage marked (→) (X)

The vehicle
sustained impact
on its Front N/s
Portion.
(see Diagram B)

The front bumper and centre cab panel, front n/s door and pillar, front n/s corner panel and headlamp panel were dented.

| S/No | Qty | Parts / Labour Descriptions | Remarks / Condition | Repairer's Estimate Amount \$ cts | Recommendation / Revised Amount \$ cts |
|---|---|---|---|---|---|
| 1 | | Remove the necessary affected parts, straighten front n/s door pillar and hinges, front n/s door and headlamp panel, repair front cab wiper garnish and replace parts | 7 hrs | 1800.00 | 1400.00 1000/ |
