Code : EQI	
<b>1. Policy Particulars :- THIRD PARTY CLAIM</b>				
	<b>Insured Veh.</b>	FBL 2843J	<b>Veh. Inspected</b>	SG 5774E
	<b>Policy No.</b>	DMMPHQ19-000842	<b>Coverage (\$)</b>	0.00
	<b>Claim No.</b>	DM20HO00164/SG	<b>Excess (\$)</b>	0.00
	<b>Assign From</b>		<b>Assign Date</b>	30/12/2019
<b>2. Vehicle Particulars &amp; Condition</b>				
	<b>Make &amp; Model</b>	MAN A95	<b>c.c</b>	10518
	<b>Engine No.</b>	HIDDEN	<b>Year of Reg.</b>	2016
	<b>Chassis No.</b>	WMAA95ZZ7G7003250	<b>Colour</b>	MULTI COLOUR
	<b>Odometer</b>	249792	<b>Steering</b>	IN ORDER
	<b>Brakes</b>	IN ORDER	<b>Modification</b>	STANDARD ALLOY RIM
	<b>General</b>	FAIR		
<b>3. Conditions of Tyres</b>				
		<b>Size</b>	<b>Make</b>	<b>Balance</b>

### ADJUSTMENT ON REPAIR COST FOR VEHICLE NO. SG 5774E

PHOTOGRAPHS FOR VEHICLE NO. SG 5774E

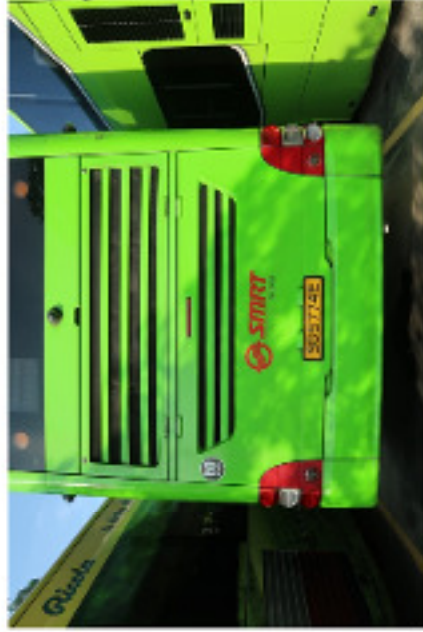
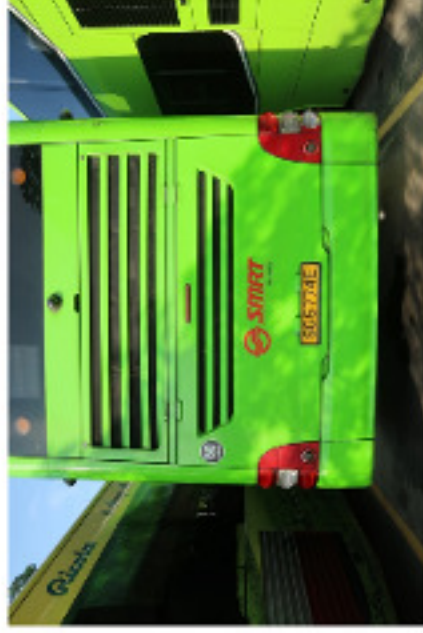
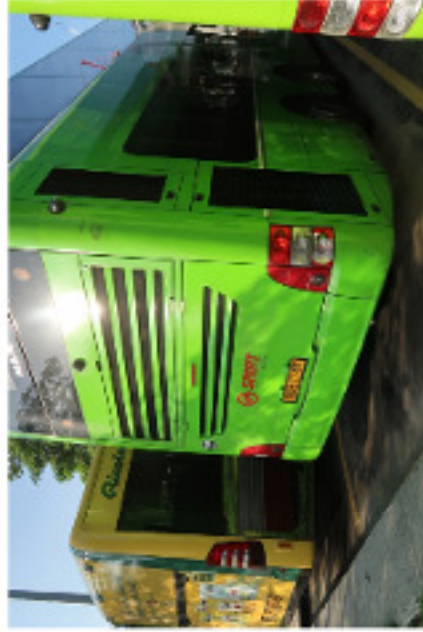
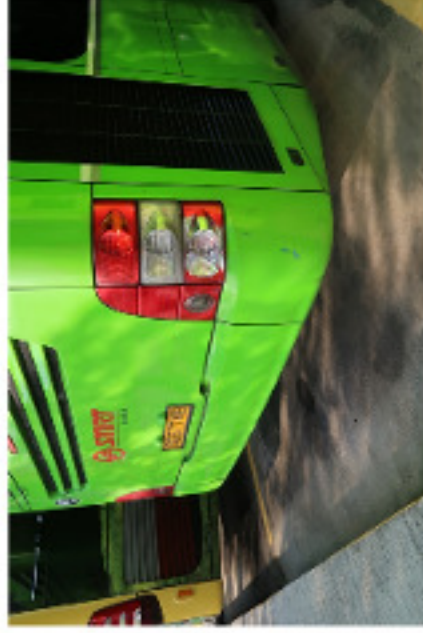
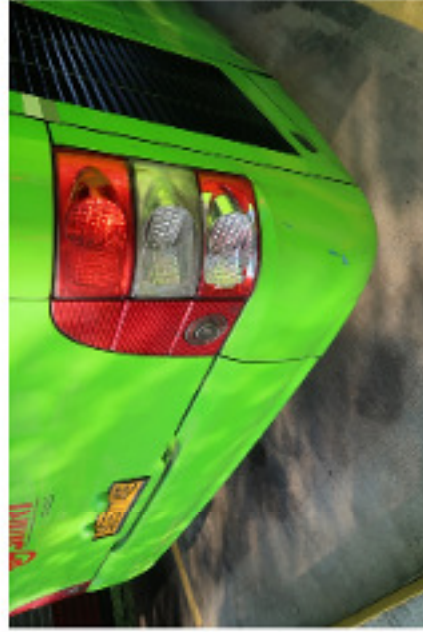
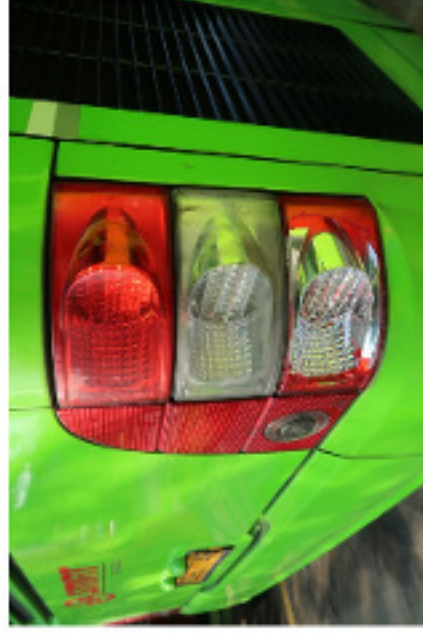
<b>R/H Front Tyre</b>	275/70 R22.5	FIRENZA	5 mm
	<b>L/H Front Tyre</b>	275/70 R22.5	FIRENZA	5 mm
	<b>R/H Rear Tyre</b>	275/70 R22.5	FIRENZA	5 mm
	<b>L/H Rear Tyre</b>	275/70 R22.5	FIRENZA	5 mm
<b>4. Description of Damages</b>				
	THE VEHICLE SUSTAINED DAMAGES AT THE REAR PORTION. DAMAGES SEE DETAILS.			
<b>5. General Information</b>				
	<b>Accident Date</b>	23/12/2019	<b>Inspection Date</b>	30/12/2019
	<b>Survey held at</b>	SMRT AUTOMOTIVE SERVICES PTE LTD 60 WOODLANDS INDUSTRIAL PARK E4 SINGAPORE 757705		
<b>5a. Remarks</b>				
	A)THE INSPECTION WAS CONDUCTED ON A"WITHOUT PREJUDICE" BASIS. B)IN ACCORDANCE TO YOUR INSTRUCTIONS, WE HAVE NOT AUTHORISED REPAIRS.			
<b>5b. Estimate Days of Repair</b>				
	ESTIMATED NORMAL PERIOD FOR REPAIR:		<b>1 Working Days</b>

Qty	Description of Parts	Condition	Estimate By Workshop (\$)	Our Adjusted (\$)
	<b><u>REPLACEMENT OF PARTS</u></b>			
1	LAMP STOP LED (MAN BUS)	CRACKED	1,141.70	1,141.70
1	LAMP INDICATOR LED (MAN BUS)	SERVICEABLE	1,274.10	-
	LESS 10% DISCOUNT		-	-114.17
			2,415.80	1,027.53
	<b><u>LABOUR</u></b>			
	TO REMOVE & INSTALL ABOVE ITEMS AND REPAIR OTHERS DAMAGED AFFECTED AREAS.		530.00	265.00
	TO PUTTY & RESPRAY .		432.00	262.00
			962.00	527.00
<b>GRAND TOTAL</b>			<b>3,377.80</b>	<b>1,554.53</b>
<b>RECOMMENDED COST OF LUMP SUM REPAIRS (TO ITS PRE-ACCIDENT CONDITION)</b>				<b>1,350.00</b>
