To Inspect Vehicle No: SLP 7494K

The U/C / Chassis frame / Body Structure affected due to collision.

NOTICE OF ACCIDENT & PRE-REPAIR SURVEY : ACCIDENT INVOLVING SLP 7494K & XD 7693Z ALONG PIE TUAS BEFORE CTE (SLE/TPE) EXIT ON 3 JANUARY 2020 @ 1415HRS

VEHICLE DAMAGE INSPECTION REPORT

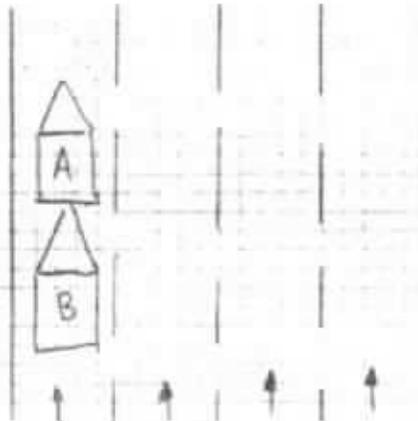
SKETCH PLAN

Type Of Accident	COLLISION - HEAD TO REAR
Weather Conditions	CLEAR
Road Surface	DRY

A: SLP 7494K

B: XD7693Z
