## DAMAGE ASSESSMENT REPORT

## ADJUSTMENT ON REPAIR COST FOR VEHICLE NO. GBD 6155C

PHOTOGRAPHS FOR VEHICLE NO. GBD 6155C

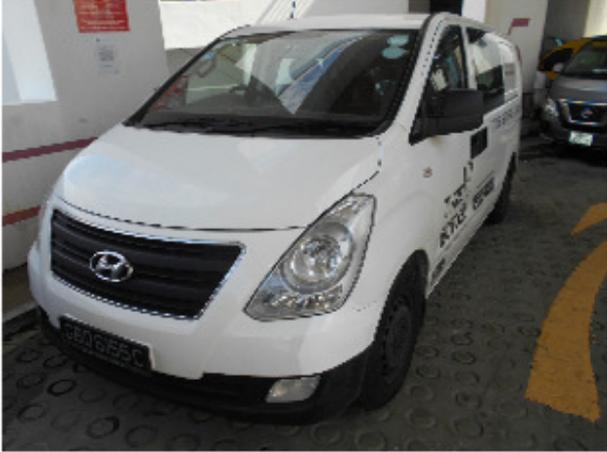
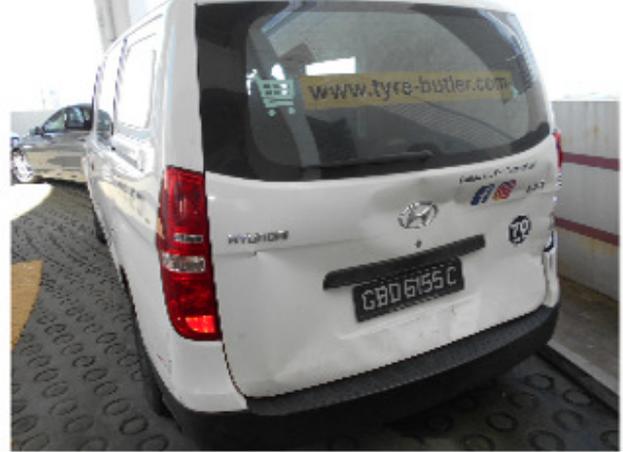
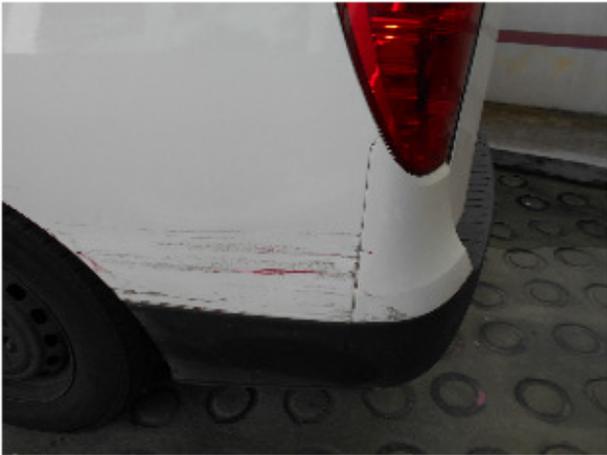
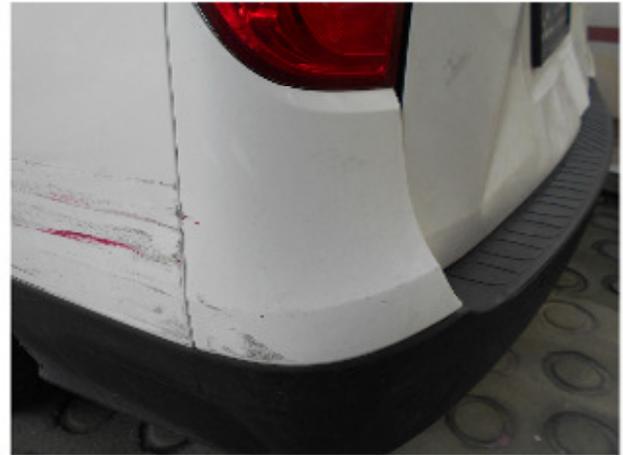
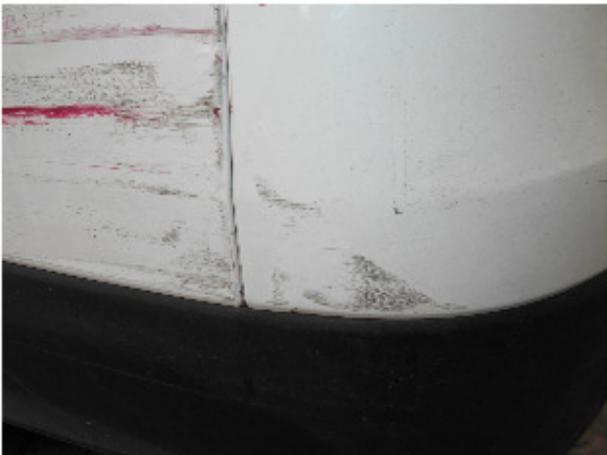
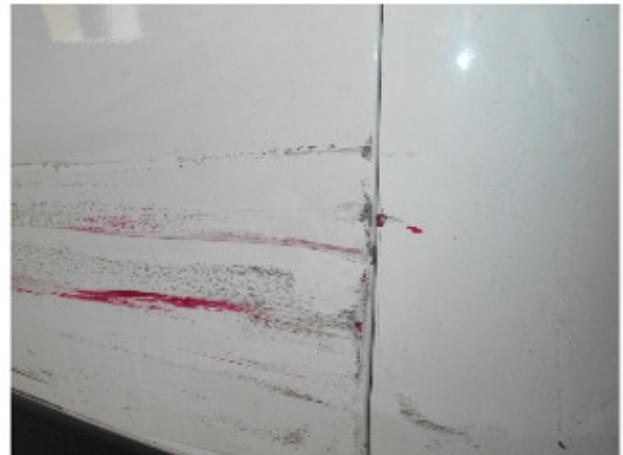
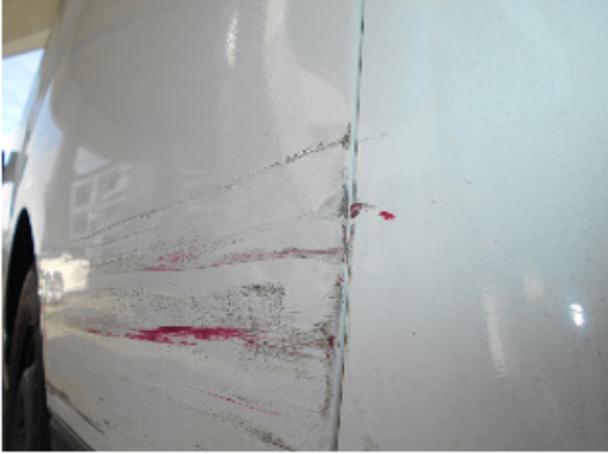
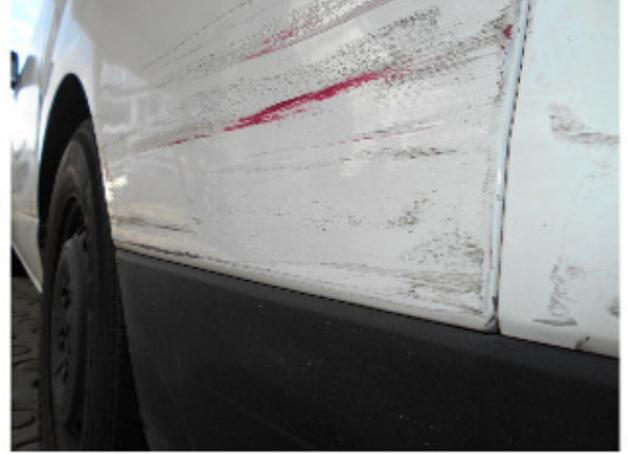
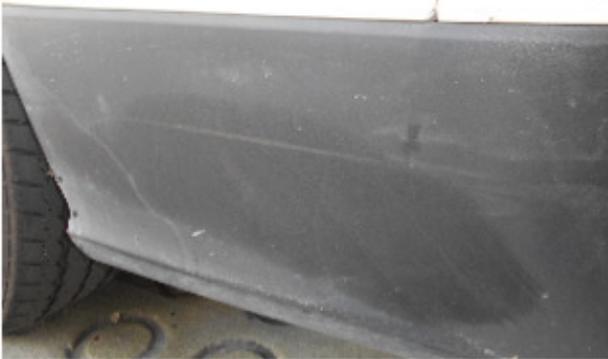
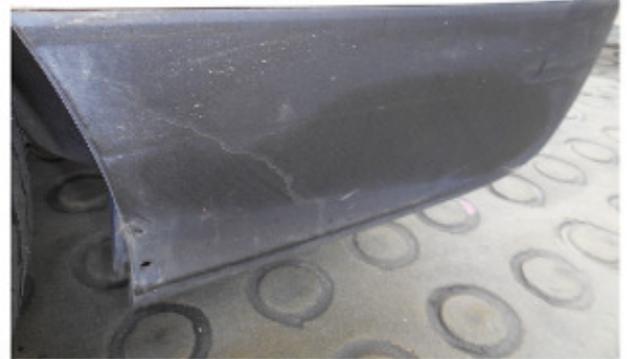
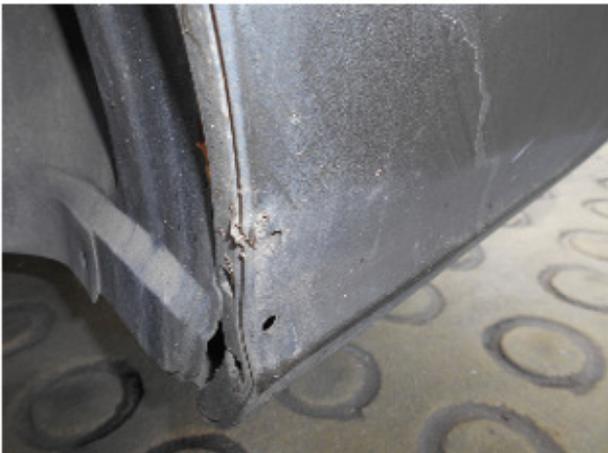
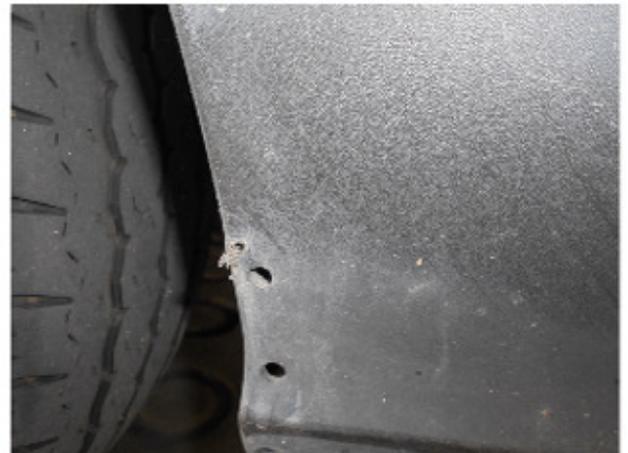
INSPECTION

THE VEHICLE SUSTAINED DAMAGES AT THE N/S REAR PORTION.  
DAMAGES SEE DETAILS.

Qty	Description of Parts	Condition	Estimate By Workshop (\$)	Our Adjusted (\$)
<b><u>REPLACEMENT OF PARTS</u></b>				
1	TAILLAMP N/S	NOT NECESSARY	696.00	-
1	TAILLAMP PANEL N/S	NOT NECESSARY	162.00	-
1	TAILLAMP LOWER GARNISH N/S	TO REPAIR SEE LABOUR	417.00	-
1	END PANEL	NOT NECESSARY	612.00	-
1	END PANEL INNER MEMBER	NOT NECESSARY	324.00	-
1	REAR FENDER PANEL N/S	TO REPAIR SEE LABOUR	875.00	-
1	REAR BUMPER	CUT	676.00	435.00
1	REAR BUMPER SPLASH GUARD N/S	NOT NECESSARY	139.00	-
4	REAR BUMPER LOWER BRACKET @\$36.00	NOT NECESSARY	144.00	-
2	REAR BUMPER SIDE RETAINER @\$189.00	NOT NECESSARY	378.00	-
	LESS 20% DISCOUNT		-884.60	-87.00
			3,538.40	348.00
<b><u>SPECIAL NETT ITEMS</u></b>				
1	REVERSE SENSOR (SN)	NOT NECESSARY	280.00	-
1	END PANEL SEALANT (SN)	NOT NECESSARY	100.00	-
1	PARKING AID HARNESS (SN)	NOT NECESSARY	350.00	-
10	REAR BUMPER CLIPS @\$5.50 (N)	NECESSARY	55.00	20.00
1	SUNDRIES (SN)	NOT NECESSARY	50.00	-

835.00	20.00
<b><u>LABOUR</u></b>				
	TO DISMANTLE/RENEW THE ACCIDENT DAMAGED PORTION.TO PANEL BEAT,RESHAPE,STRAIGHTEN, ORIENTATE AND ALIGN REPAIR/REPLACEMENT PARTS.INCLUSIVE OF THE REPAIR OF TAILLAMP LOWER GARNISH N/S AND REAR FENDER PANEL N/S.		1,000.00	300.00
	TO DISCONNECT REAR WIRE HARNESS OF ELECTRICAL COMPONENTS TO FACILITATE REPAIRS,RECONNECT AND CHECK FUNCTIONS INCLUDING TAILLAMP LIGHTINGS.		50.00	30.00
	SUPPLY SPRAY PAINT MATERIAL AND NECESSARY ITEMS TO RESPRAY END PANEL,N/S REAR FENDER PANEL AND OTHER AFFECTED AREA/PANEL.		1,000.00	250.00
