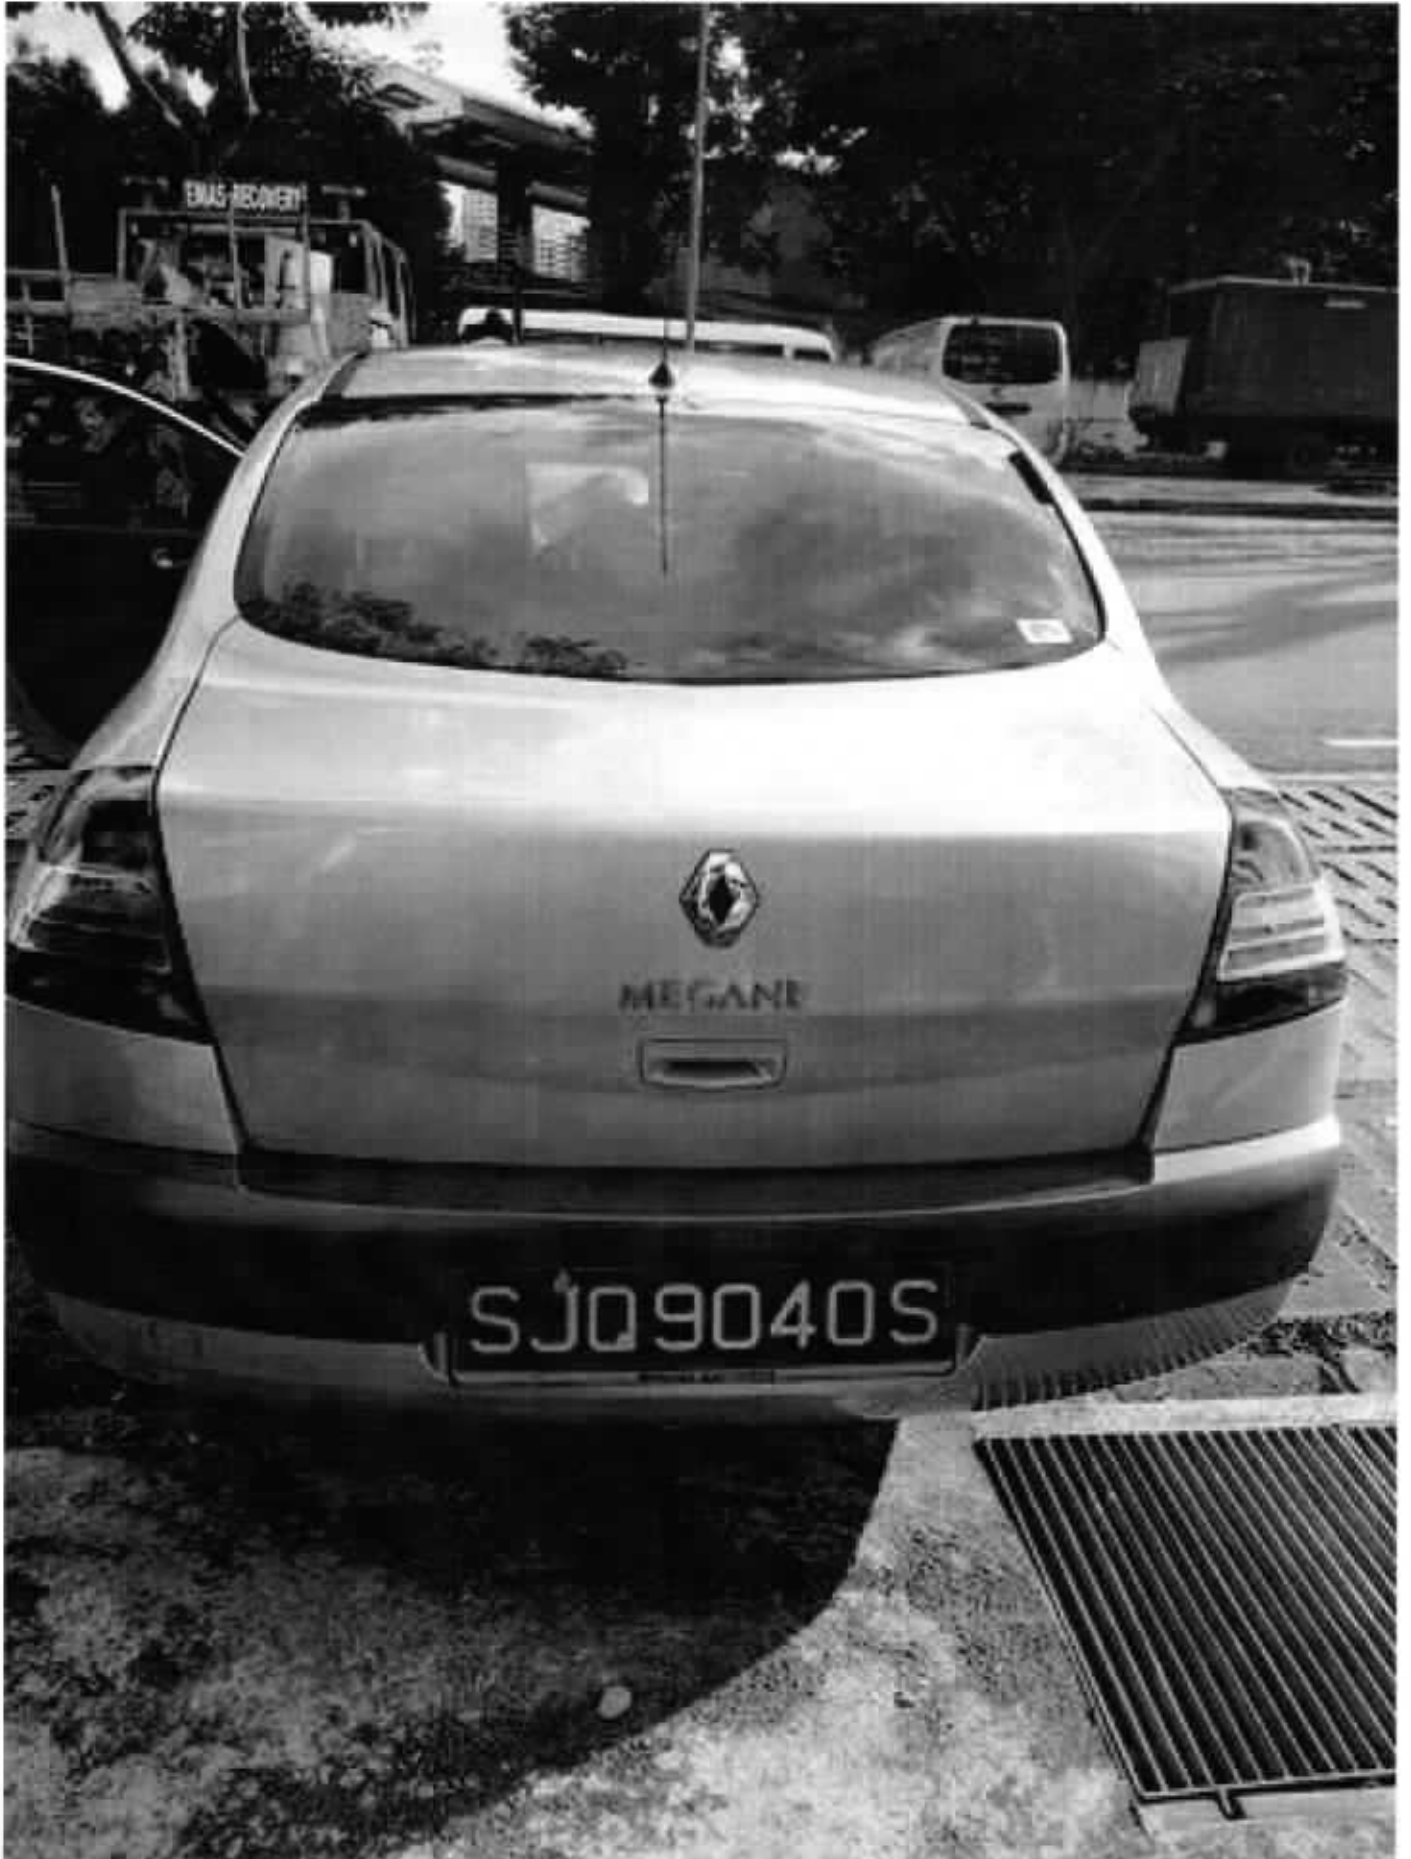
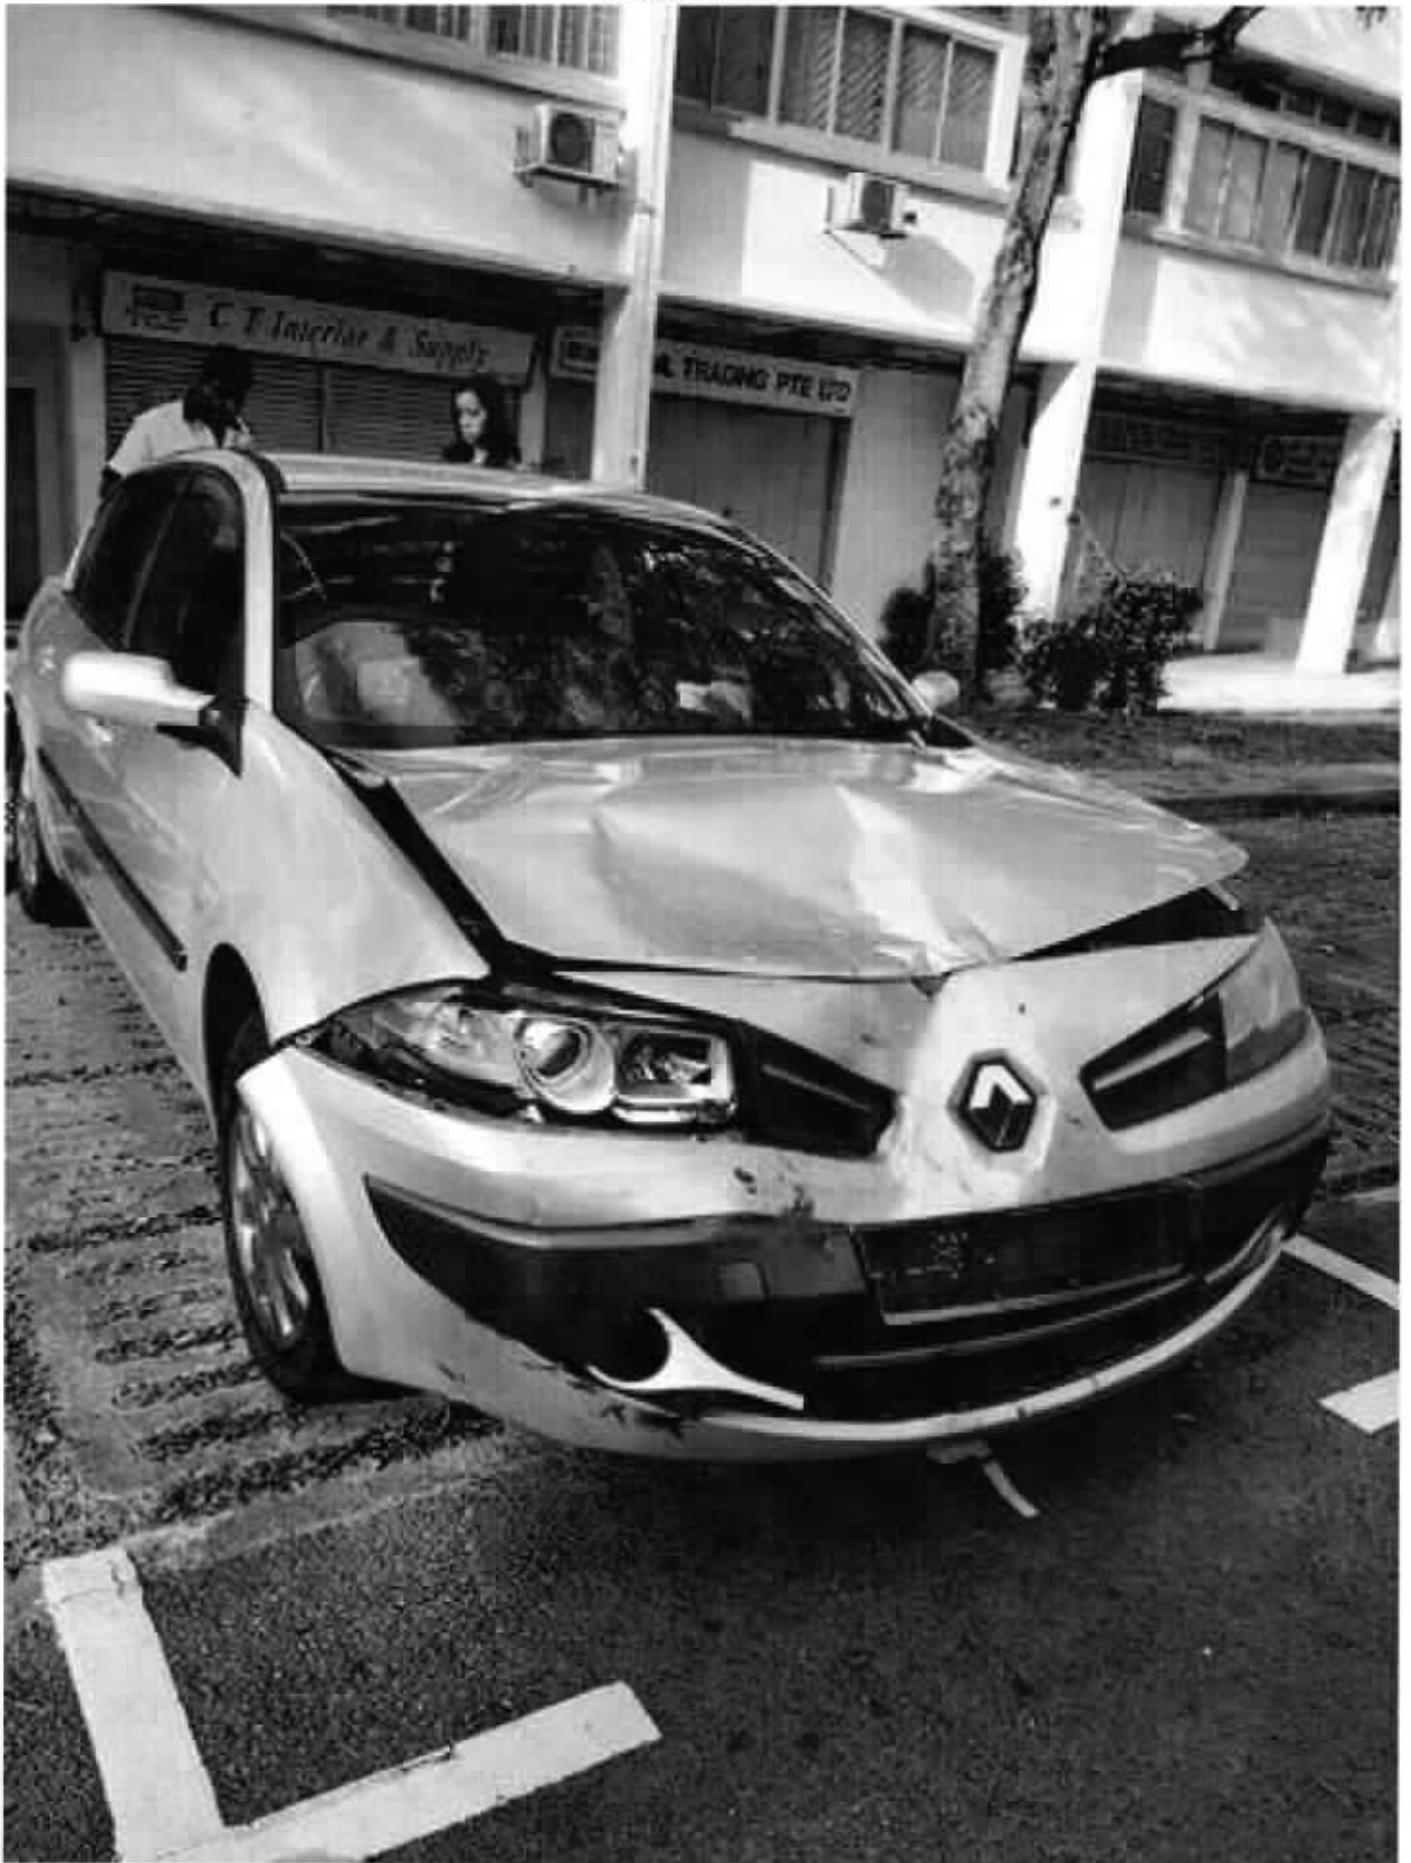
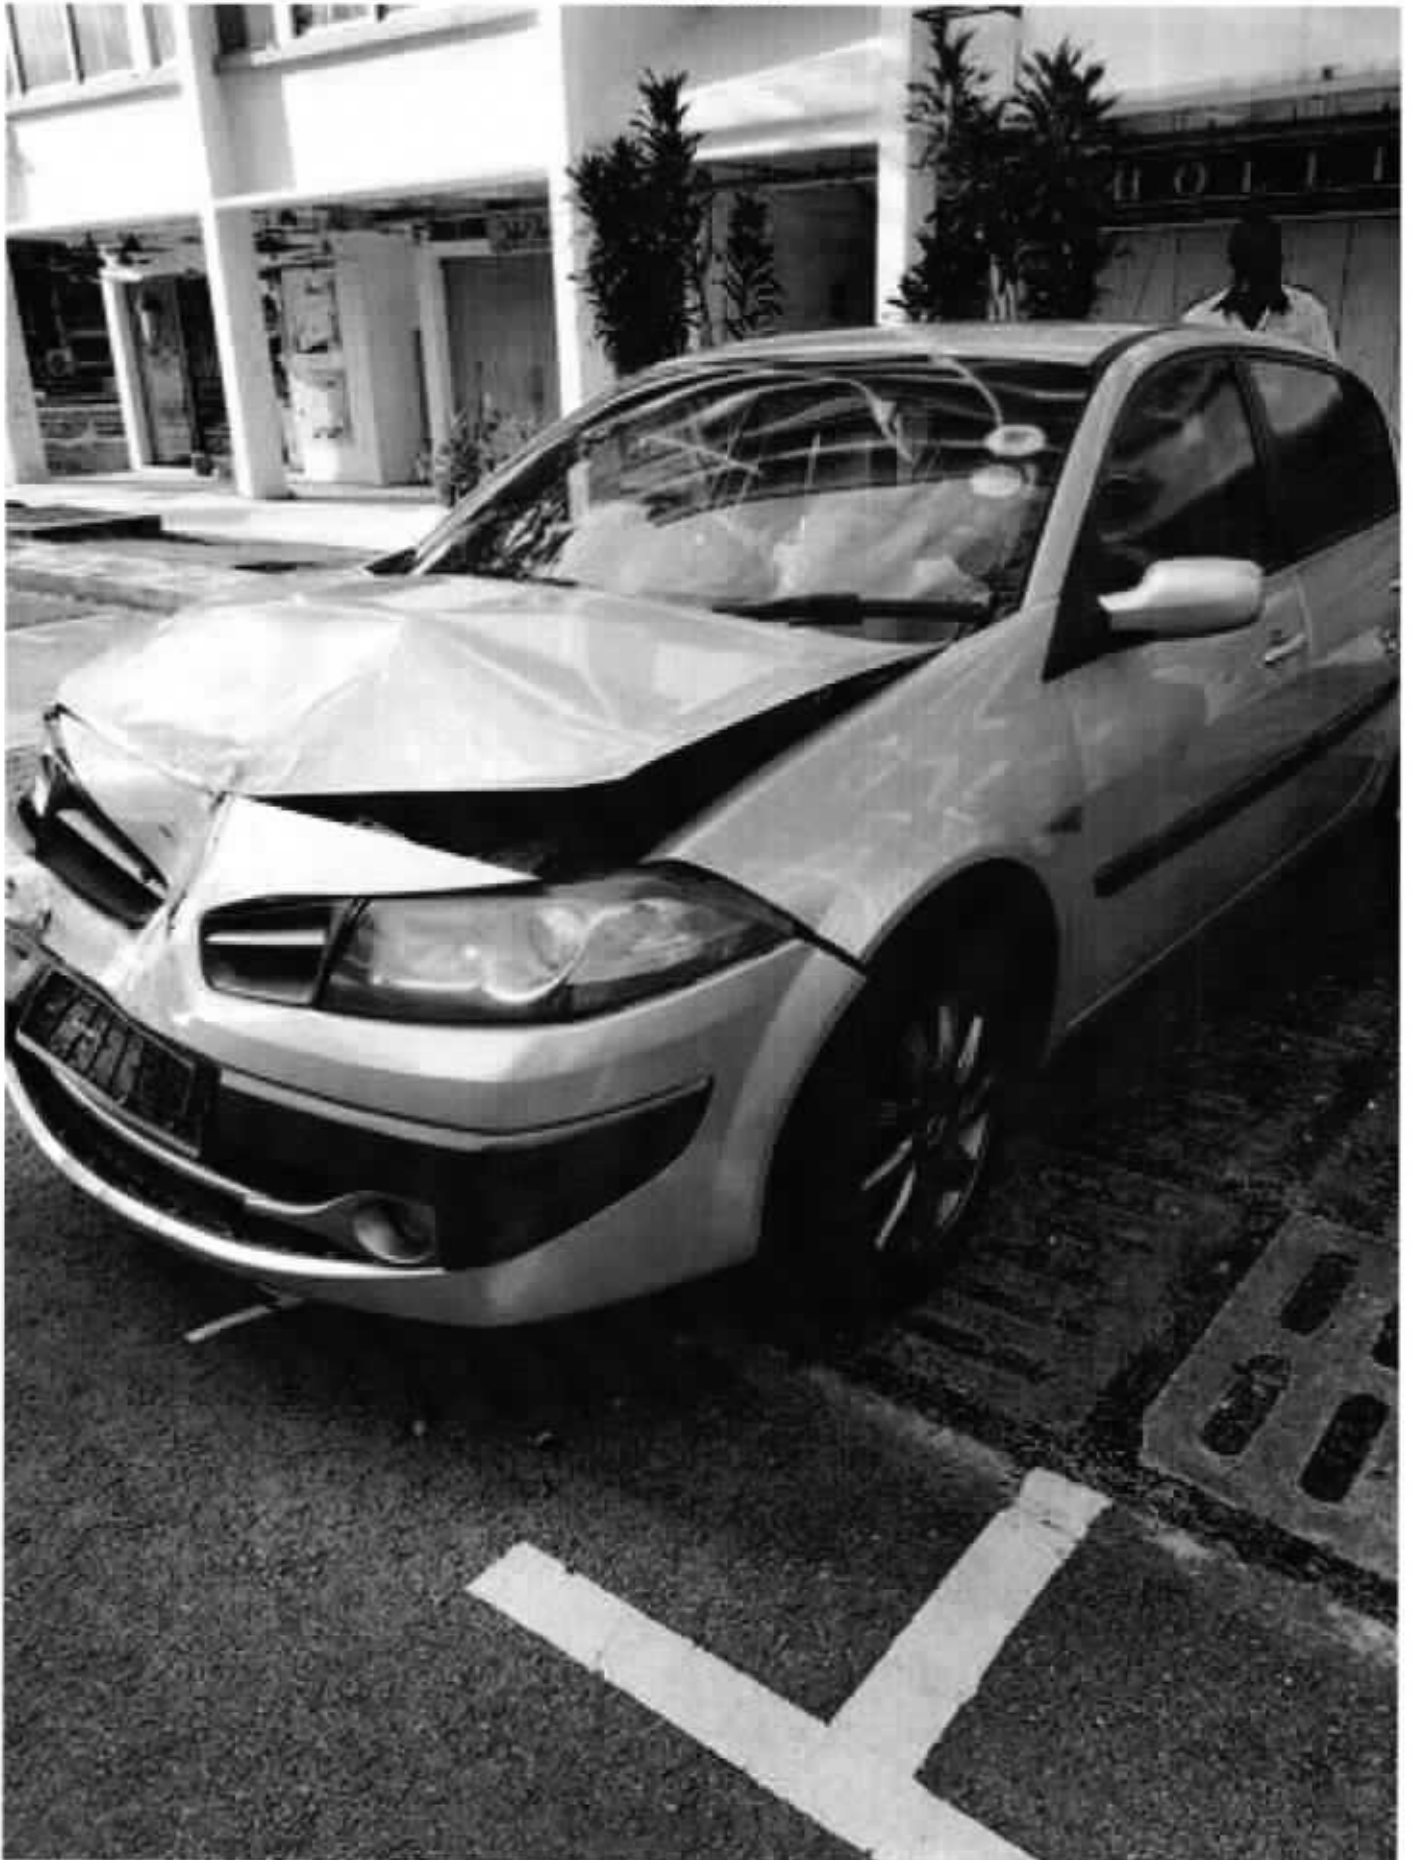
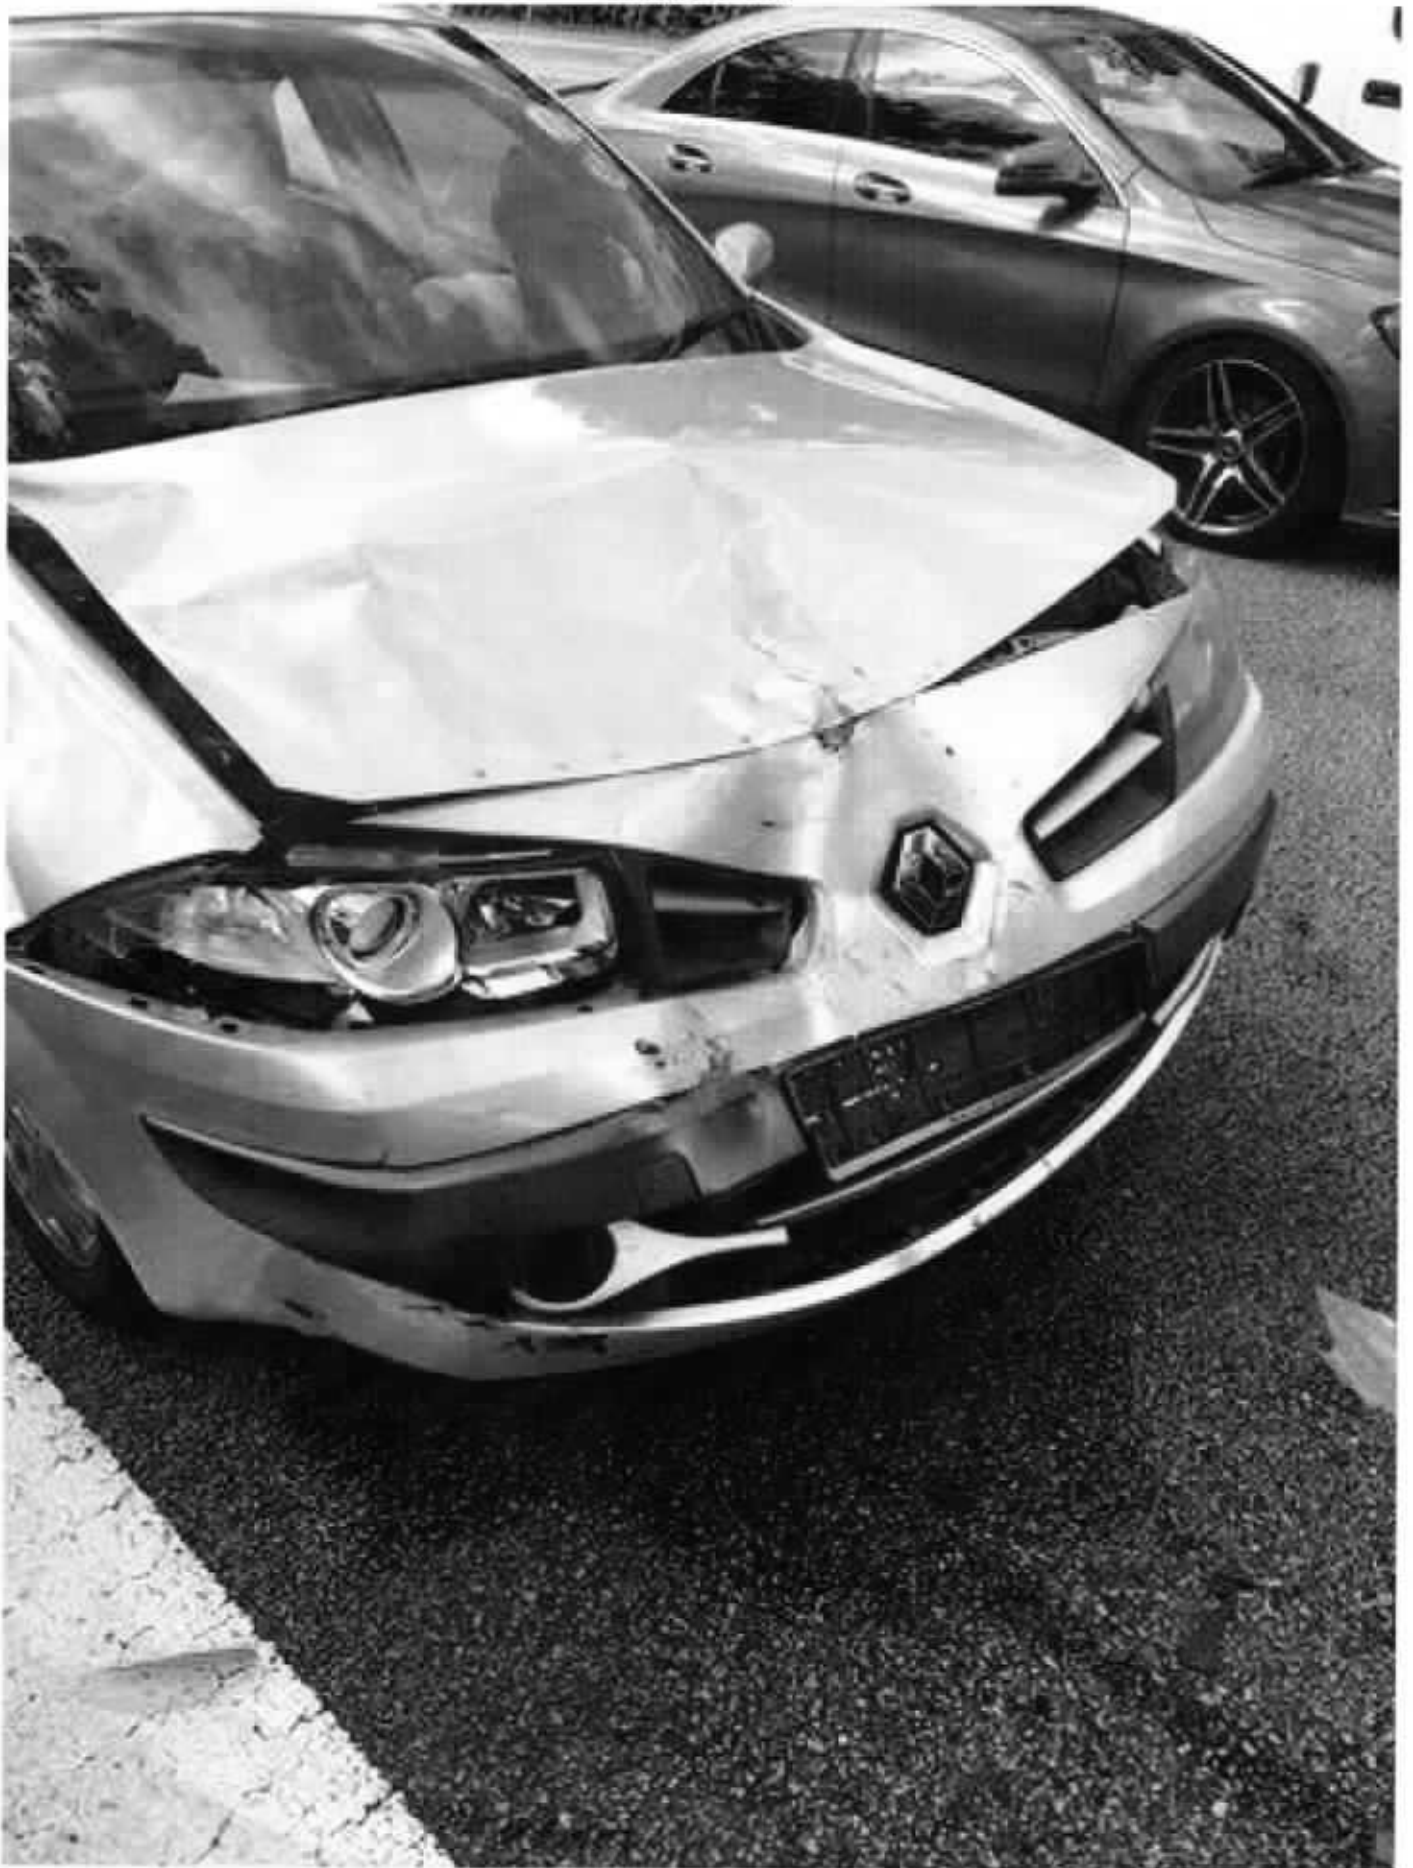
Accident Photo

4. Description of Damages				
THE VEHICLE SUSTAINED DAMAGES AT THE FRONT AND REAR PORTION. DAMAGES SEE DETAILS.				
5. General Information				
Accident Date	05/02/2019	Inspection Date	11/02/2019	
Survey held at	160 SIN MING DRIVE# 05-17			
Repairer	HIAP LEK AUTOMOBILE TRADING			
5a. Remarks				
A)THE INSPECTION WAS CONDUCTED ON A"WITHOUT PREJUDICE" BASIS. B)IN ACCORDANCE TO YOUR INSTRUCTIONS, WE HAVE NOT AUTHORISED REPAIRS.				
5b. Estimate Days of Repair				
ESTIMATED NORMAL PERIOD FOR REPAIR:		25 Working Days
