Affiliated to Federation Internationale Des Experts En Automobile			
MS F	S FIRST CAPITAL INSURANCE LTD Ref: CC4/FCl20000567/Eba3q2			
36 ROBINSON ROAD #16-01 CITY HOUSESINGAPORE 068877		Date: 24-09-2020 Code: FCI2

1.		Policy Particulars	- THIRD PARTY CLAIM	
	Insured Veh.	SHA 525C	Veh. Inspected	SJG 3131E
	Policy No.	D-19092579MFSH	Coverage (\$)	0.00
	Claim No.	D20000042MFSH	Excess (\$)	0.00
	Assign From	MERINA CHIA	Assign Date	07/01/2020

2.		Vehicle Partic	culars & Condition	
	Make & Model	PORSCHE MACAN	c.c	2997
	Engine No.	HIDDEN	Year of Reg.	2015
	Chassis No.	WP1ZZZ95ZFLB67021	Colour	BROWN
	Odometer	45676	Steering	IN ORDER
	Brakes	IN ORDER	Modification	SPORTS RIM
	General	GOOD

PHOTOGRAPHS FOR VEHICLE NO. SJG 3131E

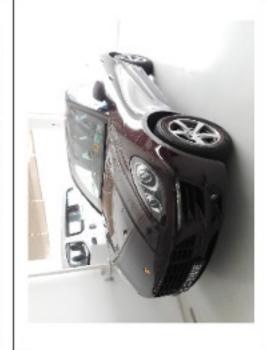
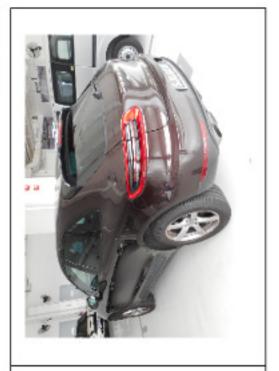
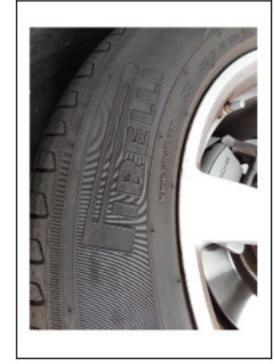
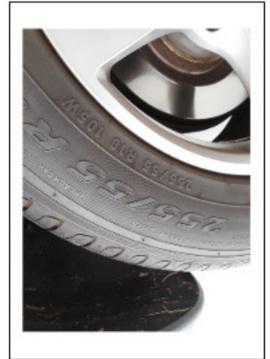
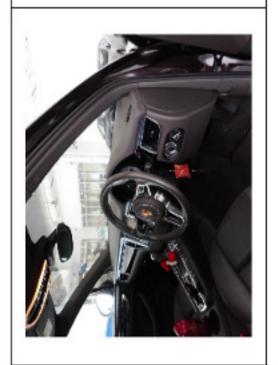
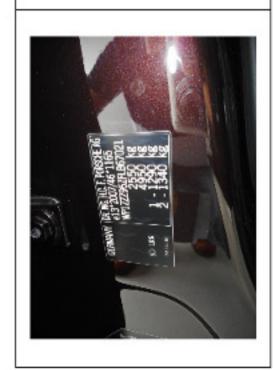
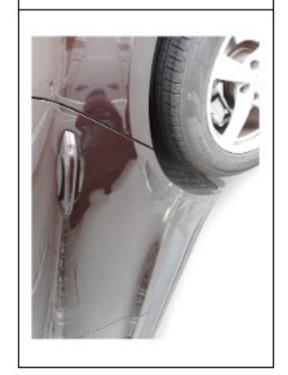
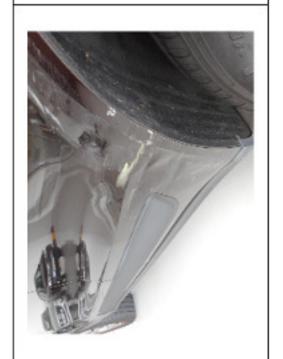
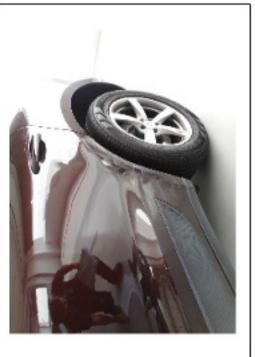
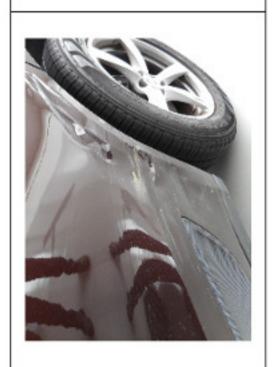
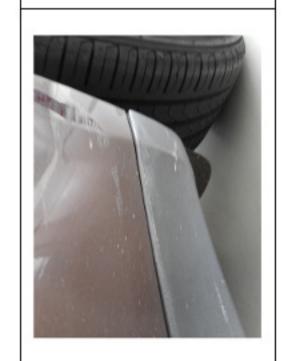
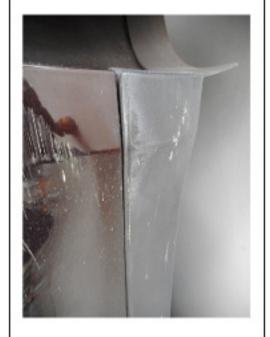
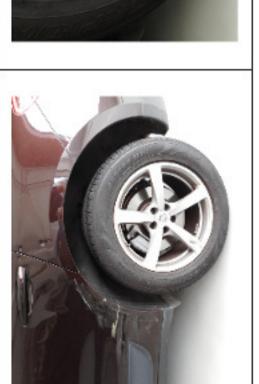
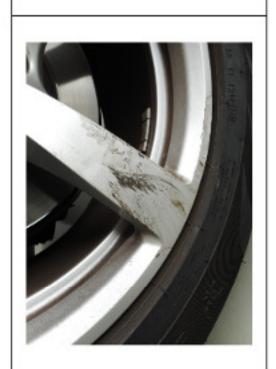
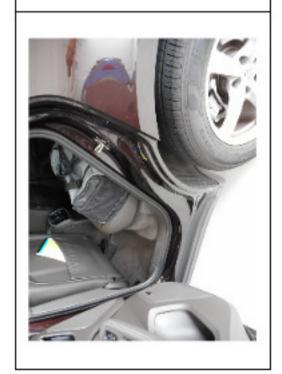
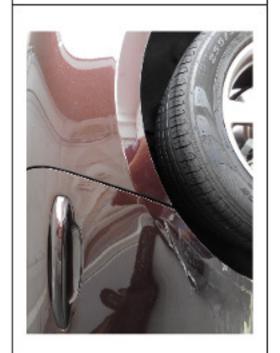
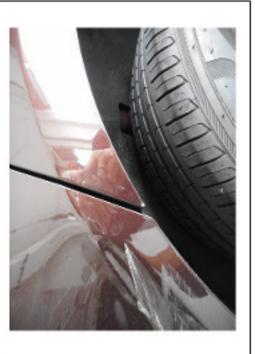
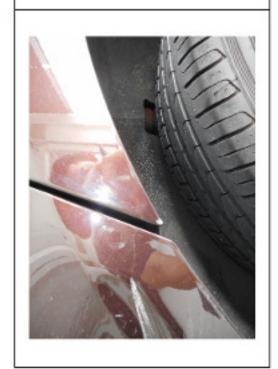
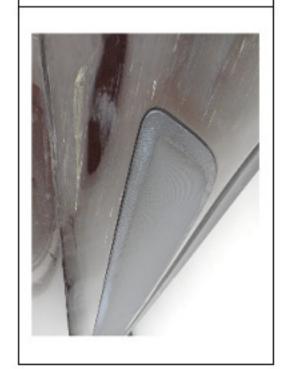
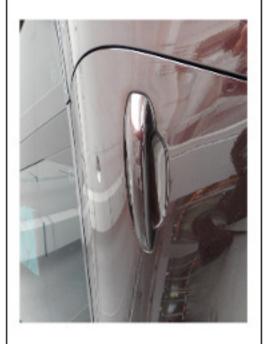
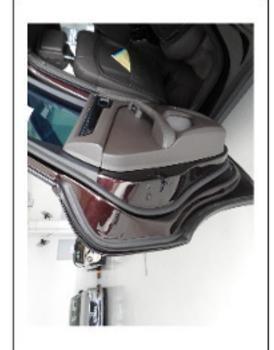
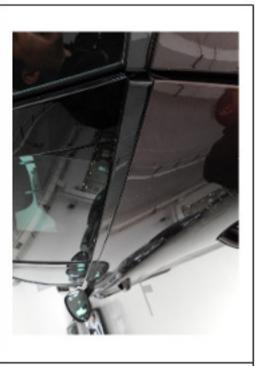
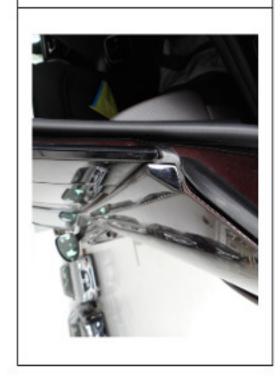
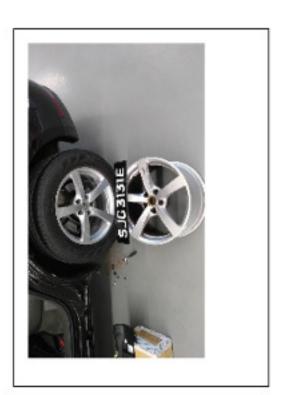
4.		·	on of Damages	
	THE VEHICLE SU	STAINED DAMAGES AT THE REA	AR N/S PORTION.	
	DAMAGES SEE D	ETAILS.		
5.		General	Information	
	Accident Date	26/12/2019	Inspection Date	10/01/2020
	Survey held at	STUTTGART AUTO PTE LTD		
		12 SUNGEI KADUT AVE . SINGAPORE 729648		
5a.		Re	emarks	
	A)THE INSPECTION WAS CONDUCTED ON A"WITHOUT PREJUDICE" BASIS. B)IN ACCORDANCE TO YOUR INSTRUCTIONS, WE HAVE NOT AUTHORISED REPAIRS.			
5b.	5b. Estimate Days of Repair			
	ESTIMATED NORMAL PERIOD FOR REPAIR: 6 Working Days

Qty	Description of Parts	Condition	Estimate By Workshop (\$))	Our Adjusted (\$)
	REPLACEMENT OF PARTS			
1	PROTECTIVE REAR FENDER	NOT NECESSARY	64.50	-
1	DOOR SHELL REAR (LH)	DENTED	1,989.40	1,989.40
1	DOOR INSULATION	NECESSARY	8.90	8.90
1	DOOR SEAL OUTER	NECESSARY	224.50	224.50
6	CLIP	NECESSARY	5.40	5.40
1	DOOR SEAL	NOT NECESSARY	172.20	-
1	DOOR SEAL	NOT NECESSARY	130.80	-
1	REPAIR KIT	NECESSARY	102.10	102.10
1	DOOR TRIM REAR BLACK LH	NECESSARY	529.70	529.70
1	MOULDING	NOT NECESSARY	210.40	-
1	SIDE SKIRT	CUT	242.30	242.30
2	SIDE SKIRT SPONGE	NECESSARY	69.40	69.40
1	ALLOY WHEEL	CUT	1,419.20	1,419.20
	LESS 10% DISCOUNT		-516.88	-459.09
			4,651.92	4,131.81
	SPECIAL NETT ITEMS			
1	SUNDRIES (SN)	NECESSARY	50.00	30.00
1	TYRE 255/55 R18 (SN)	NOT NECESSARY	980.00	-
			1,030.00	30.00
	<u>LABOUR</u>			
	TO REPLACE REAR DOOR LH ,SIDE SKIRT LH & TO REPAIR REAR FENDER LH AREAS AFFECTED BY THE ACCIDENT .		5,460.00	1,560.00

TO RESPRAY REAR DOOR LH & REAR FENDER LH.		2,400.00	2,200.00
	TO MOUNT 1 PC SPORT RIM AND CONDUCT WHEEL BALANCING.		120.00	120.00
	TO CHECK STEERING GEOMETRY & CONDUCT FULL WHEEL ALIGNMENT.		680.00	680.00
	TO TRANSFER THE DOOR MECHANISM .		780.00	780.00
	TO CHECK ELECTRICAL SYSTEM FOR PROPER FUNCTIONING.	NOT NECESSARY	250.00	-
