Vehicle No. SMG 9204D
Insured Veh. SHA 1689G
Claim No. D20000244MFSH
Policy No. D-20094922MFSH
Accident Date 06/01/2020
Inspection Date 10/01/2020

ADJUSTMENT ON REPAIR COST FOR VEHICLE NO. SMG 9204D

PHOTOGRAPHS FOR VEHICLE NO. SMG 9204D

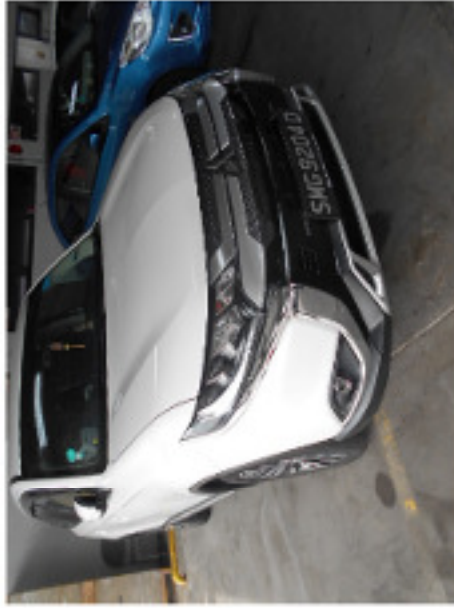
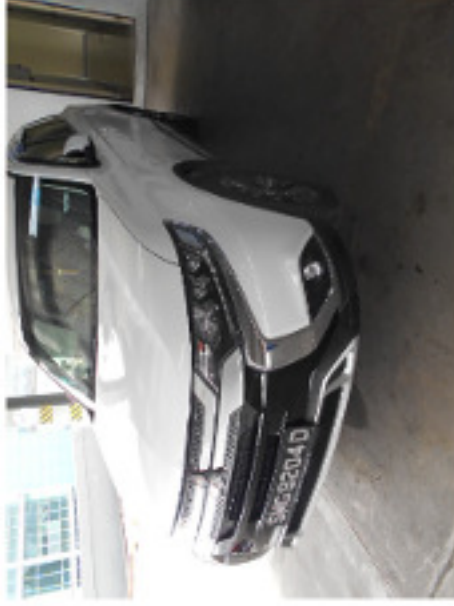
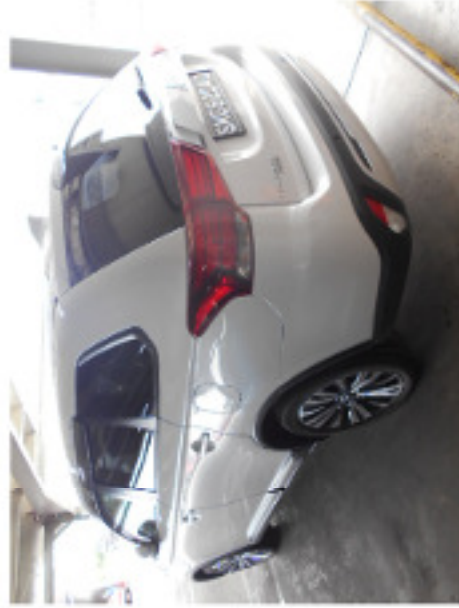
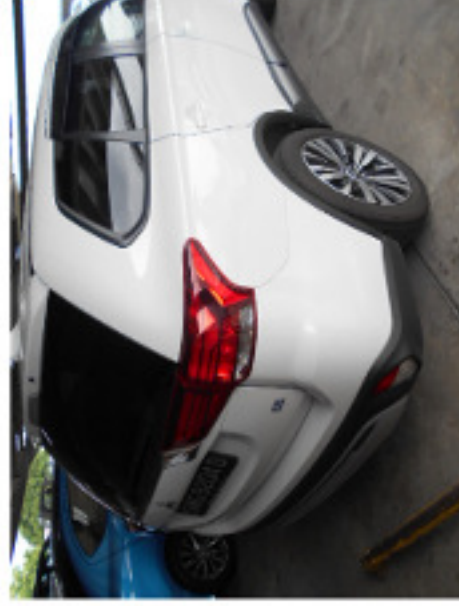
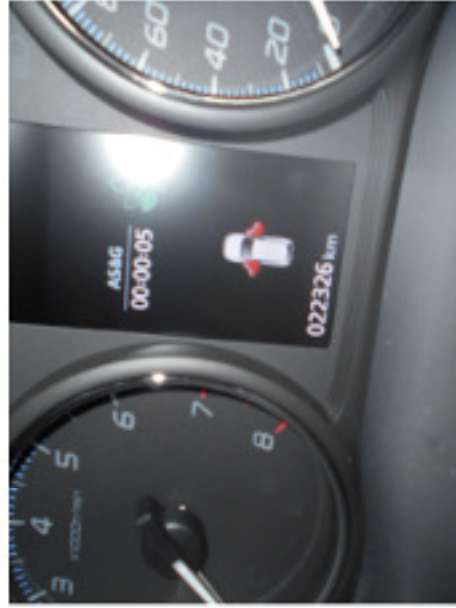
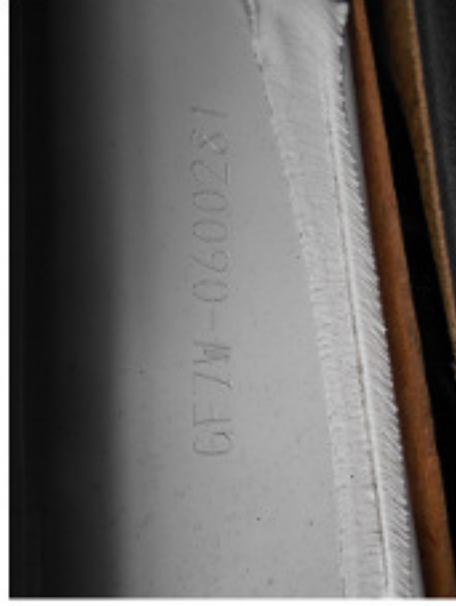
4. Description of Damages				
THE VEHICLE SUSTAINED DAMAGES AT THE FRONT PORTION. DAMAGES SEE DETAILS.				
5. General Information				
Accident Date	06/01/2020	Inspection Date	10/01/2020	
Survey held at	CYCLE & CARRIAGE.FULCO MOTOR DEALER PL NO.330 UBI ROAD 3 SINGAPORE 408650			
5a. Remarks				
A)THE INSPECTION WAS CONDUCTED ON A"WITHOUT PREJUDICE" BASIS. B)IN ACCORDANCE TO YOUR INSTRUCTIONS, WE HAVE NOT AUTHORISED REPAIRS.				
5b. Estimate Days of Repair				
ESTIMATED NORMAL PERIOD FOR REPAIR:		4 Working Days
