SINGAPORE ACCIDENT STATEMENT

ACCIDENT REPAIR ESTIMATES

VEHICLE DAMAGE INSPECTION REPORT

Date of Assignment: 10/03/2020
Date Inspected: 13/01/2020 Inspected At: Indeco Engineers Pte Ltd - Defu (HQ)
No. 39, Defu Lane 12,
Singapore 539139
Estimated Period of Repair: 2.0 days

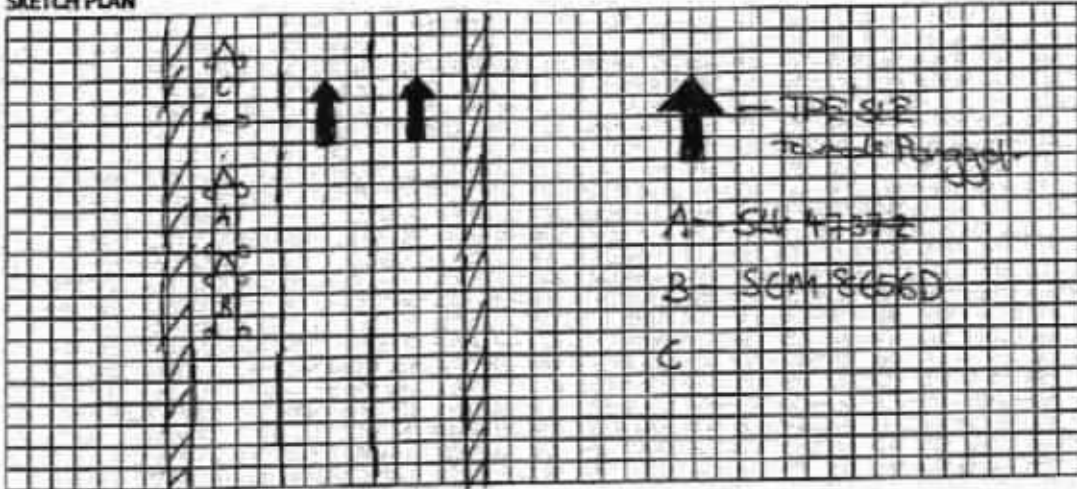
Sketch Plan #2

On 29/12/2019 at about 1605hrs, I was driving a Blazer vehicle bearing, SLV 4737Z, on the third lane along TPE/SE towards Pongol. As I was driving near to Lamp Post 615, there was one vehicle at the front driving very slowly and eventually, the vehicle halted abruptly. I was able to react on time and brake my vehicle. As soon as I came to a stop, there was an impact to the rear of my vehicle. Upon further checks, the ~~car~~ plate number of the said vehicle was SGM 8656D.

Due to the accident, the rear of my vehicle was damaged. As for the other vehicle, the front bumper & bumper was dented.
