ASSIGNMENT

Insured: SMC 6348MPolicy No. 5110402808 (13/7/2019-12/07/2020)Claims No. MT/1071073-002

Veh No: SMB 3601G Yr Regn: 01/Jul/2015

ADJUSTMENT ON REPAIR COST FOR VEHICLE NO. SMB 3601G

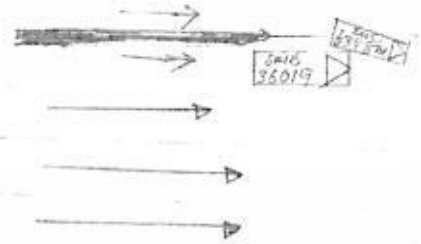
Sketch Plan Pg. 2

While my bus SMB3601G was travelling along PIE towards BKE before Adam Road Exit, the left front body of the bus was hit by the right rear body of a private car (SMC6348M) suddenly cut in front my lane. There were 70 pax onboard my bus and no injuries reported. That's all.

Adam Road Exit

PIE towards BRE
before Alam Road Exit
