Damaged Area: (Rear Left Portion Damaged)

VEHICLE DAMAGE INSPECTION REPORT

Our File No: CS/CTI20000980/UTF3N2
Date: 27/02/2020

Handling Insurer: China Taiping Insurance (Singapore) Pte. Ltd. Policy No: DMCVSN30486719022
Claimant Vehicle No: SMR951G Insured Vehicle No: GBF1433Y
Date of Loss: 04/01/2020 Nature of Claim: TP Claim No: SNM20D200081

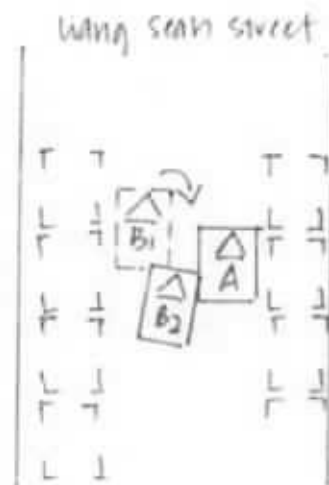
Sketch Plan #2

Vehicle A: SMR9516

Vehicle B: GBF1433Y

On the stated date & time, I, vehicle 'A', SMR9516 was travelling straight along the stated venue. Vehicle 'B', GBF1433Y, suddenly reversed and hit into my vehicle's rear left portion.
