Preliminary Advice

Vehicle No	: GBF4698E	Accident Date	: 12/01/2020
Make	: NISSAN CABSTAR	Policy No.	: DMCVSN1764991902
Assignment Date	: 22/01/2020	Excess	: S\$500.00
Date of Inspection	: 22/01/2020	Est. Duration of Repair	: 21.00
Inspection At	: S & H MOTOR PTE LTD (SIN MING) 160 SIN MING DRIVE #07-02, SIN MING AUTOCITY SINGAPORE 575722

VEHICLE DAMAGE INSPECTION REPORT

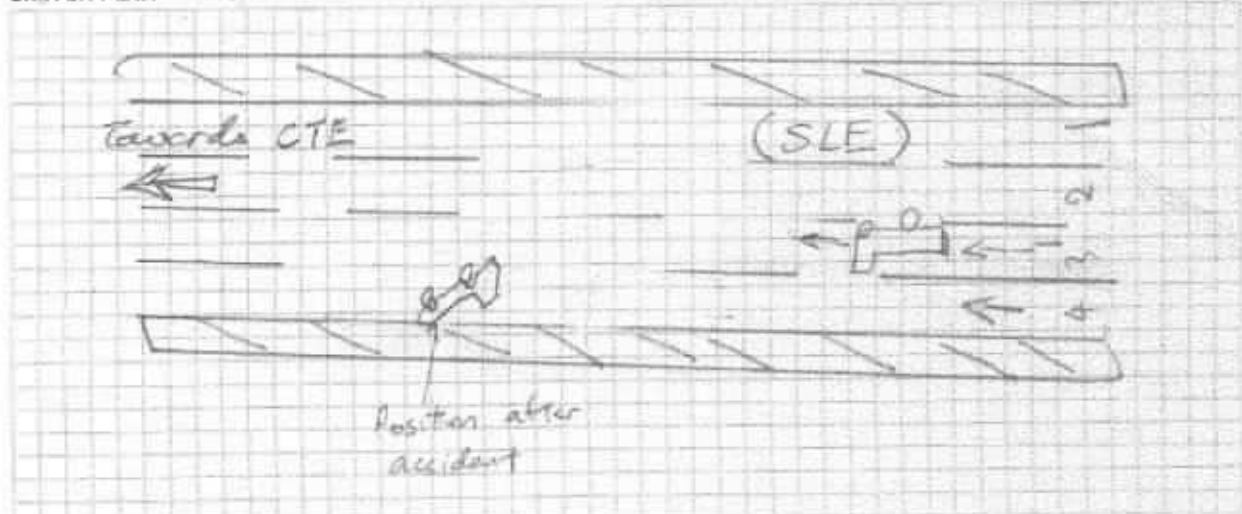
SKETCH PLAN

On the 12th JAN 2020, I was driving my lorry along SLE towards CTE at about 0550hrs. I was travelling about 60km/h in the 3rd lane when a blue car (SLW 4031 X) suddenly hit the rear left of my lorry, just before the upper thanson exst. I felt my lorry overturned and came to a stopped, on the wheels, facing the opposite direction. As a result, the four sides of the ~~vehicle~~ lorry including the top was badly damaged.

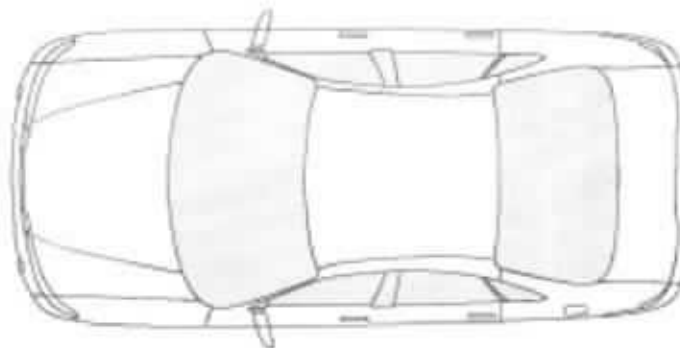
Damage Areas

All ☐
Underbody ☐
