Vehicle No. SHC 8017P  
Insured Veh. GBF 6554Z  
Claim No. SNM20D200603  
Policy No.  
Accident Date 18/01/2020  
Inspection Date 20/01/2020

## ADJUSTMENT ON REPAIR COST FOR VEHICLE NO. SHC 8017P

### PHOTOGRAPHS FOR VEHICLE NO. SHC 8017P

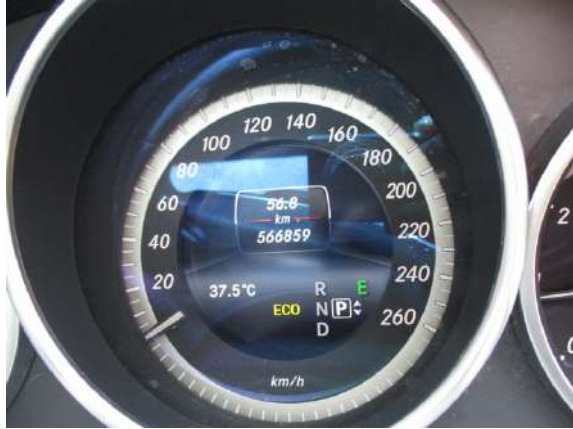
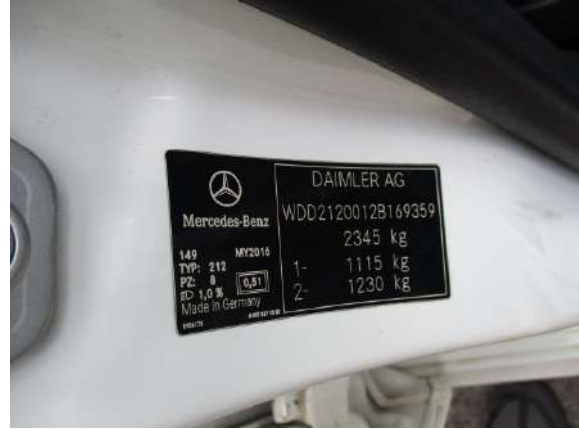
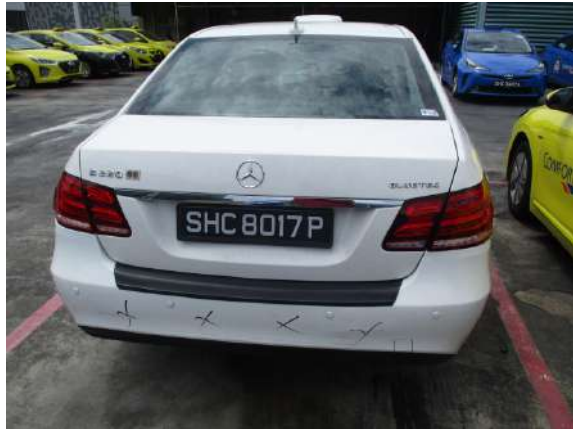
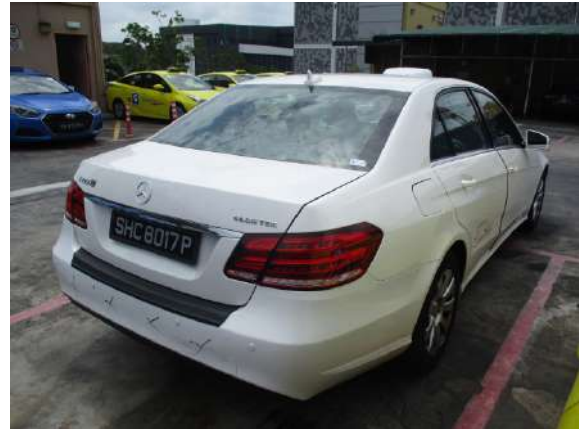
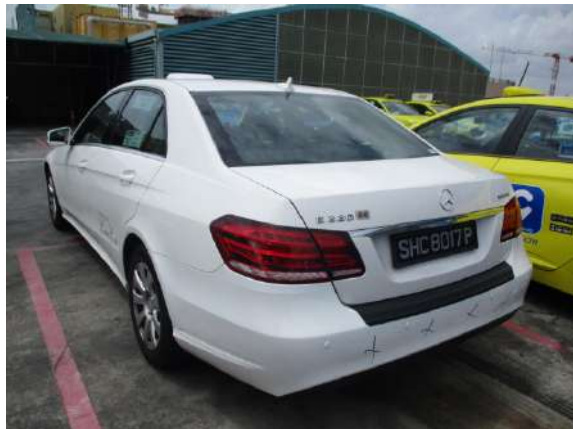
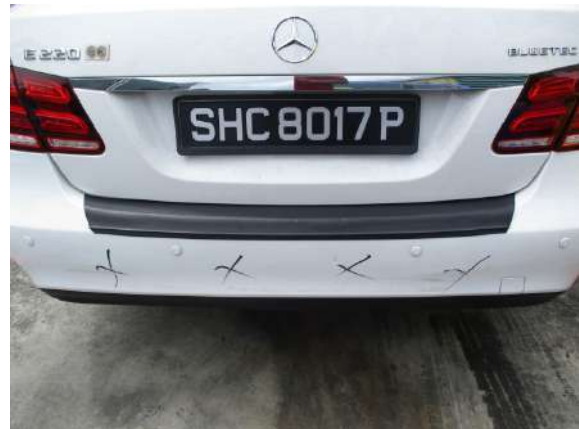
### INSPECTION

| Affiliated to Federation Internationale Des Experts En Automobile | | | | |
|---|---|---|---|---|
| THE VEHICLE SUSTAINED DAMAGES AT THE REAR PORTION.<br><br>DAMAGES SEE DETAILS. | | | | |

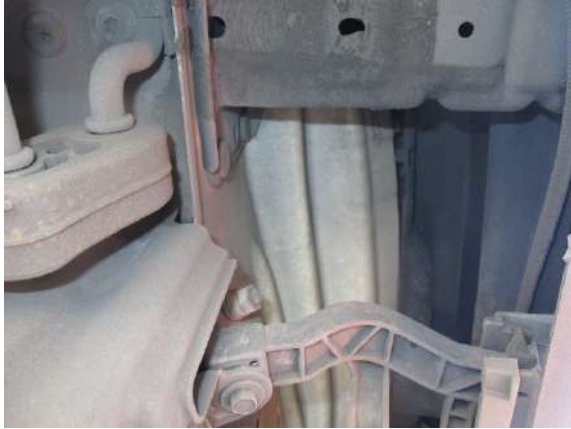
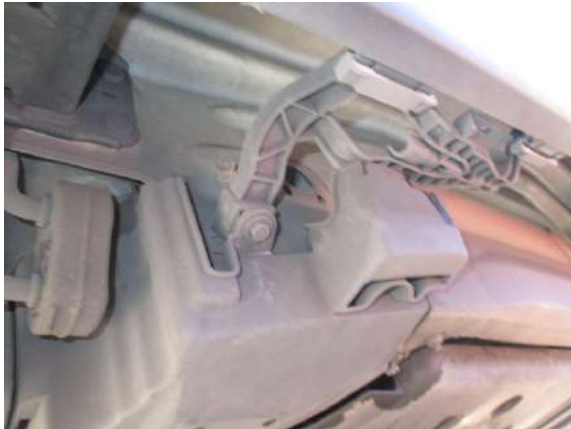
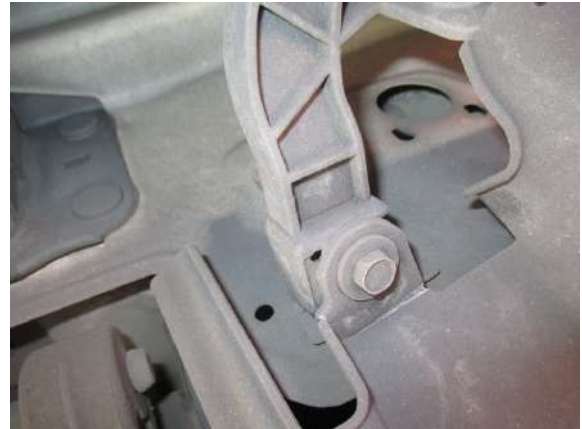
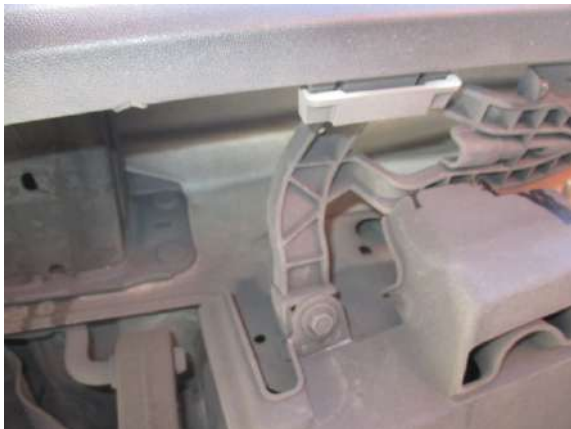
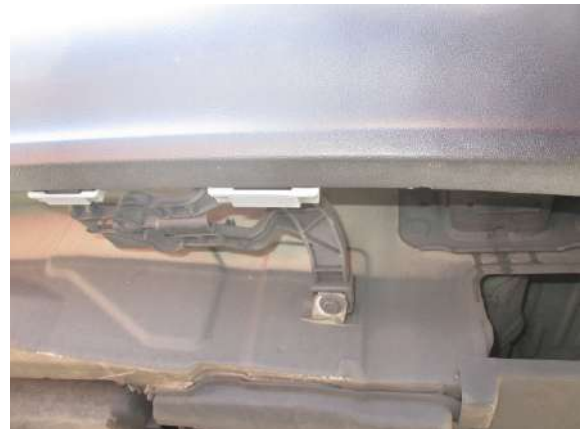
| Qty | Description of Parts | Condition | Estimate By Workshop (\$) | Our Adjusted (\$) |
|---|---|---|---|---|
| 1 | REAR BUMPER ASSY | CRACKED | 1,510.00 | 1,510.00 |
| 1 | BUMPER BRACKET RR/L | BROKEN | 135.00 | 135.00 |
| 1 | BUMPER BRACKET RR/R | BROKEN | 135.00 | 135.00 |
| | PANEL BEATING (REPAIR BOOTLID ALIGNME). | | 500.00 | 460.00 |

| Qty | Description of Parts | Condition | Estimate By Workshop (\$) | Our Adjusted (\$) |
|---|---|---|---|---|
| | <b>RECOMMENDED COST OF LUMP SUM REPAIRS<br/>(TO ITS PRE-ACCIDENT CONDITION)</b> | | | <b>1,750.00</b> |

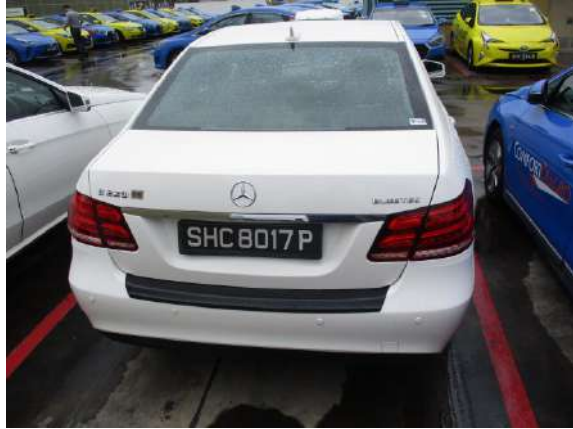
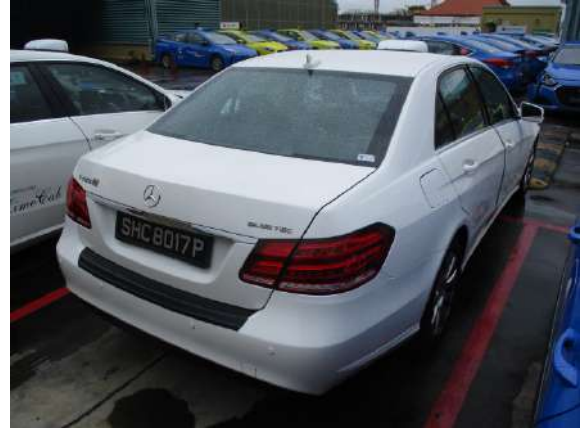
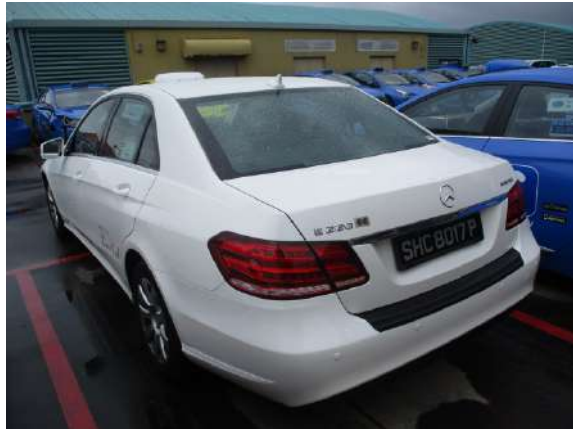
### PHOTOGRAPHS FOR VEHICLE NO. SHC 8017P

### RE-INSPECTION
