Affiliated to Federation Internationale Des Experts En Automobile							
LONI	ONPAC INSURANCE BHD Ref : CC4/LPC20001375/Ada3n2			5/Ada3n2				
	BEACH ROAD 04/07 THE CONC	OURSESINGAPORE 199555	Date: 07-07-2020 Code: LPC2

ADJUSTMENT ON REPAIR COST FOR VEHICLE NO. SMN 3198R

PHOTOGRAPHS FOR VEHICLE NO. SMN 3198R

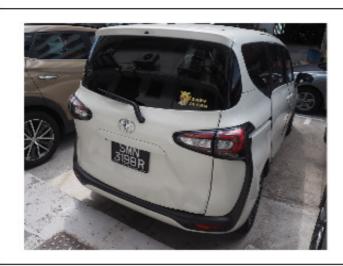
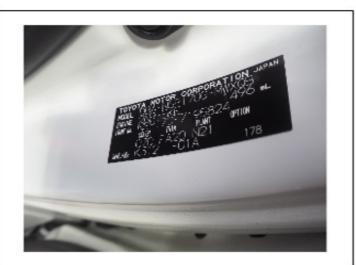
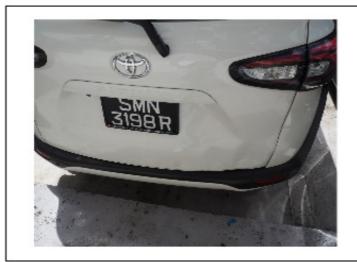
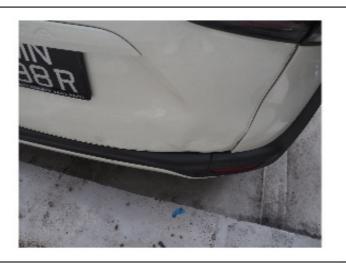
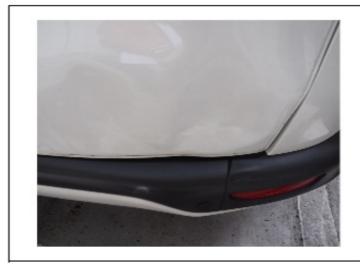
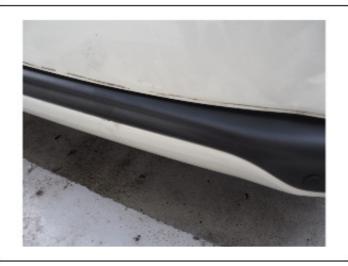
4.		Description	on of Damages					
	THE VEHICLE SU	STAINED DAMAGES AT THE RE	AR PORTION.					
	DAMAGES SEE D	ETAILS.						
5.		Genera	I Information					
	Accident Date	19/01/2020	Inspection Date	06/02/2020				
	Survey held at	JACK CARS ENTERPRISE PTE	LTD					
	BLK 3007 UBI ROAD 1 #01-450 SINGPORE 408700							
5a.		Re	emarks					
	A)THE INSPECTION WAS CONDUCTED ON A"WITHOUT PREJUDICE" BASIS. B)IN ACCORDANCE TO YOUR INSTRUCTIONS, WE HAVE NOT AUTHORISED REPAIRS.							
5b.	5b. Estimate Days of Repair							
	ESTIMATED NORI	MAL PERIOD FOR REPAIR:	4 Working Days

Qty	Description of Parts	Condition	Estimate By Workshop (\$))	Our Adjusted (\$)
	REPLACEMENT OF PARTS			
1	REAR BOOT	DENTED	1,100.00	1,100.00
1	SIDE PAD -RIGHT	DEFORMED	550.00	124.00
1	REAR BUMPER (CENTE PAD)	DEFORMED	410.00	288.00
	LESS 25% DISCOUNT		-515.00	-378.00
			1,545.00	1,134.00
	SPECIAL NETT ITEMS			
1	'TOYOTA' EMBLEM (SN)	NECESSARY	75.00	75.00
			75.00	75.00
	<u>LABOUR</u>			
	TO PUTTY & SPRAY PAINT OF AFFECTED AREA.		700.00	400.00
	TO PANEL BEAT & RENEWAL OF ALL NECESSARY DAMAGED BODY PARTS.		500.00	300.00
	TO CHECK LIGHTING SYSTEM ,WIRING & REWIRE.		250.00	30.00
	TO REMOVE AND REINSTALL TAILGATE COMPONENTS.		120.00	80.00
	TO REMOVE AND REINSTALL REAR BOOT UPHOLSTERY.		180.00	80.00
	TO REMOVE AND REINSTALL REAR WINDSCREEN.		200.00	120.00
			1,950.00	1,010.00
	GRAND TOTAL		3,570.00	2,219.00
