VEHICLE APPRAISAL REPORT

Name of Workshop : Leng Wang Motor
Place of Inspection : Blk 3007 Ubi Road 1, #01-414 Singapore 408701
Date of Assignment : 18 December 2019
Date of Accident : 03 December 2019
Date of Inspection : 18 December 2019

Registration No.	: SJV 5151E	Chassis Frame No.	: MR053REH104551807
Make / Model	: Toyota Corolla Altis 1.6 CVT	Engine No. (Logcard)	: 1ZR576103
Year of Manufacture/Reg	: 2016	Odometer Reading	: 40,266 KM
Colour	: White		
Class / Type	: Saloon

ADJUSTMENT ON REPAIR COST FOR VEHICLE NO. SJV 5151E

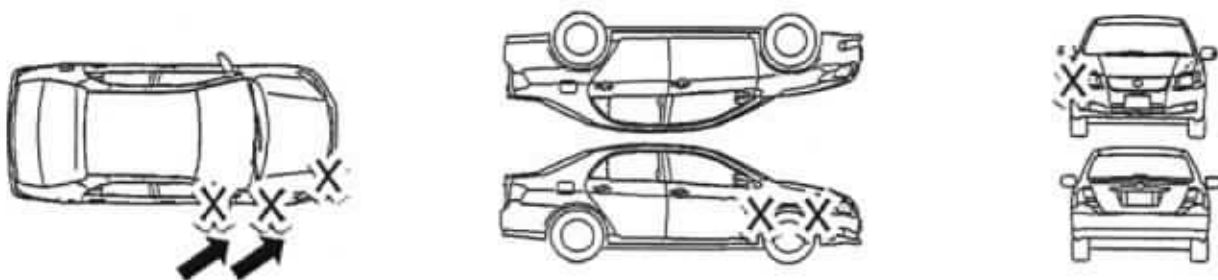
Damages sustained were consistent with the subject vehicle being involved in a collision with another vehicle and the impact was delivered Diagonally to the RH Side from rear to front; right to left; portion of the vehicle.

The general area of damages is at the RH Side portion
(Please refer to the parts list and photographs as attached for more information)

The estimated repair costs submitted by Messrs Leng Wang Motor is \$ 7,895.00 .
We have adjusted the cost to \$ 5,770.18 and the repairer has agreed to undertake the repairs at a Contract Lump Sum of \$ 4,600.00 to a acceptable quality and standards.
However, we have not given authorization and instruction to the repairer to proceed with the repairs.

The repairs should be completed within a reasonable period of ³/₅ working days.

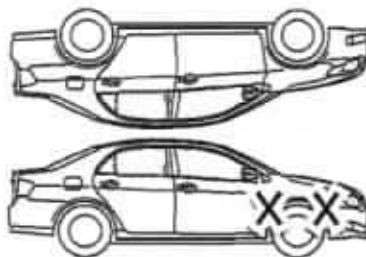
Damages sustained were consistent with the subject vehicle being involved in a collision with another vehicle and the impact was delivered Diagonally to the RH Side from rear to front; right to left; portion of the vehicle.

The general area of damages is at the RH Side portion
(Please refer to the parts list and photographs as attached for more information)

The estimated repair costs submitted by Messrs Leng Wang Motor is \$ 7,895.00 .
We have adjusted the cost to \$ 5,770.18 and the repairer has agreed to undertake the repairs at a
Contract Lump Sum of \$ 4,600.00 to a acceptable quality and standards.
However, we have not given authorization and instruction to the repairer to proceed with the repairs.

The repairs should be completed within a reasonable period of 5 working days.
