INITIAL INSPECTION REPORT OF VEHICLE NO. SLN3274R.

1. Policy Particulars :- THIRD PARTY CLAIM

ADJUSTMENT ON REPAIR COST FOR VEHICLE NO. SLN 3274R

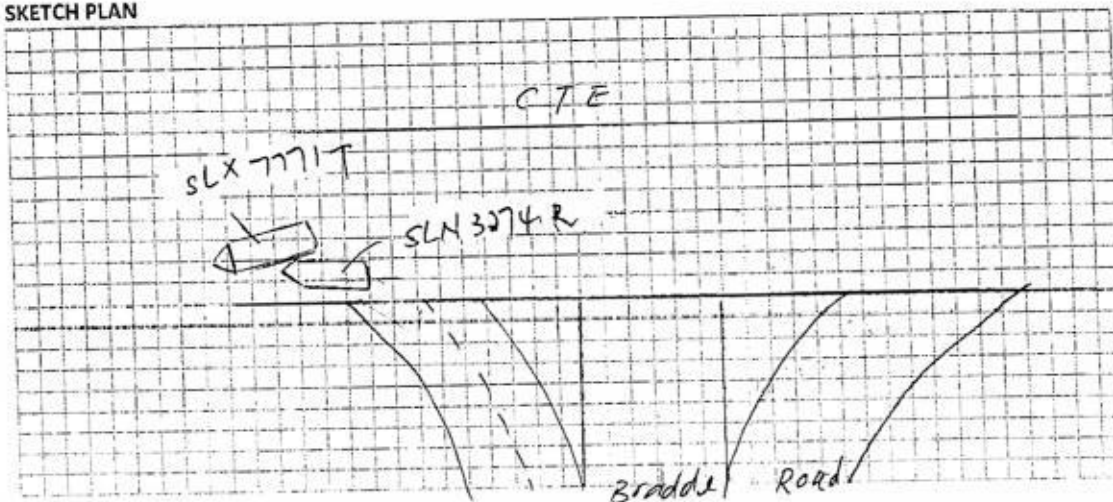
SKETCH PLAN

I was driving on the Braddel Road and going towards CTE, at the junction of the joining road out to CTE, I was on the left lane and turning out, at the same time there was a vehicle (SLX 7771T) on the right lane also turning out at the same time, After turning out I keep on my lane, and he suddenly cut in to my lane and burst/hit my car on the right corner side and also the right light.
