Preliminary Advice

Insured Vehicle No	: SMN5252D	Accident Date	: 29/01/2020
TP Vehicle No	: SMG2736G	Assignment Date	: 03/02/2020
Make	: HONDA VEZEL	Est. Duration of Repair	: 9.00
Date of Inspection	: 31/01/2020		
Inspection At	: CHENG HOE MOTOR PTE LTD (YISHUN) BLK 1019 #01-374/382, YISHUN INDUSTRIAL PARK A SINGAPORE 768761

VEHICLE DAMAGE INSPECTION REPORT

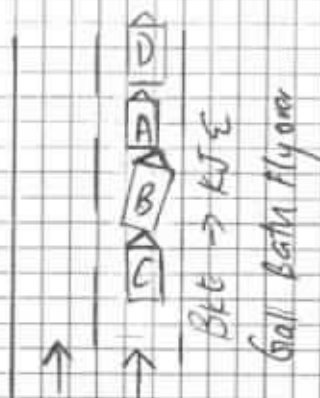
SKETCH PLAN

A = SMG 27366
 B = SMN 5252D
 Loong Chen Yit
 S 7879332E
 hp: 9698 5696
 C = GBE 6851X
 Fang Bin
 S 7167278F
 hp: —
