ASSIGNMENT

Preliminary Advice

Vehicle No	: SJF115C	Accident Date	: 07/01/2020
Make	: AUDI Q3	Policy No.	: 2100458732
Assignment Date	: 31/01/2020	Excess	: S\$0.00
Date of Inspection	: 30/01/2020	Est. Duration of Repair	: -
Inspection At	: Premium Automobiles Pte Ltd (UBI) 55 Ubi Road 1 Singapore 408699

VEHICLE DAMAGE INSPECTION REPORT

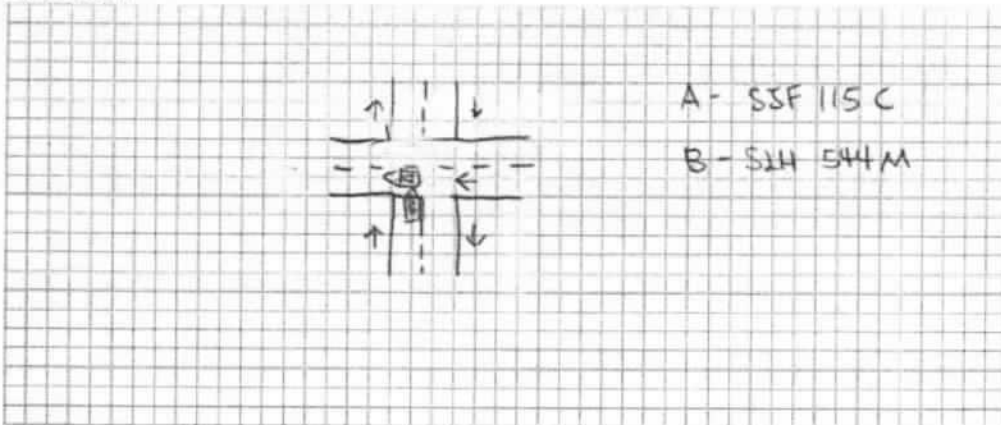
Sketch Plan #2

I was driving along Portdown Road when a car suddenly emerged from central exchange green. The car decided not to stop at the stop sign and drove ahead. I did not see the car until it approached very near and hit my car. As the result, the car hit the left side of the car. My car flipped and landed in upright position. Airbag was deployed. All side of the car was dented. The roof was torn open. I alighted and took my son out from the child seat. The passerby contacted the police & ambulance.
