VEHICLE DAMAGE INSPECTION REPORT

Our File No: CS/CTI20001931/KTD3E2

Claimant Vehicle
No : SKR6331E

Date of Loss: 24/01/2020

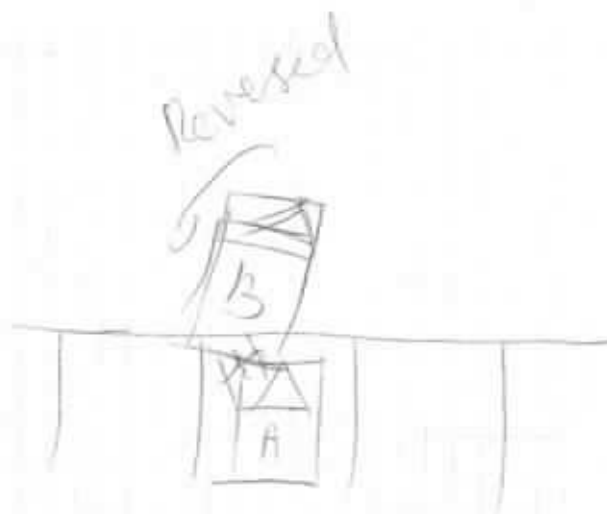
SKETCH PLAN

A - SKP6331E
B - SMP 320M

My vehicle was parked stationary in the parking lot when vehicle B reversed and hit the front left portion of my vehicle.
