Affiliated to Federation Internationale Des Experts En Automobile					
SOM	SOMPO INSURANCE SINGAPORE PL		Ref : CS/SMO20002351/Avd3n2		
50 RAFFLES PLACE #05-01/06 SINGAPORE LAND TOWERSINGAPORE 048623		Date: 11-05-2020 Code: SMO

ADJUSTMENT ON REPAIR COST FOR VEHICLE NO. SLZ 618P

PHOTOGRAPHS FOR VEHICLE NO. SLZ 618P

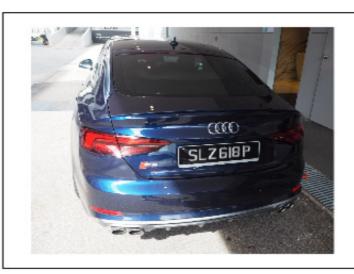
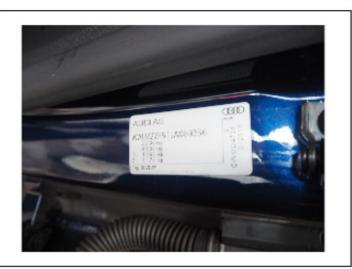
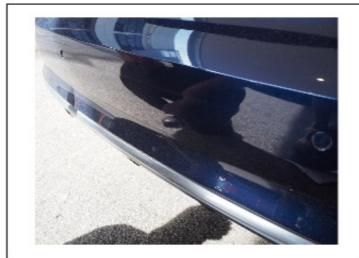
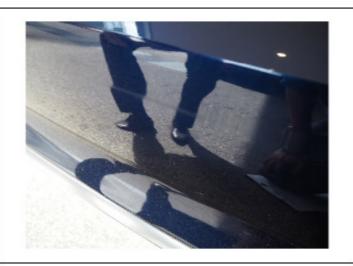
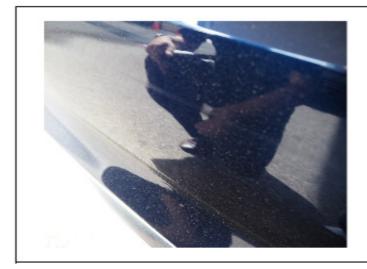
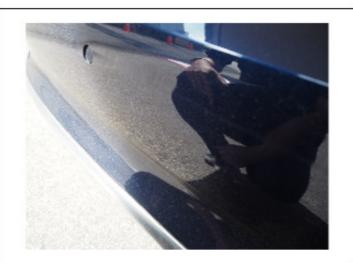
4.		•	on of Damages		
	THE VEHICLE SU	STAINED DAMAGES AT THE REA	AR PORTION.		
	DAMAGES SEE D				
5.	1		I Information		
	Accident Date	09/02/2020	Inspection Date	13/02/2020	
	Survey held at	•			
		55 UBI ROAD 1 . SINGAPORE 408699			
5a.			emarks		
	A)THE INSPECTION WAS CONDUCTED ON A"WITHOUT PREJUDICE" BASIS. B)IN ACCORDANCE TO YOUR INSTRUCTIONS, WE HAVE NOT AUTHORISED REPAIRS.				
5b.	5b. Estimate Days of Repair				
	ESTIMATED NORMAL PERIOD FOR REPAIR: 3 Working Days

Qty	Description of Parts	Condition	Estimate By Workshop (\$))	Our Adjusted (\$)
	REPLACEMENT OF PARTS			
1	REAR BUMPER (SN)	DEFORMED	2,570.00	2,570.00
1	REAR BUMPER FIXING SET (SN)	NOT NECESSARY	156.00	-
1	REAR BUMPER SECURING STRIP (SN)	NOT NECESSARY	210.00	-
1	REAR BUMPER SPOILER (SN)	CUT	773.00	772.50
1	REAR BUMPER TRIM (SN)	NOT NECESSARY	316.00	-
1	REAR BUMPER TRIM-CENTRE (SN)	NOT NECESSARY	545.00	-
2	REAR BUMNPER SIDE MOULDING-LH/RH (SN)	NOT NECESSARY	544.00	-
2	REAR BUMNPER LOWER TRIM-LH/RH (SN)	NOT NECESSARY	76.00	-
2	REAR LIGHT REFLECTOR-LH/RH (SN)	NOT NECESSARY	78.00	-
1	REAR BUMPER CARRIER (SN)	NOT NECESSARY	845.00	-
2	REAR BUMPER SEAL (SN)	NOT NECESSARY	26.00	-
2	REAR BUMPER GUIDE SECTION-LH/RH (SN)	NOT NECESSARY	42.00	-
2	REAR PARKING AID SENSOR-INNER/OUTER (NPA)(SN)	NOT NECESSARY	-	-
4	REAR PARKING AID SEAL RING (SN)	NOT NECESSARY	14.00	-
1	SUNDRIES (SN)	NOT NECESSARY	200.00	-
			6,395.00	3,342.50

<u>LABOUR</u>			
	TO REMOVE AND TRANSFER REAR PARKING AID AND REAR LID KICK SENSOR.CHECK FUNCTION AND RENEW ACCORDING TO DAMAGE.		360.00	360.00
	TO DISMANTLE AND RENEW REAR BUMPER.RE- ORGANISE CRASH MANAGEMENT COMPONENTS.REINSTALL ALL PARTS REMOVED.		1,200.00	800.00
	TO RESPRAY REAR BUMPER.		1,000.00	800.00
	TO CARRY OUT DIAGNOSTIC CHECKS.		192.00	192.00
