Accident involving vehicle no: SLZ2506R/SJX5365U

Estimate cost of repair to SLZ2506R

Affiliated to Federation Internationale Des Experts En Automobile				
WEI LEE MOTOR WORKS		Ref : CS/TP20002408/Kqf3e2		
BLOCK 9 SIN MING INDUSTRIAL ESTATE #01-32 SINGAPORE 575644		Date : 26-03-2020		 
ON BEHALF OF KH LEASING PTE. LTD.		Code : TP389

ADJUSTMENT ON REPAIR COST FOR VEHICLE NO. SLZ 2506R

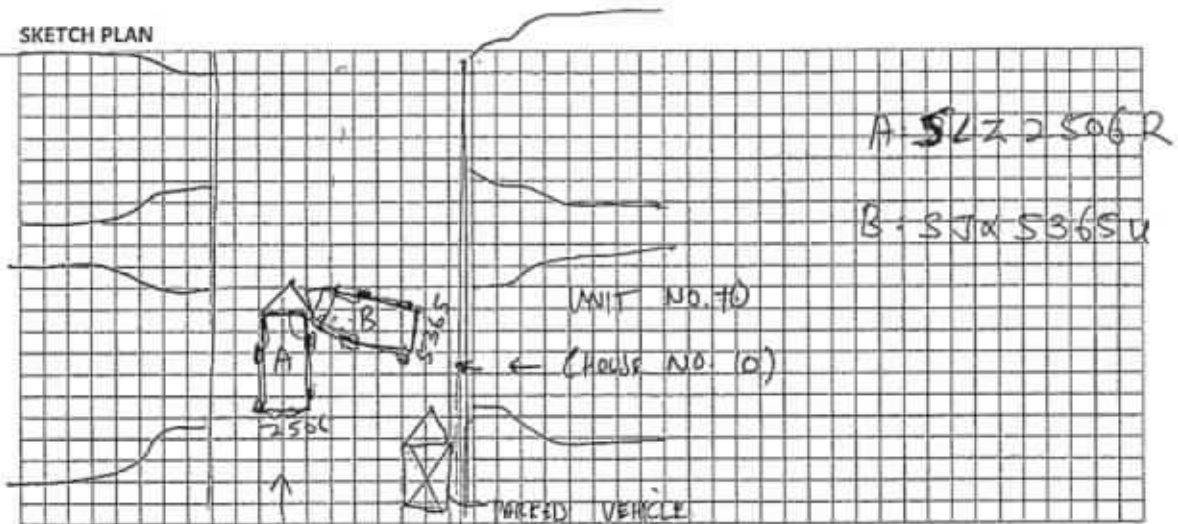
SKETCH PLAN

I was Driving straight along Sarangam Garden Rise. Suddenly a vehicle "B" (SJX 5365U) came out from his house without stopping to check oncoming vehicles. It resulted the said vehicle "B" hit on front right side of my vehicle "A" (SLZ 2506R).
