Subject: RE: OUR REF: SNM20D200756/GBJ2225D/CBS - SURVEY INVITATION for accident on 10/02/2020 at BKE towards PIE (bef ERP gantry) involving vehicles GBH6114A & GBJ2225D

VEHICLE NO : GBH6114A
 MAKE & MODEL : NISSAN NV350
 CHASSIS NO : JN1MC2E26Z0008864

VEHICLE DAMAGE INSPECTION REPORT

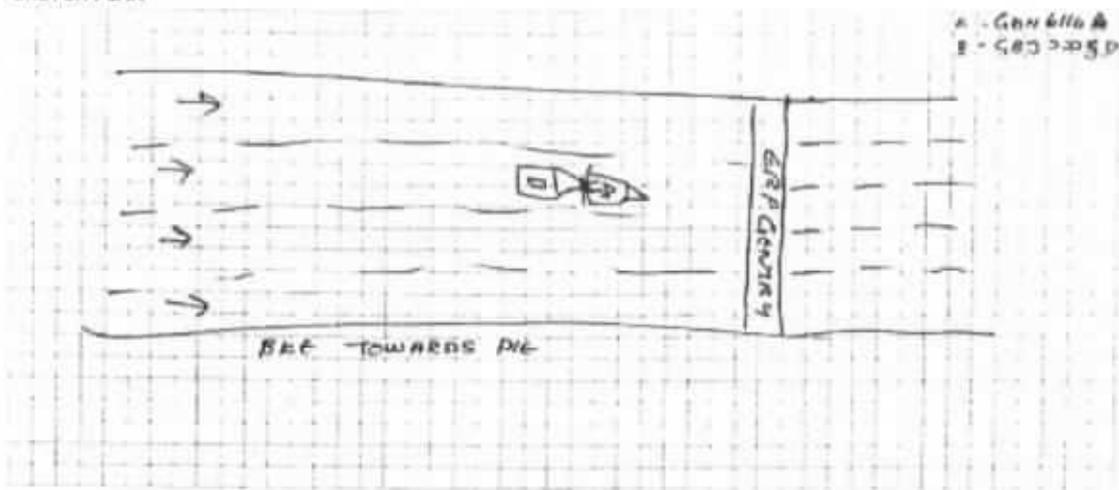
Sketch Plan #2

on 10/02/2020 at about 0915 hrs, I was driving my vehicle GEN 6116 A along BEE towards PIE. While moving forward on third lane, due to traffic congestion I was moving slowly. Suddenly I felt an impact on vehicle's rear portion. Vehicle G8J 2250 Rear ended onto my vehicle. As a result my vehicle's rear portion damaged, back door unable to open and dented. Nobody was injured.
