**Estimated cost of repair for repairing of vehicle no.: GBD6912J -- OD Claim**

**Preliminary Advice**

Vehicle No	: GBD6912J	Accident Date	: 13/01/2020
Make	: CITROEN DISPATCH	Policy No.	: 0999993937
Assignment Date	: 13/02/2020	Excess	: S\$0.00
Date of Inspection	: 13/02/2020	Est. Duration of Repair	: 6.00
Inspection At	: TONG LUCK AUTO PTE LTD (HQ) 160 SIN MING DRIVE, #07-01 SIN MING AUTOCITY SINGAPORE 575722

## VEHICLE DAMAGE INSPECTION REPORT

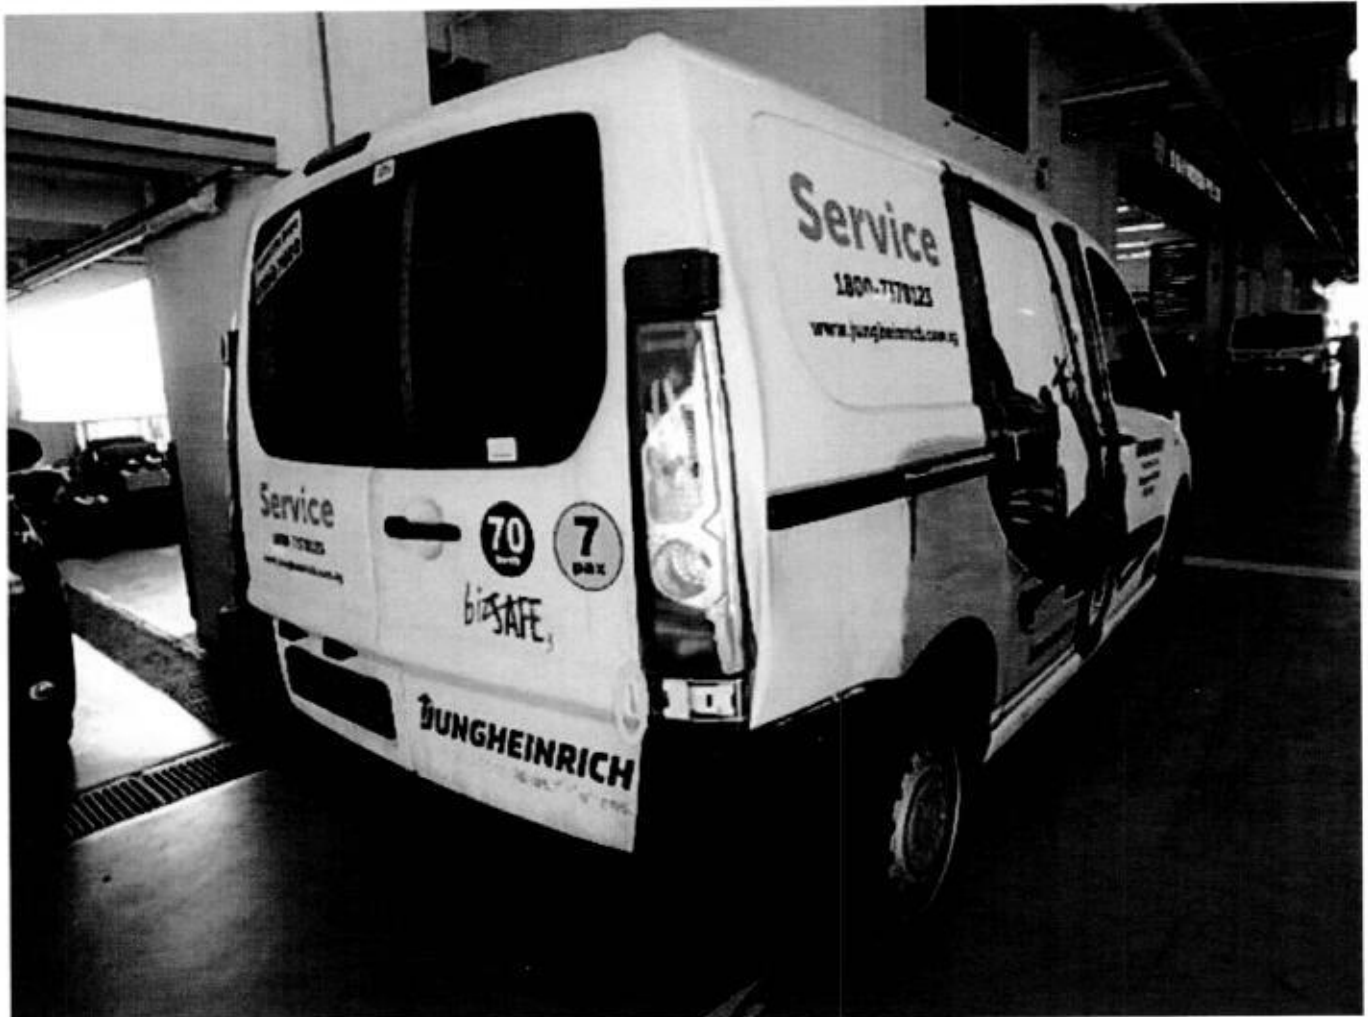
RH rear door dent (circle in yellow) not consistent. To amend parts and labour accordingly. Mandate approve and authorize repair.

RH rear door to repair.

Please find attached photos showing that the tail lamp and the rear door have the same scratches marks, the door pillar and door hinge was also badly dented

Therefore the RH rear door is related to the accident

Please find attached photos showing that the tail lamp and the rear door have the same scratches marks, the door pillar and door hinge is badly dented
