SMF1521X

TO : CHINA TAIPING MOTOR CLAIMS DEPTS
VEHICLE NO : SMF1521X
MODEL : HONDA FREED
DATE OF ACCIDENT : 16.01.20
TIME OF ACCIDENT : 14:00HRS

LKK Auto Consultants Pte Ltd (Co.Reg.No:199607198R)

VEHICLE DAMAGE INSPECTION REPORT

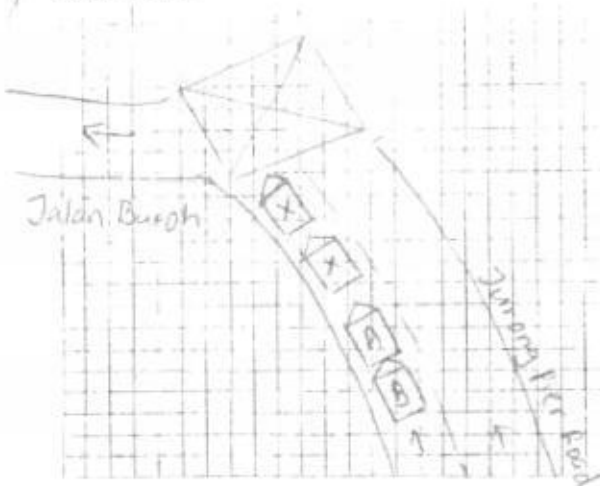
SKETCH PLAN

A = SMF 1521X

B = GBJ 3196Y

Jurong Pier Circus

On 16.01.2020 at about 14:00 hours at Jurong Pier Circus. I was stationary on lane 2 (along Slip Road of Jurong Pier Road towards Jalan Buroh, before entering the Jurong Pier Circus) as the front vehicles were waiting for the oncoming traffic to clear.

Suddenly I heard a loud bang from behind. When I alighted I realised vehicle (B) had collided onto rear portion of my vehicle (A).
