To Inspect Vehicle No: GBC3853X Insured: GBB 992Cat Workshop m/s Faatech Auto Tel: 6746 5405of 1 Kaki Bukit Ave 6 #01-46Policy No: _____ Claim No: DMF620000288

From: Jacelyn Foo <jacelyn.foo@ergo.com.sg>
Sent: Tuesday, 18 February 2020 2:22 PM
To: admin-d@lkkauto.com; admin-a@lkkauto.com; Meikwan@lkkauto.com
Cc: Jason; Ong Shiyong; Zheng Hanyang; Lina Pang
Subject: RE: ERGO Claims Ref: CDMFG20000288 | REQUEST FOR PRE-REPAIR INSPECTION FOR GBC 3853X DOA: 16.02.2020

VEHICLE DAMAGE INSPECTION REPORT

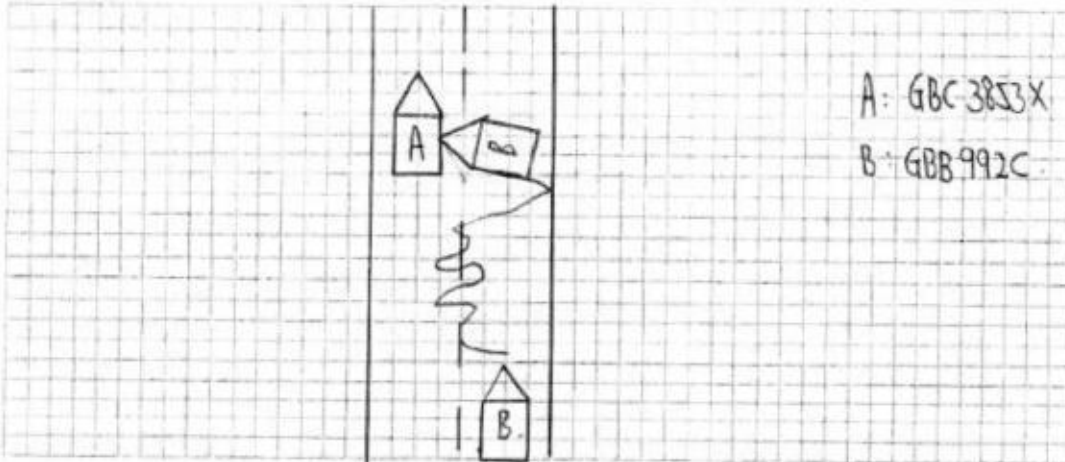
SKETCH PLAN

On 16.02.2020 at about 18.45. I was travelling along CTE Towards.
PIE Changi Exit. I was travelling straight. Suddenly Vehicle B lost
control and hit on my vehicle.
