1. Policy Particulars :- THIRD PARTY CLAIM				
Insured Veh.	SJS 2378D	Veh. Inspected	SHA 6214K	
Policy No.	5113334825	Coverage (\$)	0.00	
Claim No.	MT/1089526-003	Excess (\$)	0.00	
Assign From		Assign Date	18/02/2020

2. Vehicle Particulars & Condition				
Make & Model	TOYOTA PRIUS HYBRID	c.c	1798	
Engine No.	HIDDEN	Year of Reg.	2019	
Chassis No.	JTDKB3FU003081109	Colour	BLUE	
Odometer	113685	Steering	IN ORDER	
Brakes	IN ORDER	Modification	SPORTS RIM	
General	GOOD

ADJUSTMENT ON REPAIR COST FOR VEHICLE NO. SHA 6214K

PHOTOGRAPHS FOR VEHICLE NO. SHA 6214K

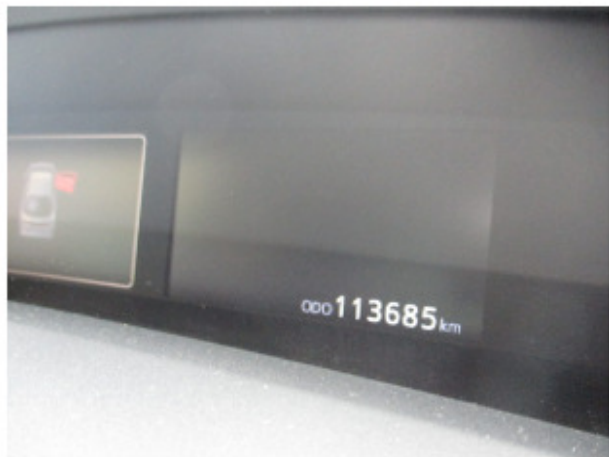
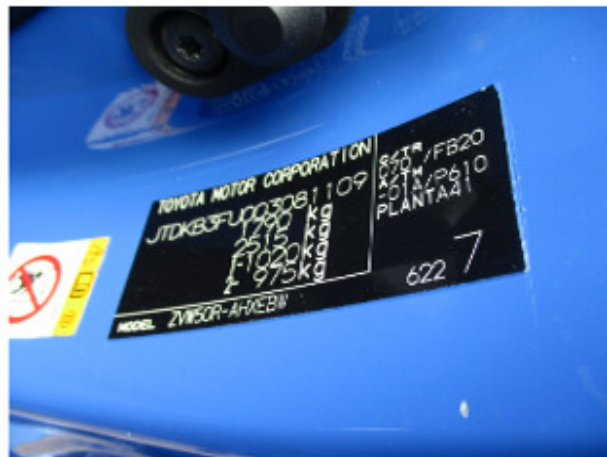
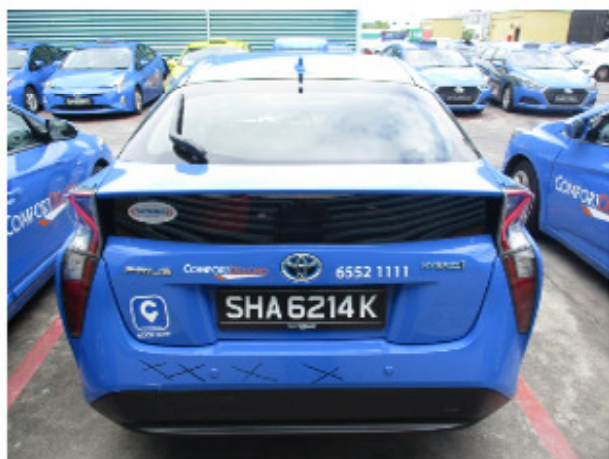
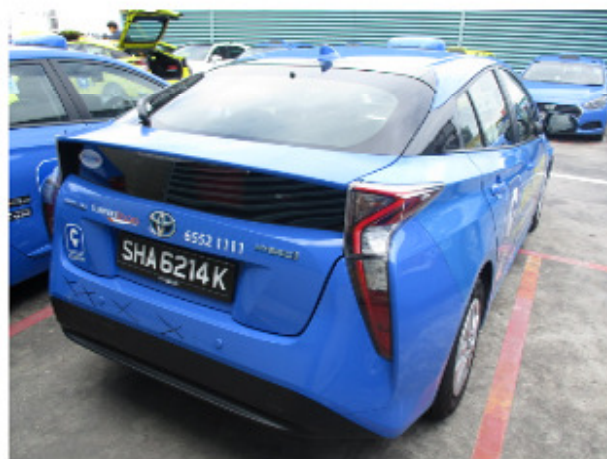
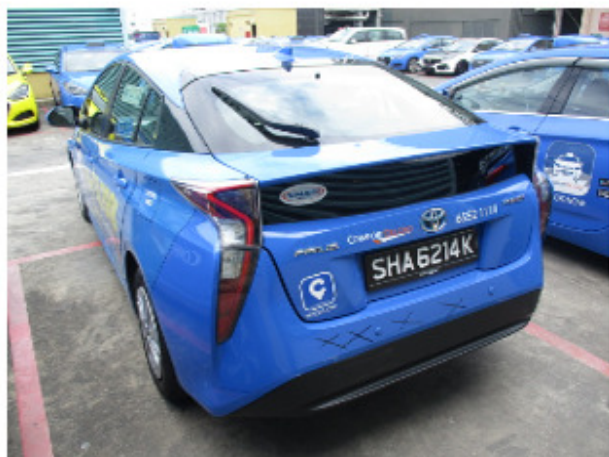
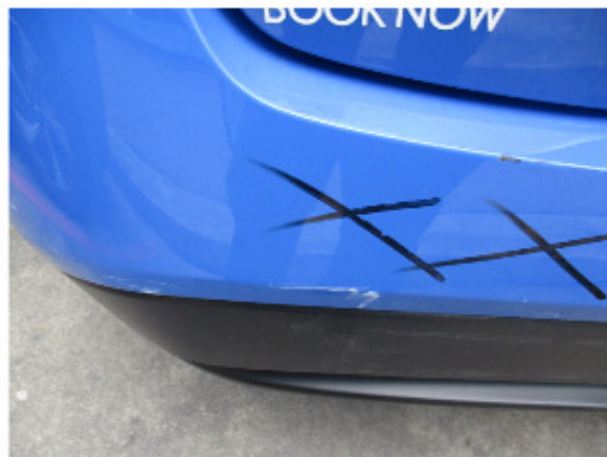
4. Description of Damages				
	THE VEHICLE SUSTAINED DAMAGES AT THE REAR PORTION. DAMAGES SEE DETAILS.			
5. General Information				
Accident Date	17/02/2020	Inspection Date	18/02/2020	
Survey held at	COMFORTDELGRO ENGINEERING PTE LTD 59 LOYANG DRIVE SINGAPORE 508969			
5a. Remarks				
	A)THE INSPECTION WAS CONDUCTED ON A"WITHOUT PREJUDICE" BASIS. B)IN ACCORDANCE TO YOUR INSTRUCTIONS, WE HAVE NOT AUTHORISED REPAIRS.			
5b. Estimate Days of Repair				
	ESTIMATED NORMAL PERIOD FOR REPAIR: 2 Working Days

Qty	Description of Parts	Condition	Estimate By Workshop (\$)	Our Adjusted (\$)
	<u>REPLACEMENT OF PARTS</u>			
1	REAR BUMPER	TO REPAIR SEE LABOUR	458.60	-
1	REAR BUMPER REINFORCEMENT	NOT NECESSARY	318.80	-
1	REAR BUMPER UNDERCOVER	DEFORMED	552.60	552.60
10	REAR BUMPER CLIPS @\$2.20	NOT NECESSARY	22.00	-
	LESS 25% DISCOUNT		-338.00	-138.15
			1,014.00	414.45
	<u>SPECIAL NETT ITEMS</u>			
1	REVERSE SENSOR (SN)	NOT NECESSARY	135.70	-
			135.70	-
	<u>LABOUR</u>			
	PANEL BEATING.INCLUSIVE OF THE REPAIR OF REAR BUMPER.		350.00	320.00
	SPRAY PAINTING CHARGE.		250.00	200.00
	REMOVE/REFIX REVERSE SENSOR.		80.00	60.00
			680.00	580.00
GRAND TOTAL			1,829.70	994.45
RECOMMENDED COST OF REPAIRS (CONFIRMED)				994.45
