Vehicle No. SMR 9656A
Insured Veh. SHC 7591D
Claim No. D20001073MFSH
Policy No. D-20094921MFSH
Accident Date 15/02/2020
Inspection Date 25/02/2020

2. Vehicle Particulars & Condition				
	Make & Model	HYUNDAI AVANTE	c.c	1591
	Engine No.	HIDDEN	Year of Reg.	2020
	Chassis No.	KMHD841CMLU030900	Colour	BLUE
	Odometer	1095 KM	Steering	IN ORDER
	Brakes	IN ORDER	Modification	SPORTS RIM
	General	GOOD

ADJUSTMENT ON REPAIR COST FOR VEHICLE NO. SMR 9656A

PHOTOGRAPHS FOR VEHICLE NO. SMR 9656A

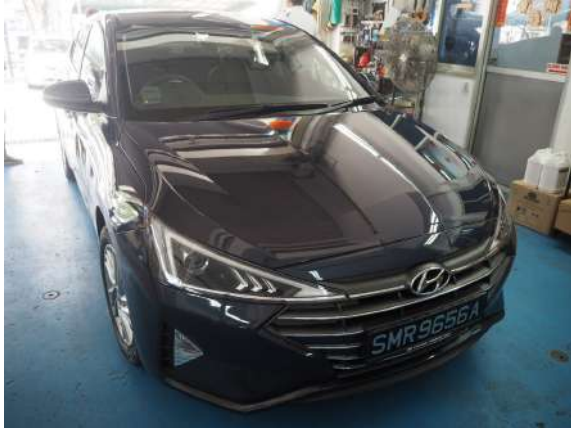
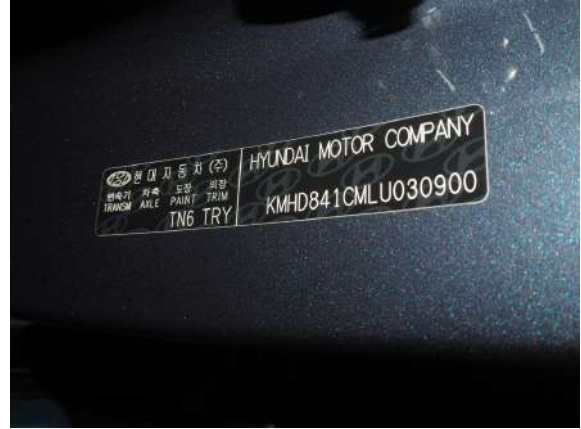
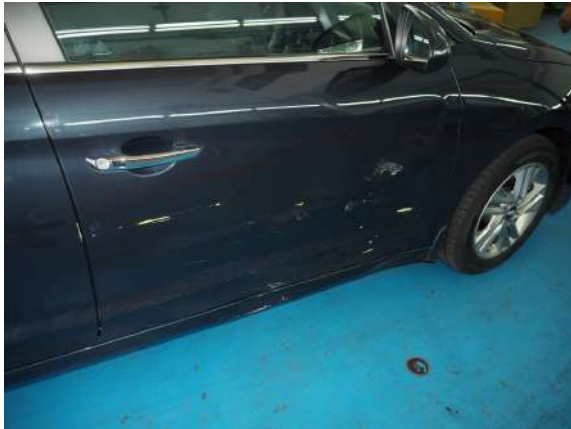
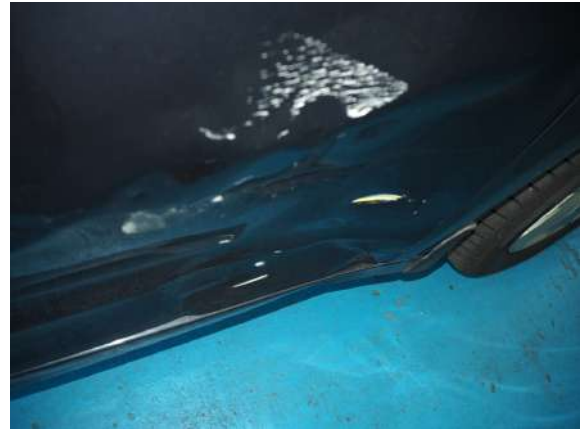
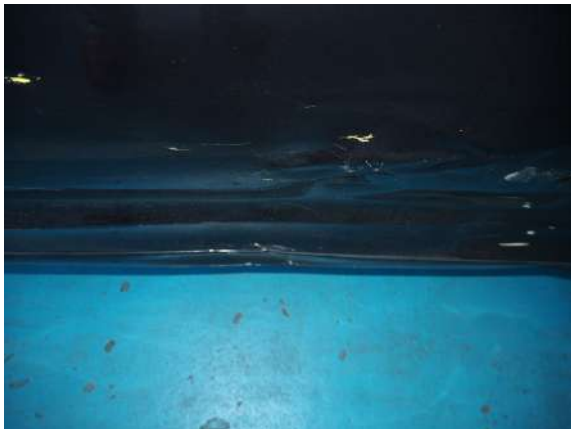
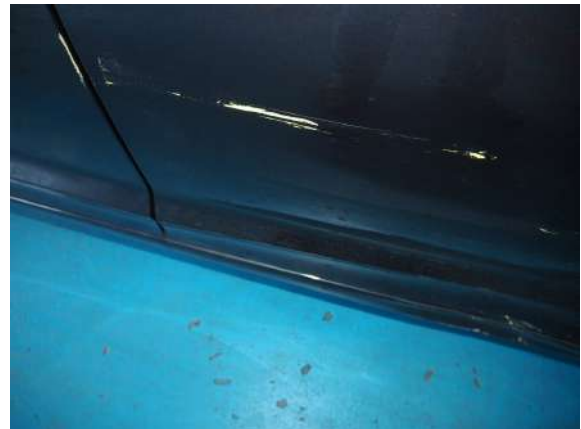
4. Description of Damages				
	THE VEHICLE SUSTAINED DAMAGES AT THE O/S BODY. DAMAGES SEE DETAILS.			
5. General Information				
	Accident Date	15/02/2020	Inspection Date	25/02/2020
	Survey held at	PROGRESSIVE CAR CARE PTE LTD BLK 3022A UBI ROAD 1 #01-45/46, SINGAPORE 048716		
5a. Remarks				
	A)THE INSPECTION WAS CONDUCTED ON A"WITHOUT PREJUDICE" BASIS. B)IN ACCORDANCE TO YOUR INSTRUCTIONS, WE HAVE NOT AUTHORISED REPAIRS.			
5b. Estimate Days of Repair				
	ESTIMATED NORMAL PERIOD FOR REPAIR:		5 Working Days

Qty	Description of Parts	Condition	Estimate By Workshop (\$)	Our Adjusted (\$)
	<u>REPLACEMENT OF PARTS</u>			
1	FRONT DOOR -RH	DISTORTED	1,831.10	1,831.10
1	FRONT DOOR CHECK -RH	NOT NECESSARY	39.80	-
2	FRONT DOOR STICKER-RH @\$18.00	NECESSARY	36.00	36.00
1	FRONT DOOR RUBBER -RH	NOT NECESSARY	112.30	-
1	FRONT DOOR HINGE ,TOP -RH	NOT NECESSARY	41.10	-
1	FRONT DOOR HINGE ,LOWER -RH	NOT NECESSARY	41.10	-
1	FRONT DOOR REGULATOR GEAR -RH	NOT NECESSARY	250.40	-
1	FRONT DOOR REGULATOR GEAR MOTOR-RH	NOT NECESSARY	297.80	-
1	FRONT DOOR LOCK -RH	NOT NECESSARY	191.50	-
1	ROCKER PANEL -RH (NPA)	TO REPAIR SEE LABOUR	-	-
	LESS 20% DISCOUNT		-568.22	-373.42
			2,272.88	1,493.68
	<u>LABOUR</u>			
	TO KNOCK OUT DENTS ,RH FRONT ROCKER PANEL INNER ,CUT /WELD ,RH FRONT ROCKER PANEL OUTER ,REMOVE,REPLACE ACCIDENT PARTS.INCLUSIVE OF THE REPAIR OF ROCKER PANEL -RH .		1,000.00	500.00
	TO RESPRAY PAINT ON ACCIDENT PORTIONS.		800.00	600.00

TO CHECK WIRING .		20.00	20.00
	TO TUFF -KOTE.		50.00	50.00
	TO TRANSFER DOOR AND DOOR FITTING.		80.00	80.00
	TO RESET CHECK LIGHT.	NOT NECESSARY	60.00	-
			2,010.00	1,250.00
GRAND TOTAL			4,282.88	2,743.68
RECOMMENDED COST OF REPAIRS				2,743.68
