PROPERTY DAMAGE CLAIM ARISING FROM A ROAD TRAFFIC ACCIDENT ON 6TH AUGUST 2019 INVOLVING MOTOR VEHICLES NO. SJM 288A AND SHD 3123T ALONG NEWTOWN ROAD TOWARD

Make/Model: MERCEDES BENZ C200

VEHICLE DAMAGE INSPECTION REPORT

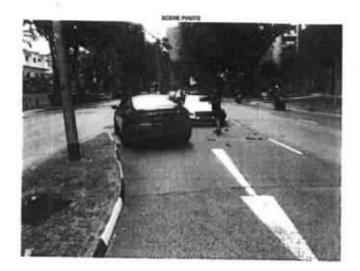
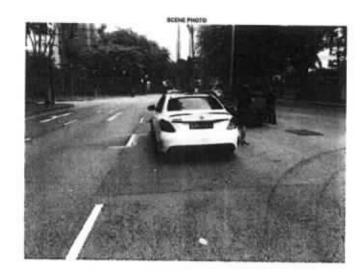
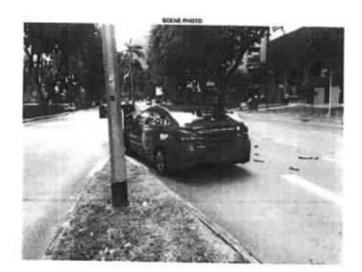
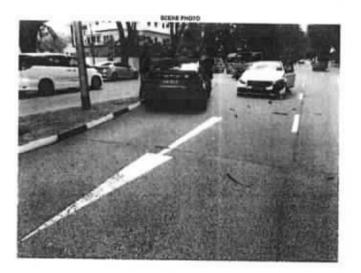
Damaged at the left hand front, right hand front and front portion

Our visual inspection of the vehicle revealed that the damages noted are at the left hand front, right hand front and front portion.

We have inspected the actual damages found on the vehicle and recommend the replacement of parts and repairs accordingly. The estimated repair cost is \$39,004.50. The repairer has agreed to undertake the repairs at our adjusted lump sum amount of \$30,800.00.
