Affiliated to Federation Internationale Des Experts En Automobile				
AUTO & GENERAL INSURANCE (S) PL			Ref : CS/AGI20003272/Aqd3n2	
(BUDGET DIRECT INSURANCE) 190 CLEMENCEAU AVENUE #03-01 SINGAPORE SHOPPING CENTRESINGAPORE 239924			Date : 16-03-2020 Code : AGI

4. Description of Damages				
THE VEHICLE SUSTAINED DAMAGES AT THE REAR PORTION.				
DAMAGES SEE DETAILS.				
5. General Information				
Accident Date	25/02/2020	Inspection Date	28/02/2020	
Survey held at	ACE AUTO SOLUTION 23 KAKI BUKIT AVE 4,#04-01 (SOUTH WING) SINGAPORE 415933			
5a. Remarks				
A)THE INSPECTION WAS CONDUCTED ON A"WITHOUT PREJUDICE" BASIS. B)IN ACCORDANCE TO YOUR INSTRUCTIONS, WE HAVE NOT AUTHORISED REPAIRS.				
5b. Estimate Days of Repair				
ESTIMATED NORMAL PERIOD FOR REPAIR:			5 Working Days

ADJUSTMENT ON REPAIR COST FOR VEHICLE NO. SMR 9416B

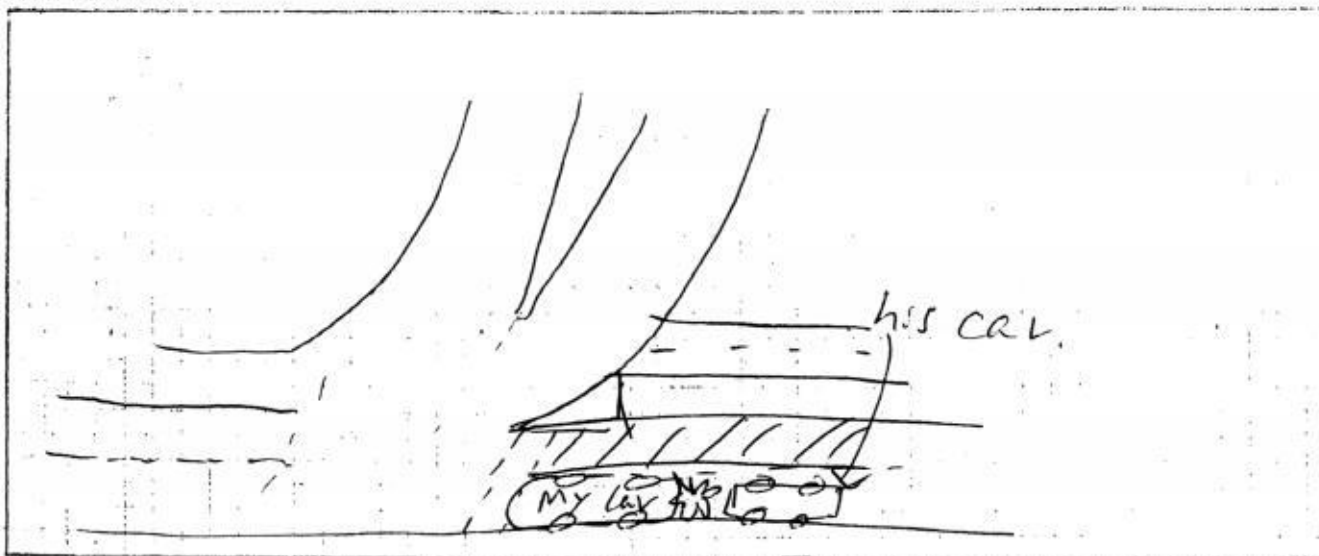
SKETCH PLAN

Was driving down the North Buena Vista Road, when the road merged 3-way, I did full stop, then drove slowly, then ~~the~~ my car was rammed from behind by a light brown Nissan Teana.

The collision took place behind the double white dotted line. Debris is on the floor, picture submitted
