Vehicle No. FBN 4682H

4.		•	on of Damages						
	THE VEHICLE SU	STAINED DAMAGES AT THE FRO	ONT PORTION.						
	DAMAGES SEE D	ETAILS.							
5.			I Information						
	Accident Date	27/02/2020	Inspection Date	02/03/2020					
	Survey held at	SG 98 MOTOR PTE LTD							
	BLK 4001 ANG MO KIO INDUSTRIAL PARK 1 #01-21 SINGAPORE 569622								
5a.		Re	emarks						
	A)THE INSPECTION WAS CONDUCTED ON A"WITHOUT PREJUDICE" BASIS. B)IN ACCORDANCE TO YOUR INSTRUCTIONS, WE HAVE NOT AUTHORISED REPAIRS.								
5b.	5b. Estimate Days of Repair								
	ESTIMATED NORI	MAL PERIOD FOR REPAIR:	3 Working Days

ADJUSTMENT ON REPAIR COST FOR VEHICLE NO. FBN 4682H

PHOTOGRAPHS FOR VEHICLE NO. FBN 4682H

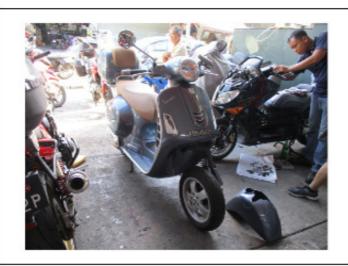
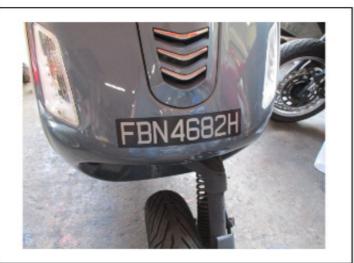
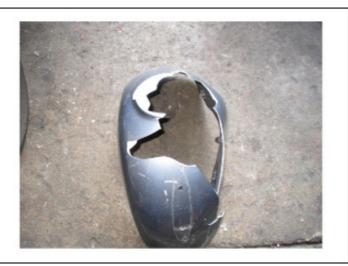
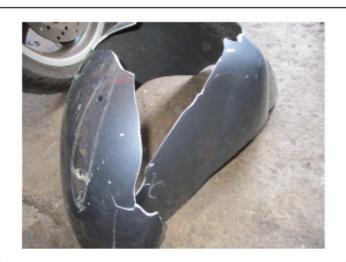
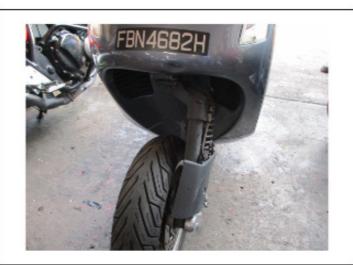
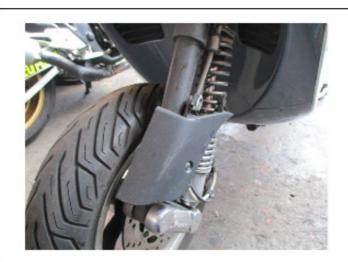
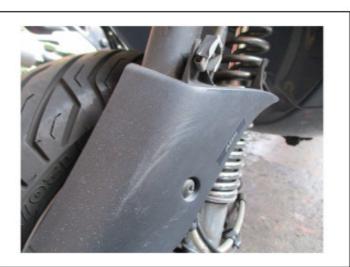
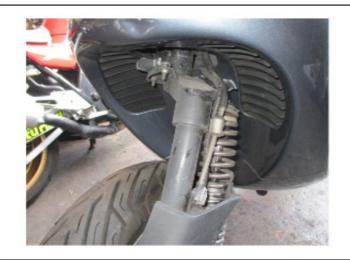
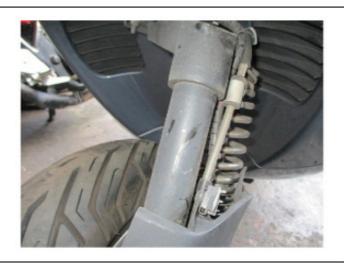
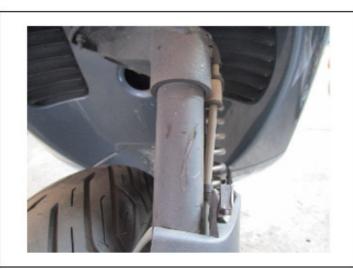
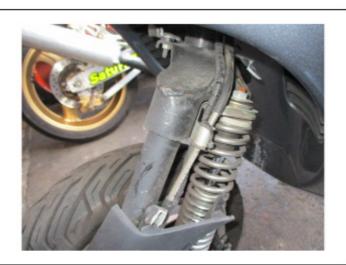
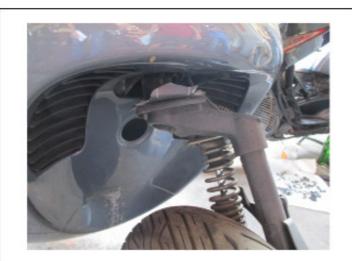
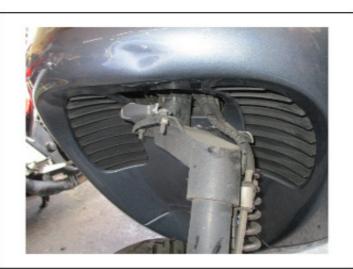
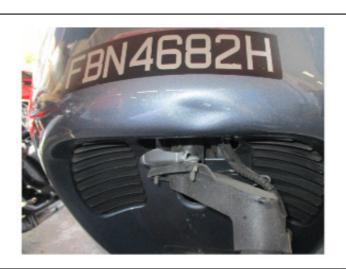
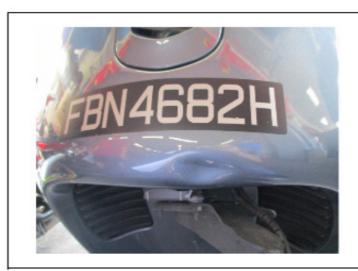
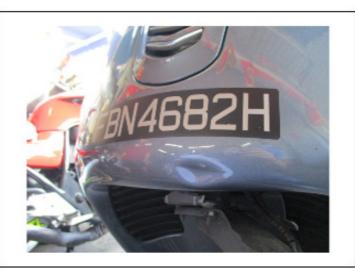
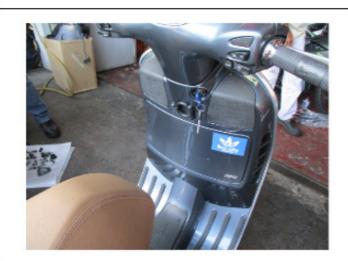
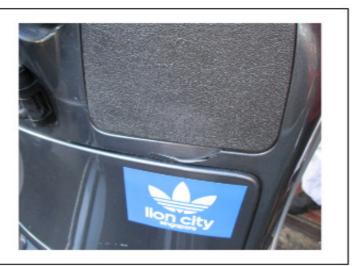
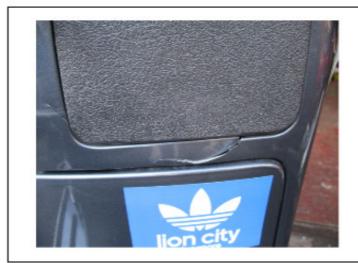
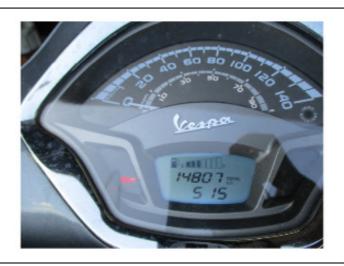
INSPECTION

Qty	Description of Parts	Condition	Estimate By Workshop (\$))	Our Adjusted (\$)
	REPLACEMENT OF PARTS			
1	HANDLE BAR	NOT NECESSARY	250.00	-
1	FRONT MUDGUARD	BROKEN	280.00	280.00
1	FRONT RIM	NOT NECESSARY	350.00	-
1	FRONT FORK ASSY	DISTORTED	520.00	520.00
1	FORK GUARD	CUT	250.00	250.00
1	FRONT DASHBOARD	CRACKED	195.00	195.00
1	BRAKE DISC	NOT NECESSARY	295.00	-
2	FRONT SIGNAL L/RH	CRACKED	250.00	250.00
	LESS 10% DISCOUNT		-239.00	-149.50
			2,151.00	1,345.50
	SPECIAL NETT ITEMS			
1	FRONT NUMBER PLATE (SN)	NECESSARY	15.00	15.00
1	FRONT MUDGUARD EMBLEM (SN)	DISLODGE	95.00	95.00

110.00	110.00
	<u>LABOUR</u>			
	TOWING FEE.	NOT NECESSARY	40.00	-
	REMOVE & REPLACE NECESSARY PARTS,ALIGN,KNOCK OUT BODY DENTS,WELDING WHERE NECESSARY.		380.00	250.00
	REMOVE & REPLACE FORK ASSY & FRONT RIM,BRAKE DISC.		150.00	80.00
	PUTTY & RESPRAY PAINT ON AFFECTED AREA-2K PAINT.		350.00	180.00

RECOMMENDED COST OF LUMP SUM REPAIRS		1,550.00
(TO ITS PRE-ACCIDENT CONDITION)
