## **PAPER SURVEY OF GBE6321J**

<b>4. Description of Damages</b>				
THE VEHICLE SUSTAINED DAMAGES AT THE O/S FRONT PORTION. DAMAGES SEE DETAILS.				
<b>5. General Information</b>				
Accident Date	21/12/2019	Inspection Date	02/01/2020	
Survey held at	ANN JOO MOTOR SERVICES BLK 176, SIN MING DRIVE #01-17 SIN MING AUTOCARE SINGAPORE 575721			
<b>5a. Remarks</b>

## ADJUSTMENT ON REPAIR COST FOR VEHICLE NO. GBE 6321J

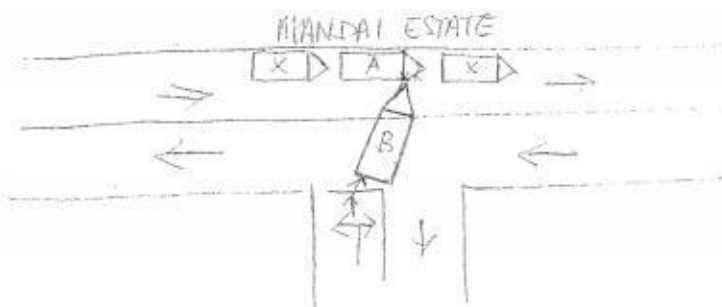
SKETCH PLAN

A: GBE 6321J

B: YP 7799C

On 21/12/2019 at about 11:30PM along Mandai Estate.

My vehicle 'A' (GBE 6321J) was parked at the side of the road. I was at my dormitory sleeping when I received a call and said he hit my lorry ask me come out. I came out and saw vehicle 'B' (YP 7799C) started and collided onto my vehicle 'A'.

Vehicle 'B' apologized said that he turned out and hit my lorry. We Exchanged particulars, and I informed my manager.

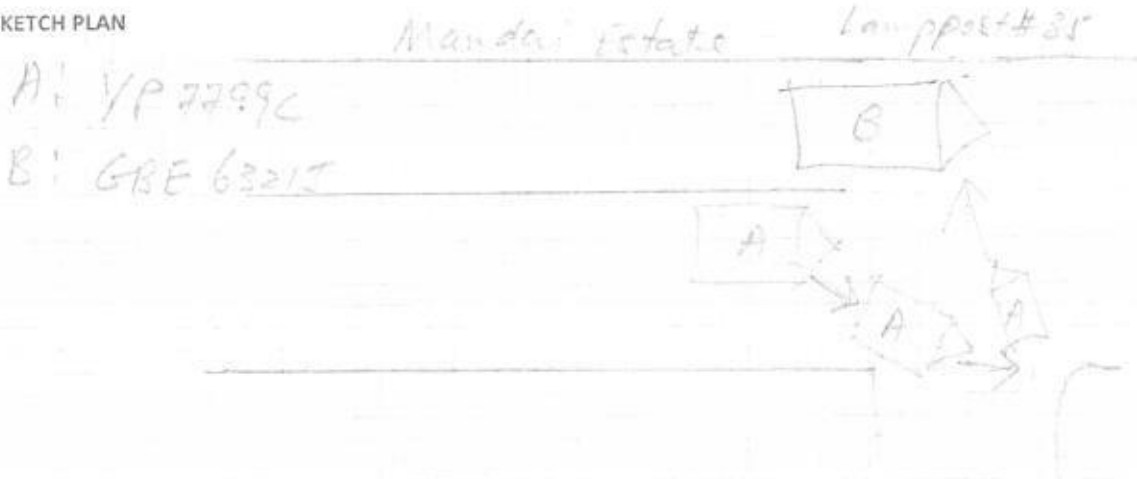
## SKETCH PLAN

I driving the lorry 22.12.2019. Night 11:30pm.  
that time lorry make the U turn. Unfortunately  
to hit the another lorry right side door.  
That lorry side door glass all broken.  
and door also bend.

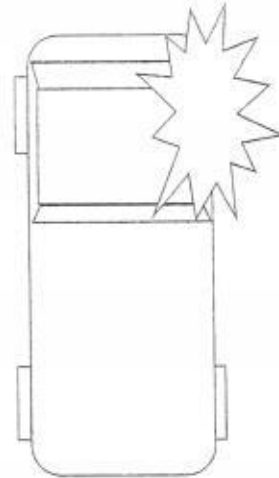
#### 4. DESCRIPTION OF DAMAGE

At the time of the inspection, the vehicle sustained damages to the  
FRONT portion:

Pursuant to your instruction, we have **NOT AUTHORISED** repair.
