INITIAL INSPECTION REPORT OF VEHICLE NO. SHD9764D

VEHICLE DAMAGE INSPECTION REPORT

Our File No: CC3/TMI20003642/KYF3E2
Date: 03/04/2020

Claimant Vehicle No: SHD9764D

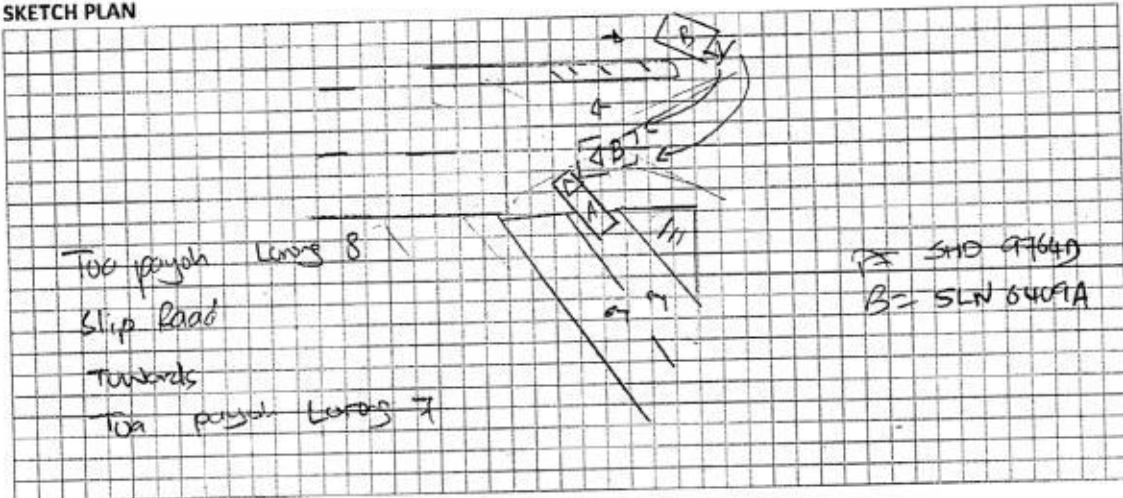
Sketch Plan #2 Pg. 1

On 03.03.2020 at about 1325hours, I was travelling on the extreme right lane along Lorong 8 Toa Payoh slip road towards Lorong 7 Toa Payoh when I check there's no oncoming Vehicle, I slowly move forward. Suddenly I felt an impact. Vehicle B (SLN6409A) which was making a U-turn from opposite lane and hit onto my taxi's right side front portion.
