Preliminary Advice

Vehicle No	: SGU1052A	Accident Date	: 07/03/2020
Make	: TOYOTA WISH	Policy No.	: MPC19P00005900
Assignment Date	: 09/03/2020	Excess	: S\$0.00
Date of Inspection	: 10/03/2020	Est. Duration of Repair	: 4.00
Inspection At	: FALCON-AIR AUTO SERVICES PTE LTD (TAMPINES) BLK 9006 #01-200 TAMPINES ST 93 SINGAPORE

VEHICLE DAMAGE INSPECTION REPORT

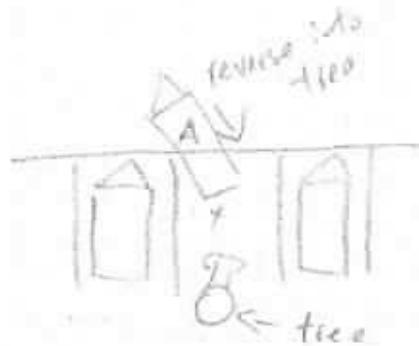
SKETCH PLAN

I was reversing into the lot at Tempins St 21
blk 232 open carpark. I did not realise that
the tree was into the lot & thus collided into
the tree causing serious damage to the rear of
my vehicle
