Preliminary Advice

Insured Vehicle No	: SMK425X		
TP Vehicle No	: SHA1405J	Accident Date	: 09/03/2020
Make	: HYUNDAI IONIQ HYBRID	Assignment Date	: 11/03/2020
Date of Inspection	: 10/03/2020	Est. Duration of Repair	: 2 days
Inspection At	: ComfortDelGro Engineering Pte Ltd (Loyang) 59 Loyang Drive Singapore 508969

VEHICLE DAMAGE INSPECTION REPORT

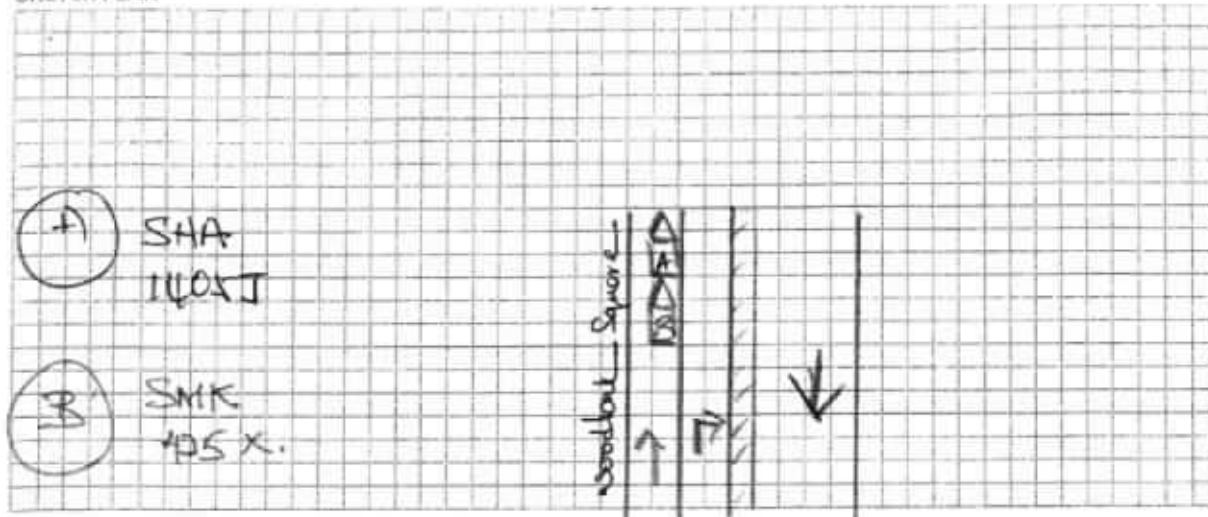
SKETCH PLAN

on 9 March 2020 @ 14:45 hrs I, VEH (A)

slow down at stop @ the Traffic Junction

few seconds later VEH (B) from the Rear

hit VEH (A) Rear @ the point of

accident - VEH (A) no pain.
