# ASSIGNMENT

Final repair bill for vehicle no. SMK 8260 B

PERSONAL INJURY ARISING FROM ACCIDENT INVOLVING SMK 8280 B / SHA 3479 H  
ON 29/11/2019 ALONG GTE NEAR MERCHANT ROAD EXIT

## ADJUSTMENT ON REPAIR COST FOR VEHICLE NO. SMK 8260B

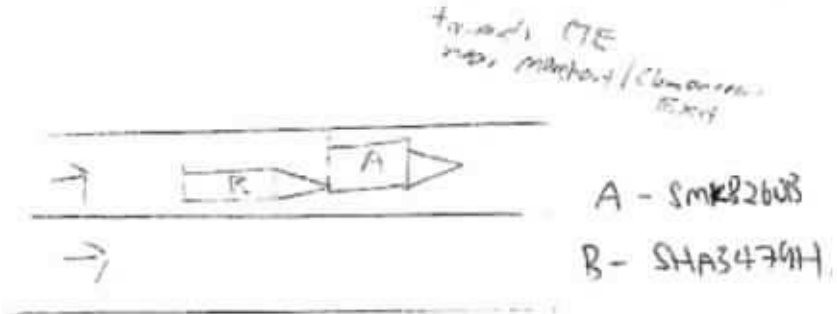
## SKETCH PLAN

I was driving towards CTE, my vehicle was stationary due to heavy traffic instant. Suddenly vehicle B hit against the rear of my vehicle, causing damage to the rear of my vehicle.

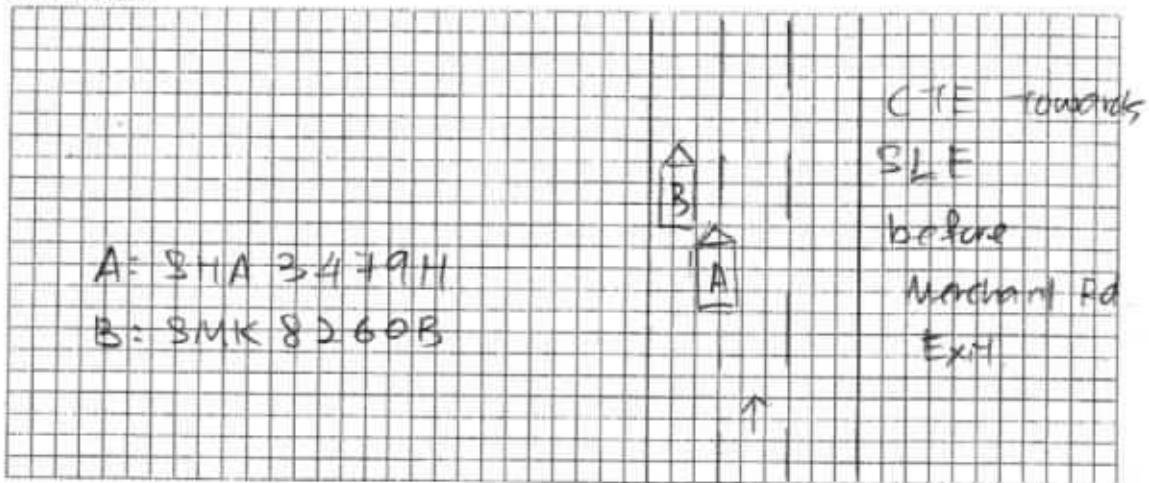
## SKETCH PLAN

On 29/11/19 at about 19:20hrs, I Veh A driving at above said location with a male passenger onboard. I wanted him to middle lane with signal light on. I apply brake to stop my taxi upon noticed vehicle ahead brake to stop. luckily I manage to avoid contact with veh B in front of my taxi. However Veh B driver blamed me have collided on his car. In the fact, Veh B rear right portion sustained old damage and my taxi front left portion as well. Scene photo taken for investigation. No injury reported.
