To inspect Vehicle No: SJM 6725R

Fiat Doblo

**PRE-REPAIR INSPECTION REQUEST – SJM6725R vs GBJ1469Z (OI) on D.O.A.: 06/03/2020**

## VEHICLE DAMAGE INSPECTION REPORT

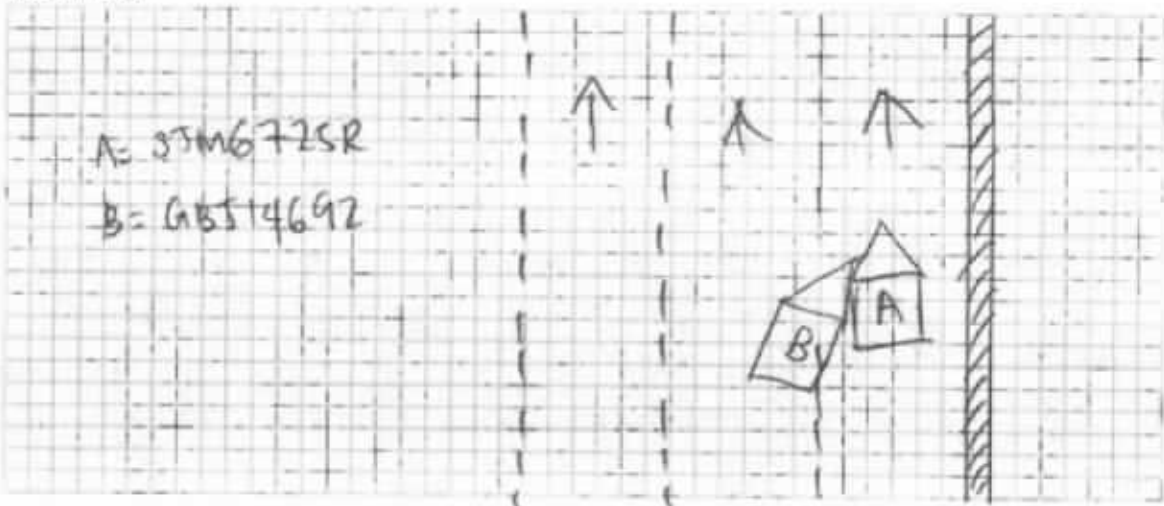
### SKETCH PLAN

Suddenly, a lorry driver (GBJ1469Z) turned right into my lane as he was trying to avoid a trailer which was turning into his lane from the 3rd lane. As a result, my car front left side was damaged seriously and his lorry front right was also damaged. The lorry driver is namely Govindasamy Sathishkumar, HP:91361889).
