**Vehicle Inspection Report**

Report No: AAS/2019/587

Registration no: SLT4882Y  
Make/Model: BMW 116d (A)  
Year of registration: 2015  
Colour: Pearl White

## ADJUSTMENT ON REPAIR COST FOR VEHICLE NO. SLT 4882Y

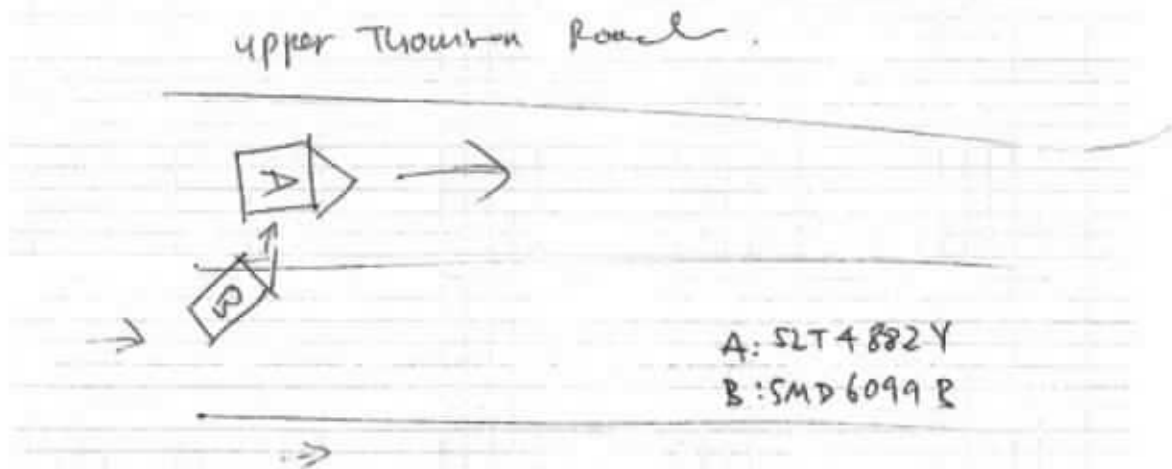
SKETCH PLAN

I was driving along Upper Thomson Road, towards Novena, on 30/11/2019, about 1915hrs. I was on left most lane, going straight. A car on my right, SMD6099B, cut into my lane, I sounded the horn <sup>but he continued</sup> & he knocked into the right passenger door of my car and scraped all the way to the right back bumper.

We stopped at the side of the road to exchange contacts and take photo. The driver of SMD6099B said that he was turning to Marymount MRT to pick his wife. Hence, he would needed to take the left lane.

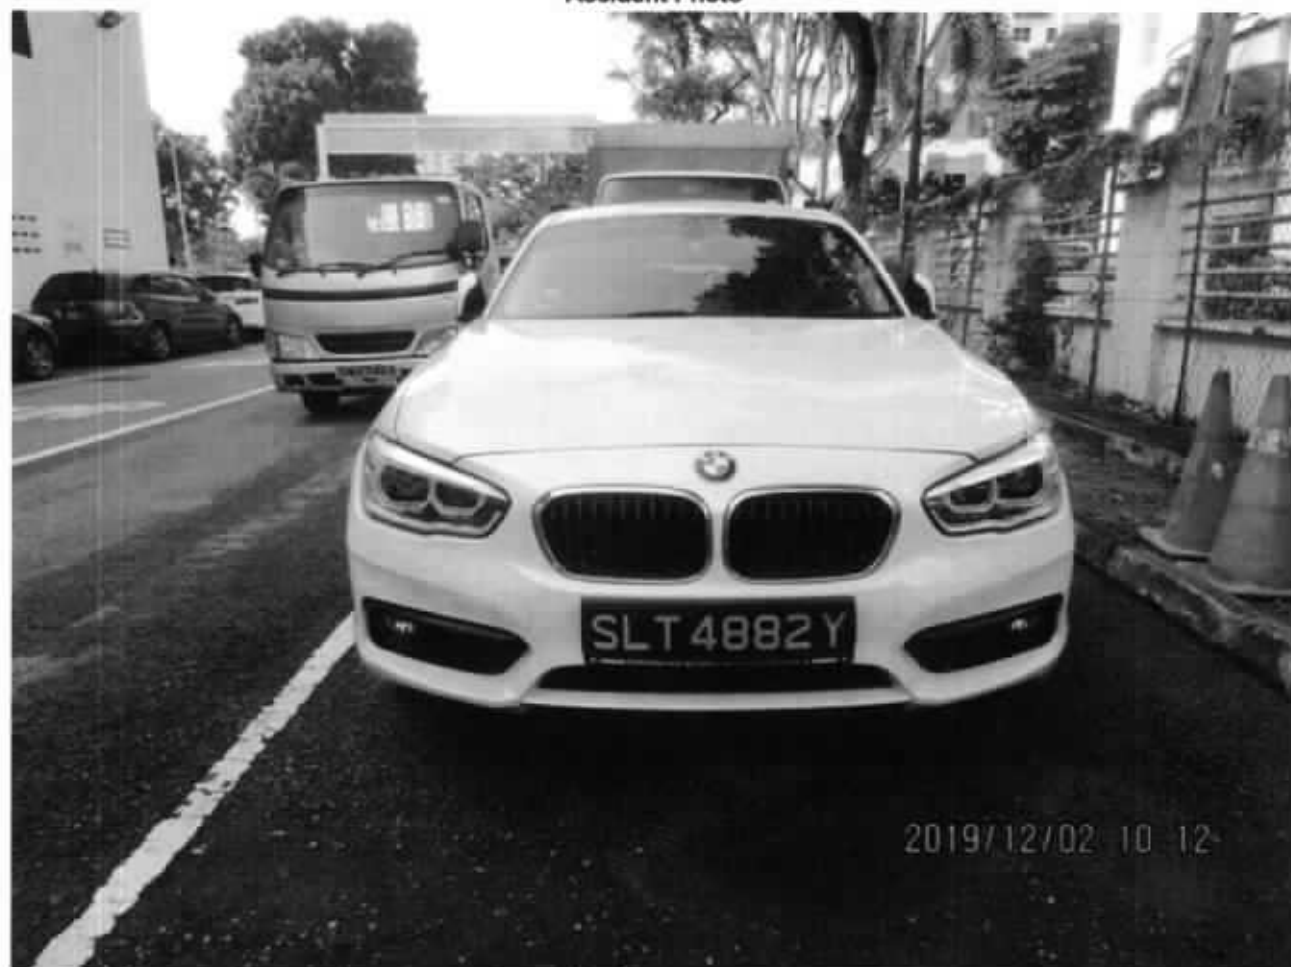
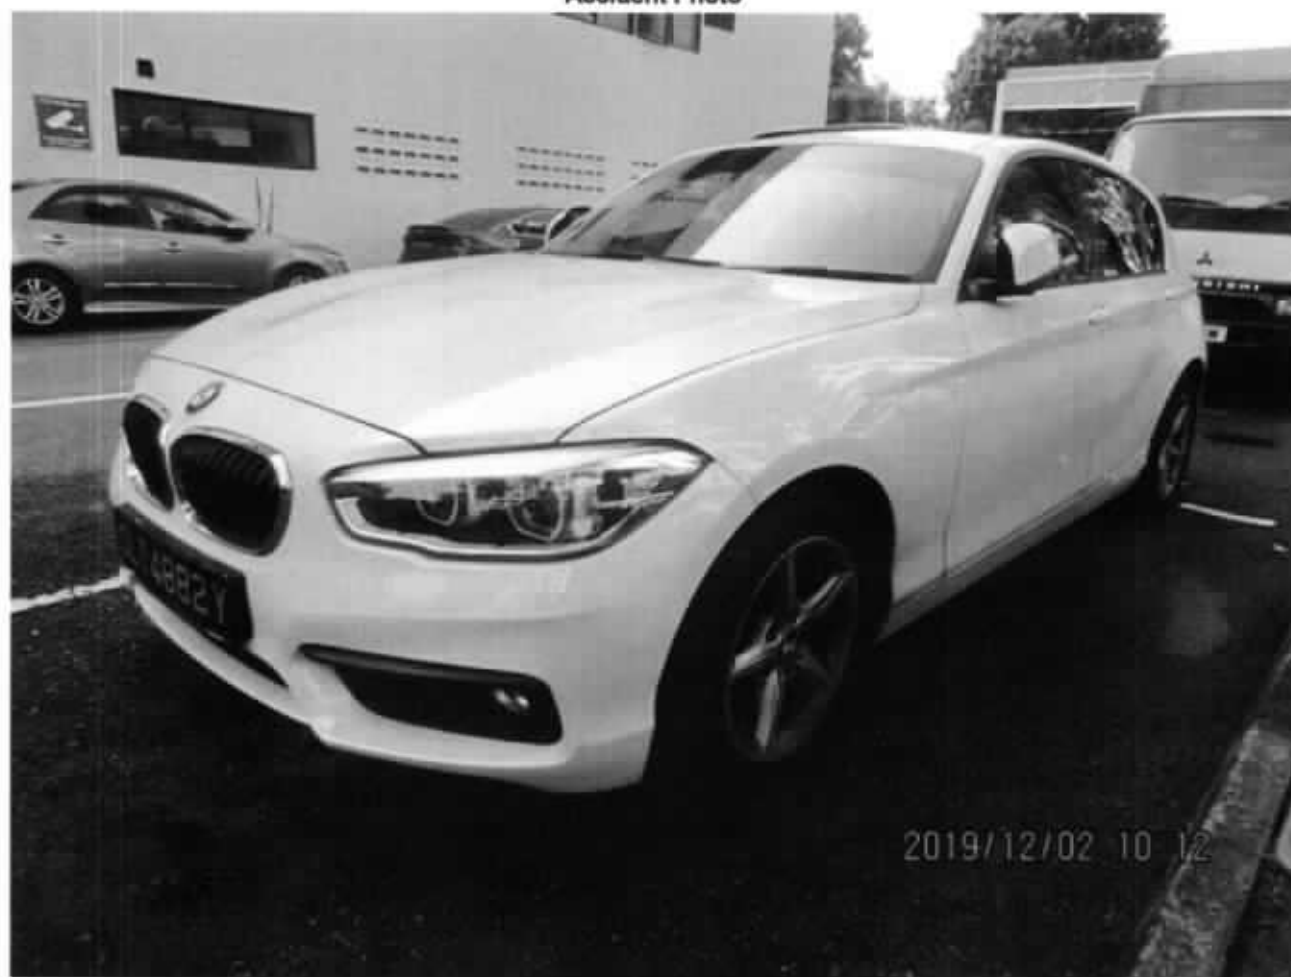
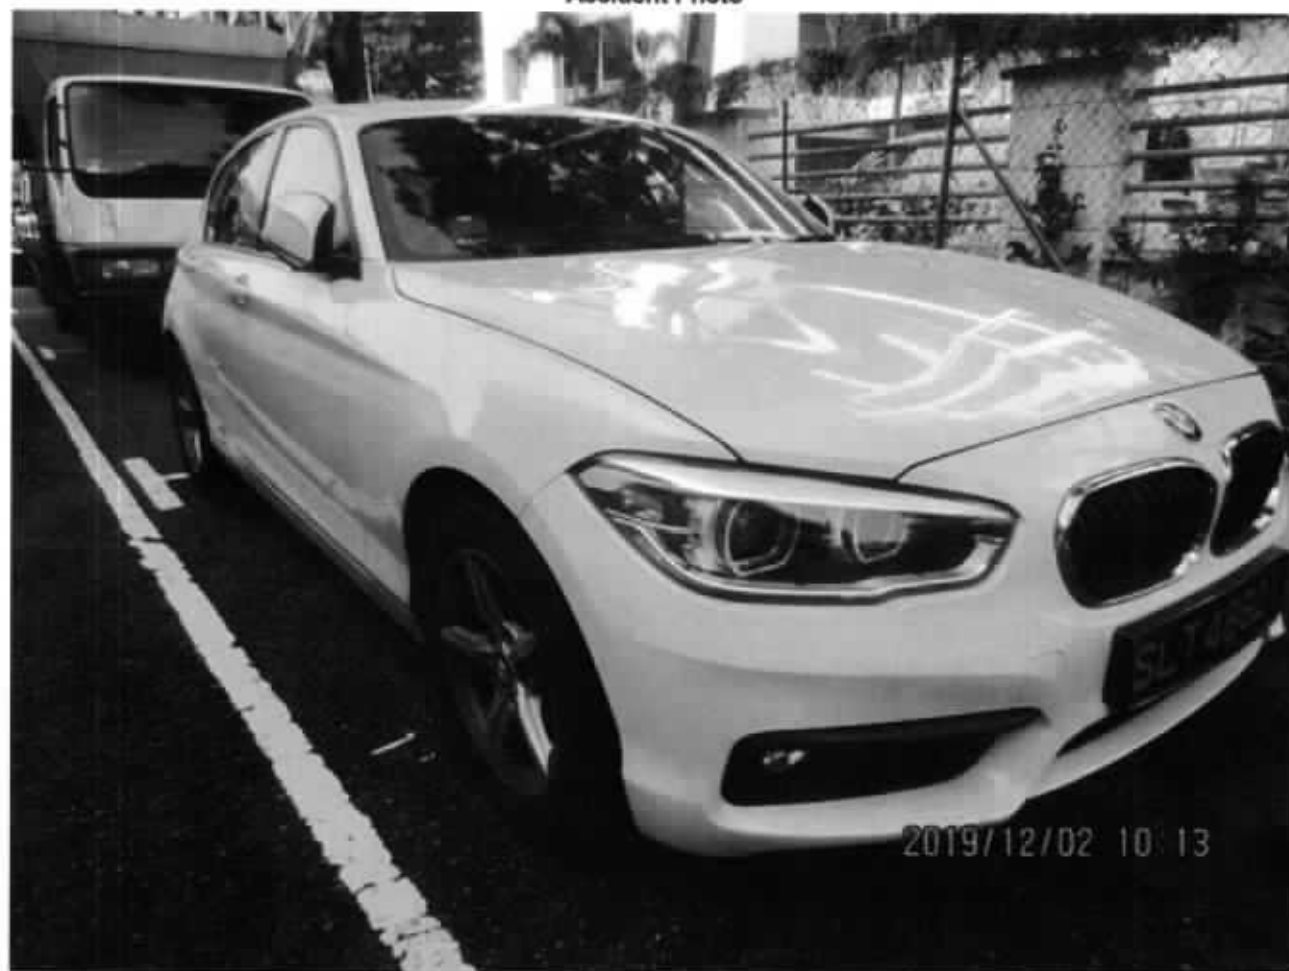
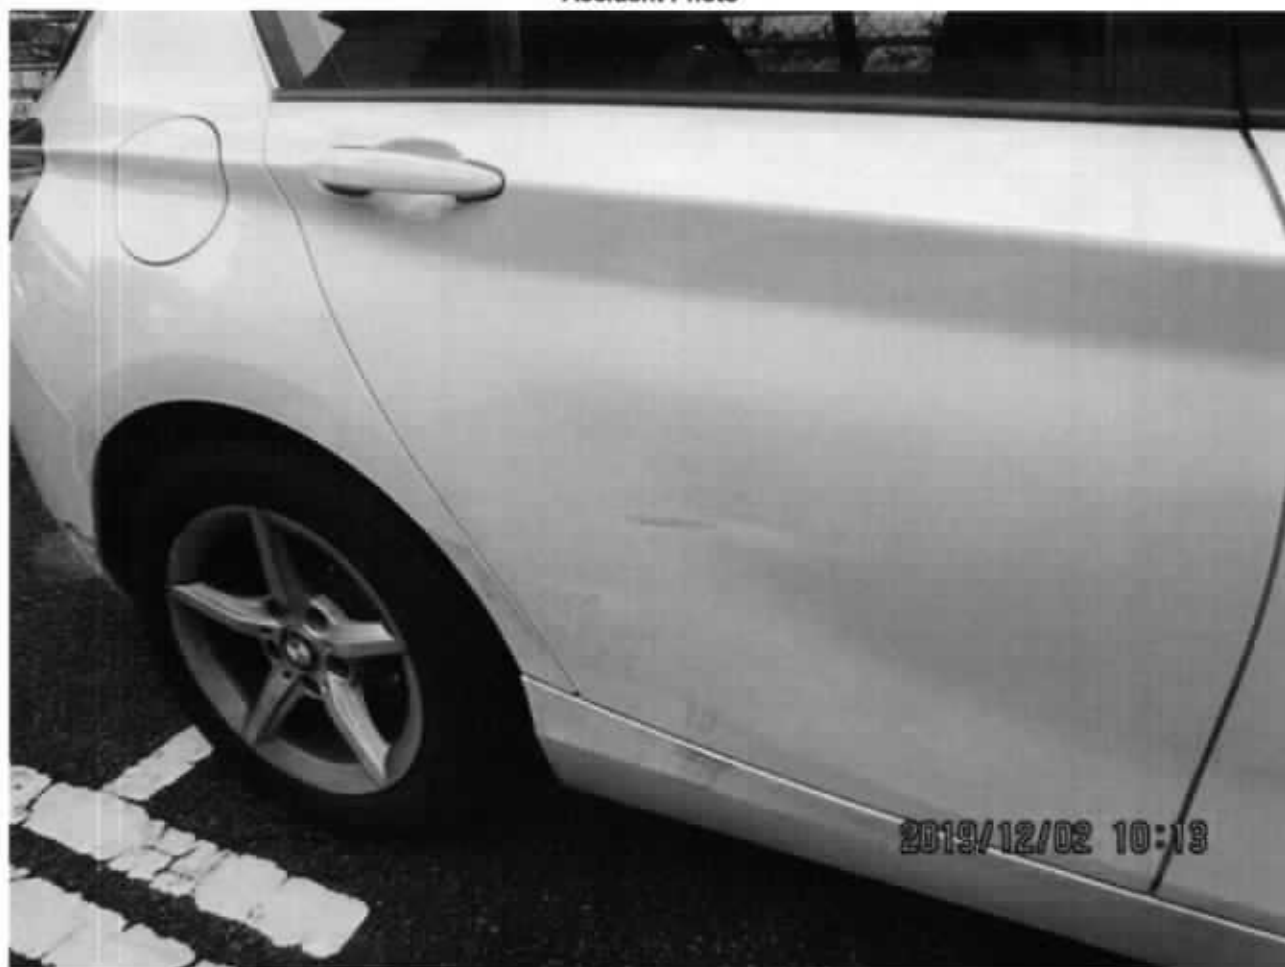
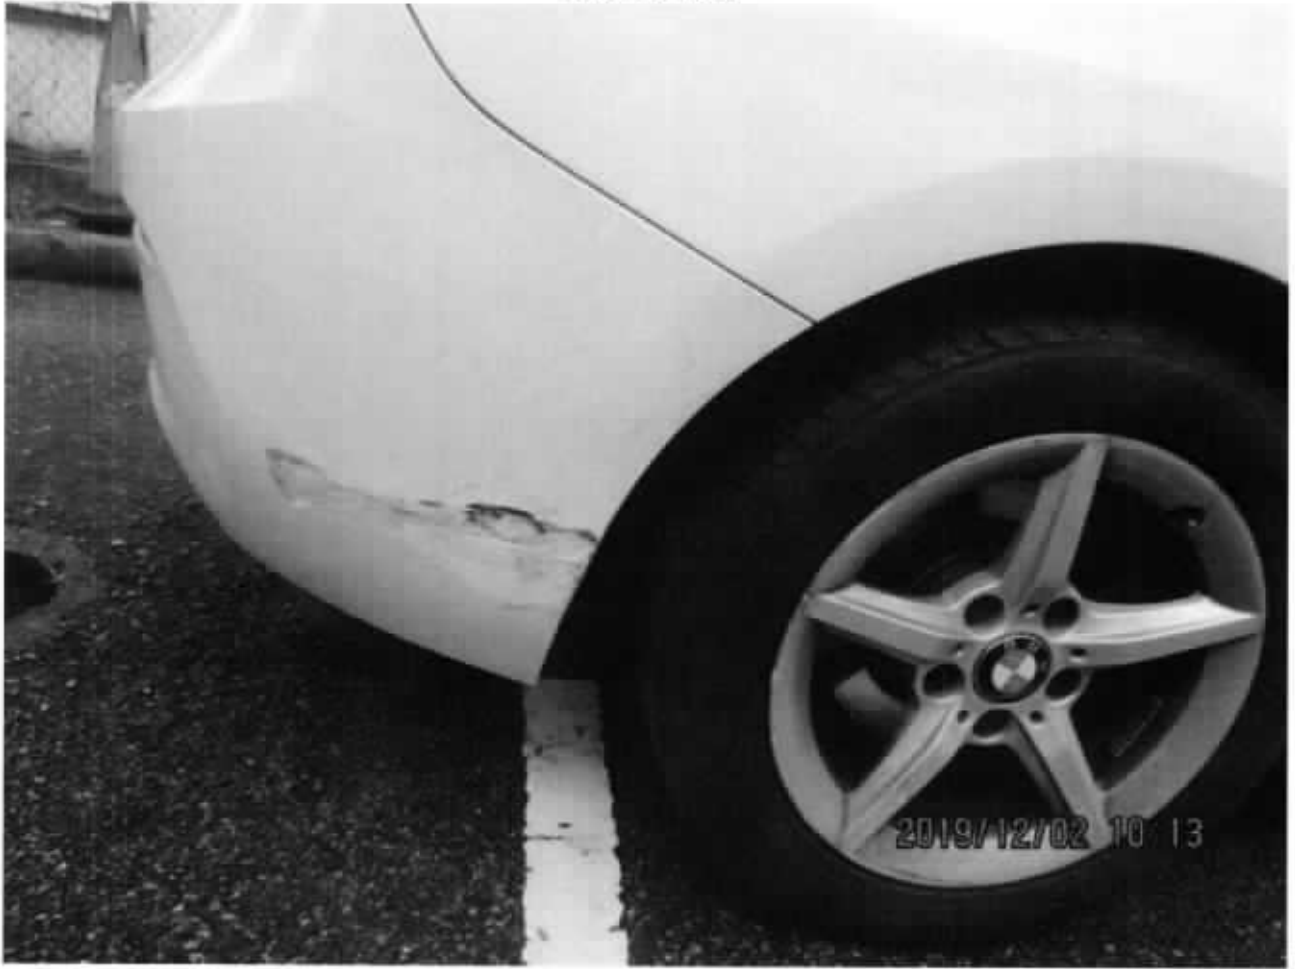
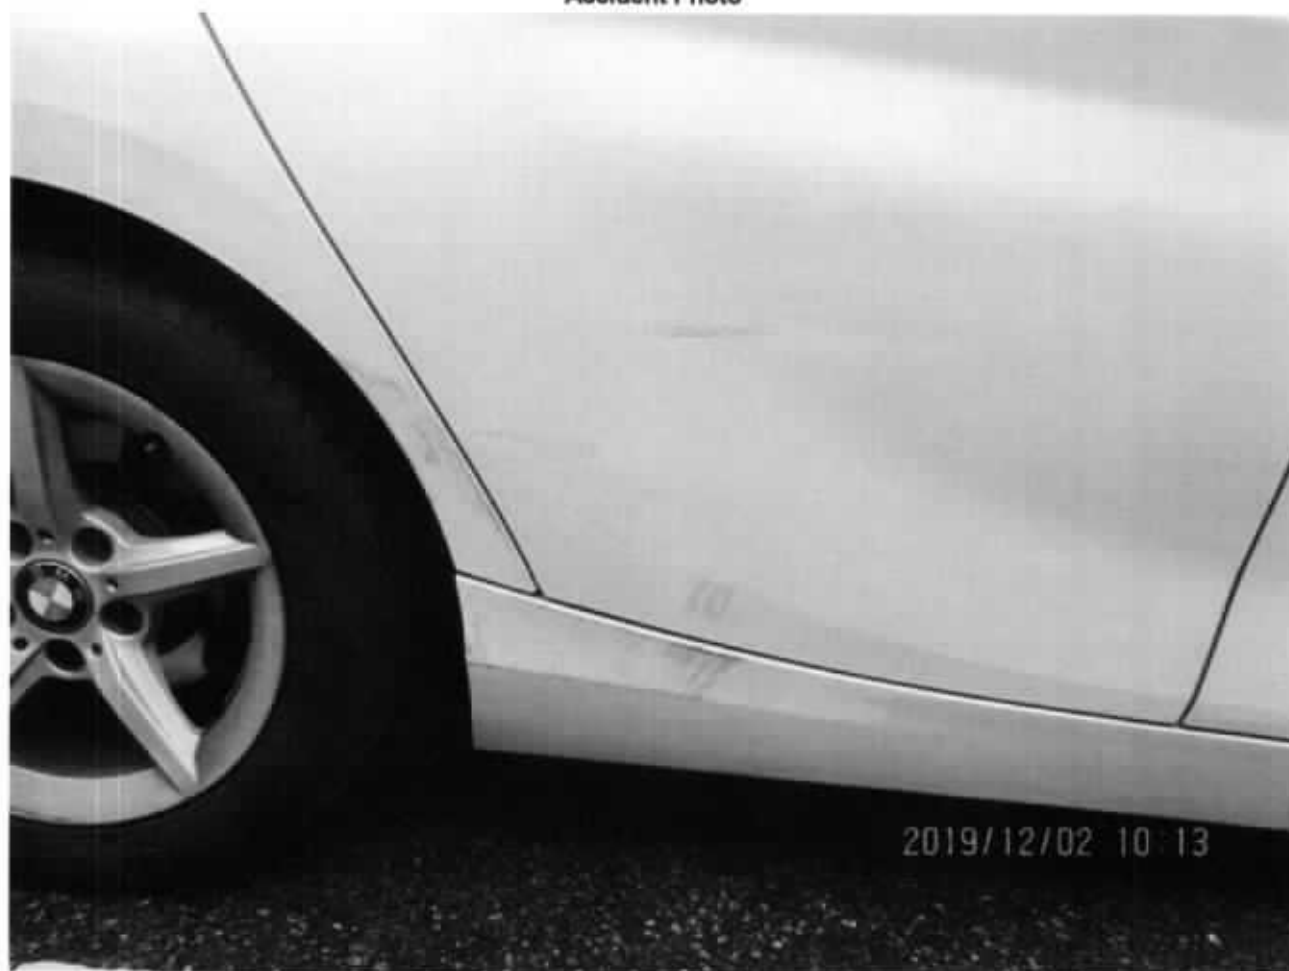
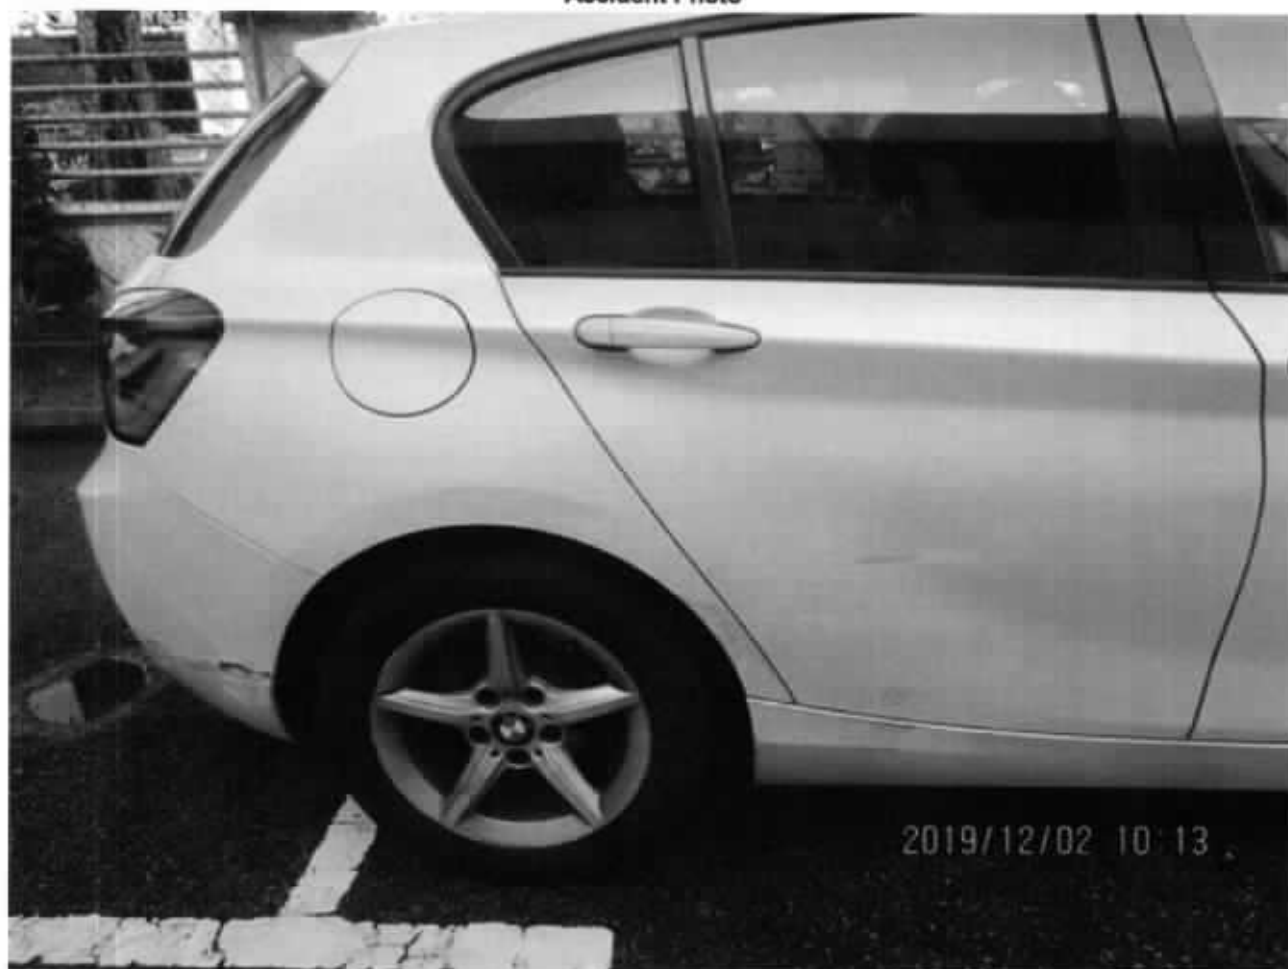
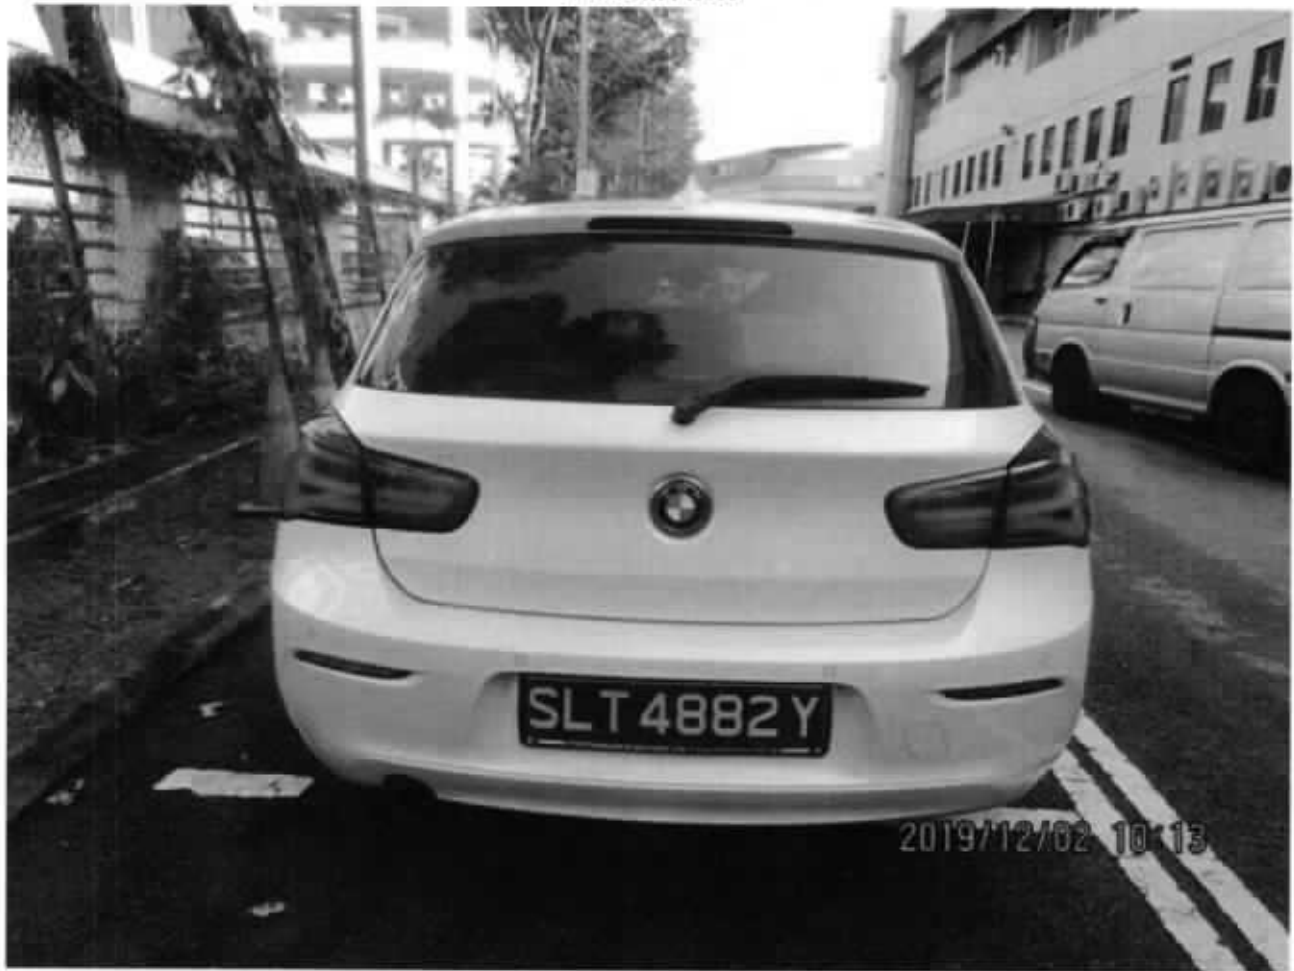
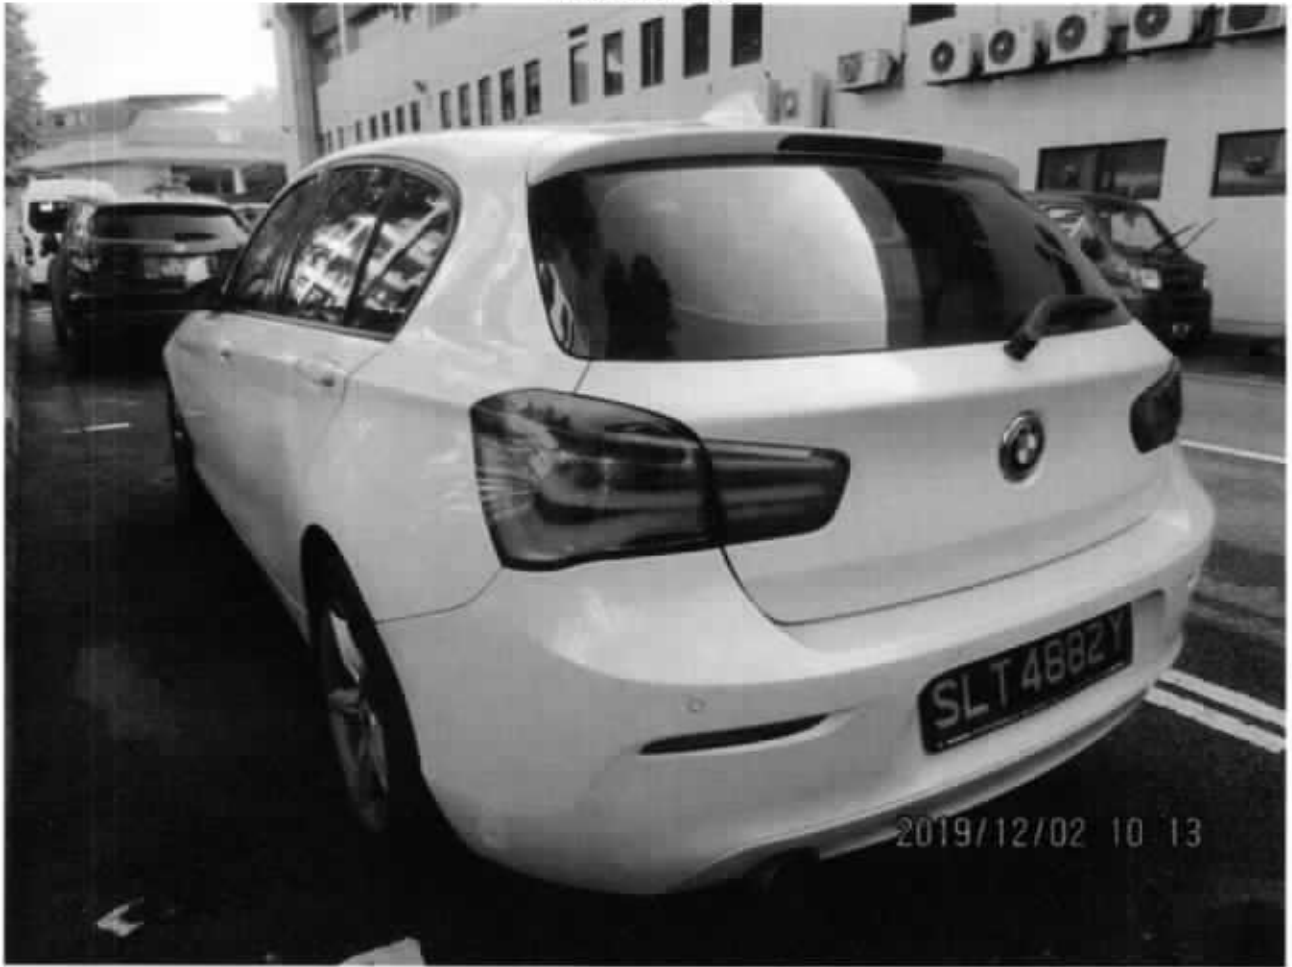
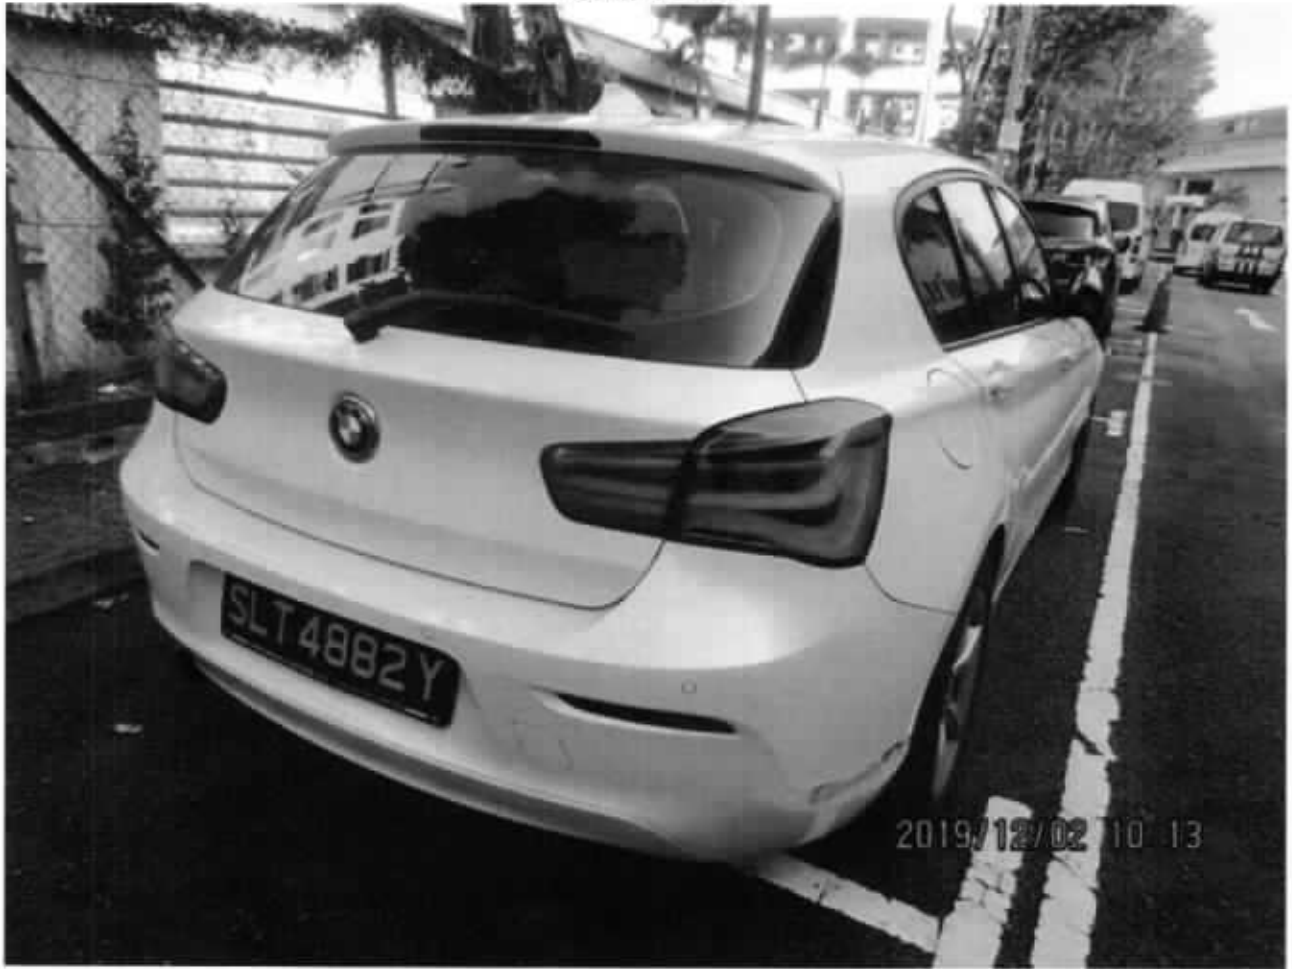
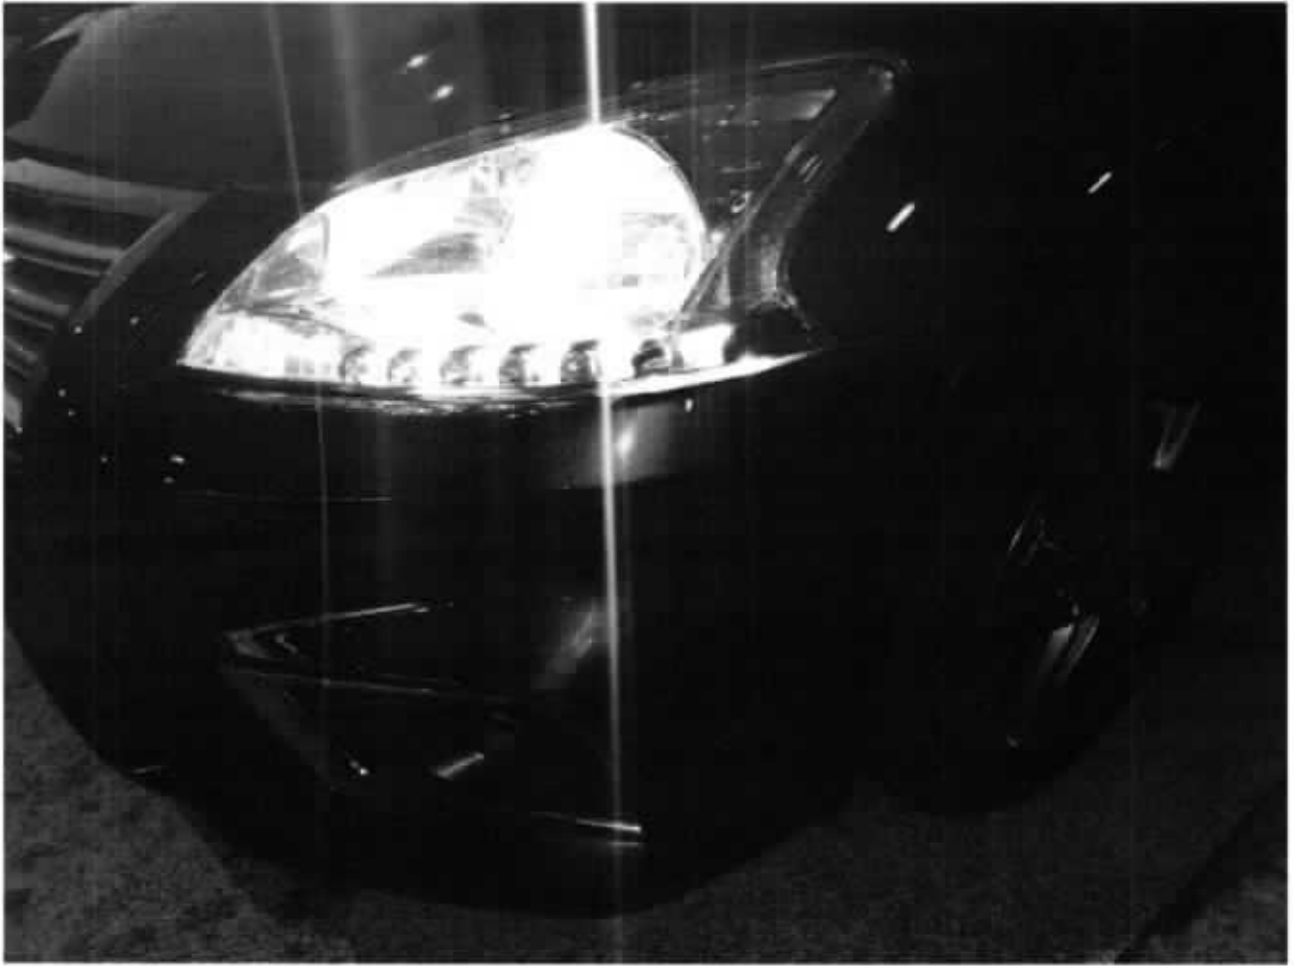
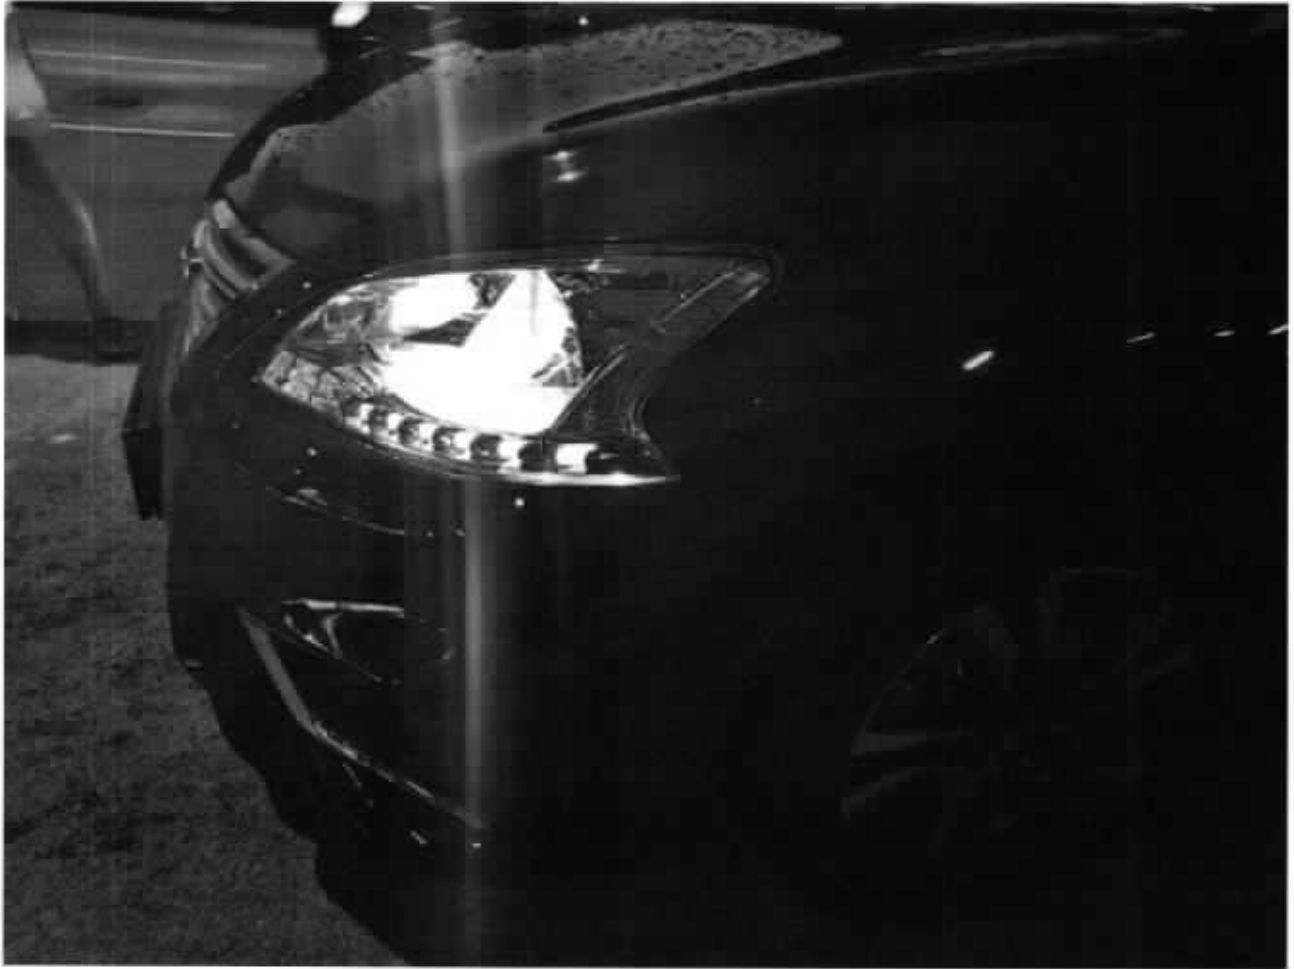
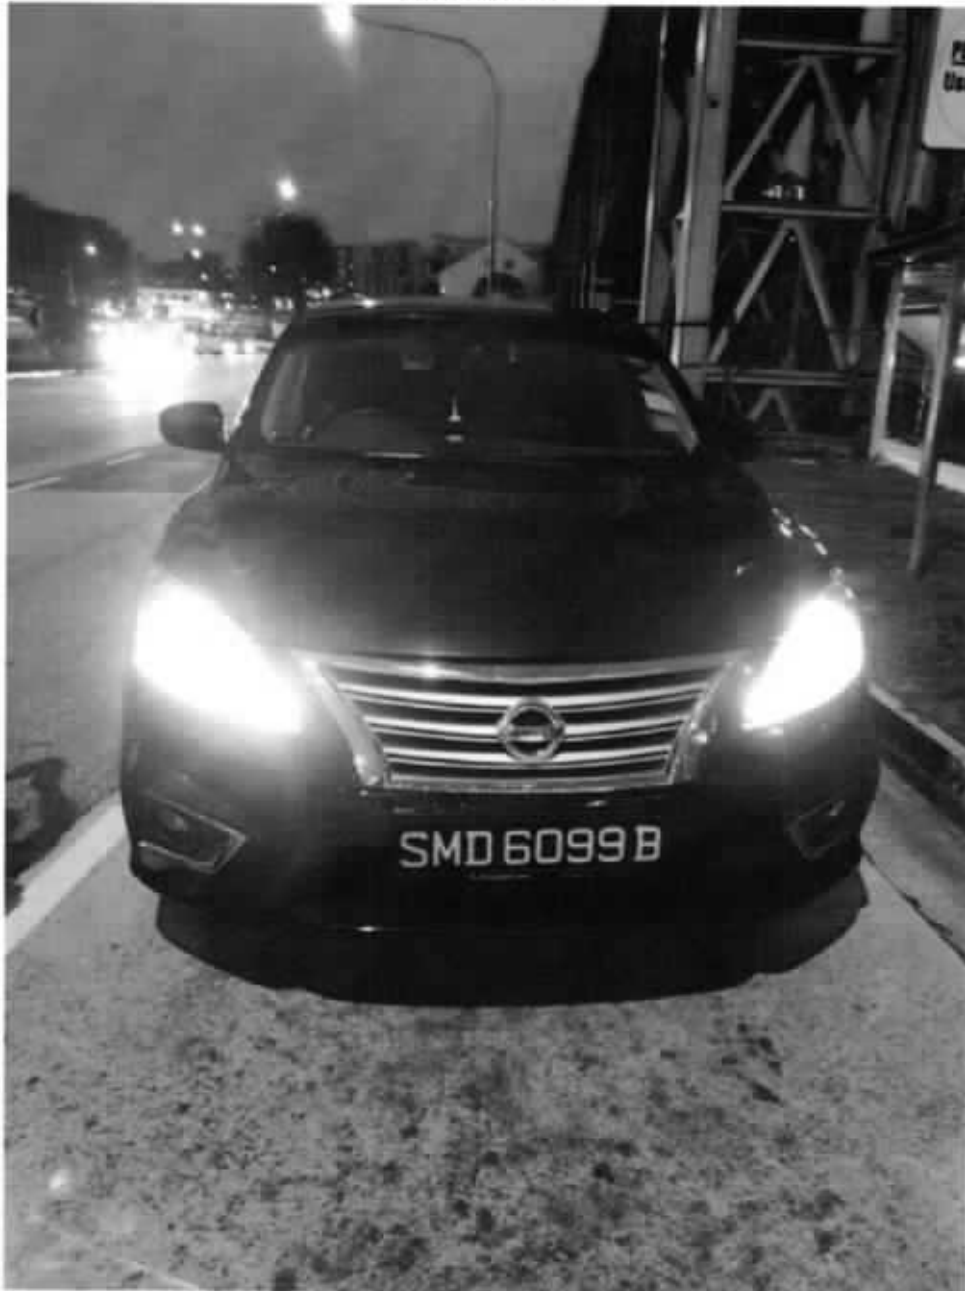
Accident Photo

At the RHR portion. The RHR road wheel was also affected.

The rear bumper, RHR fender, RHR door, RHR road wheel, RHR undercarriages, etc.

The estimate cost of repair submitted by M/s Eng Shing Mechanical Works as per schedule attached have been revise and scrutinize. We list the breakdown of our findings and recommendation as per attached.

The repairer has agreed to undertake the repair at a lumpsum of SGD \$7,250.00
